Safety First

The Airbus Safety Magazine

03 | December 2006

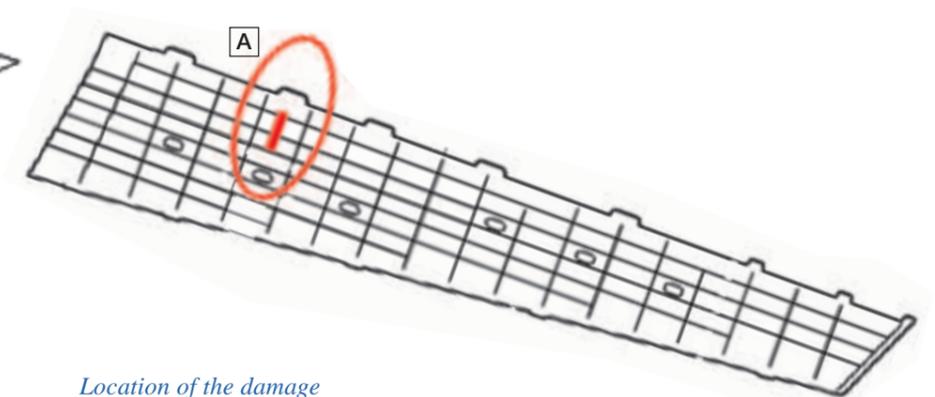
Location of the damage

On 21st of August 2004 upon landing, the subject airplane was found with a torn lower skin of the right hand THS Lateral Box. This damage was thought to be due to a Foreign Object Damage (FOD) and resulted in a leaking Trim Tank.

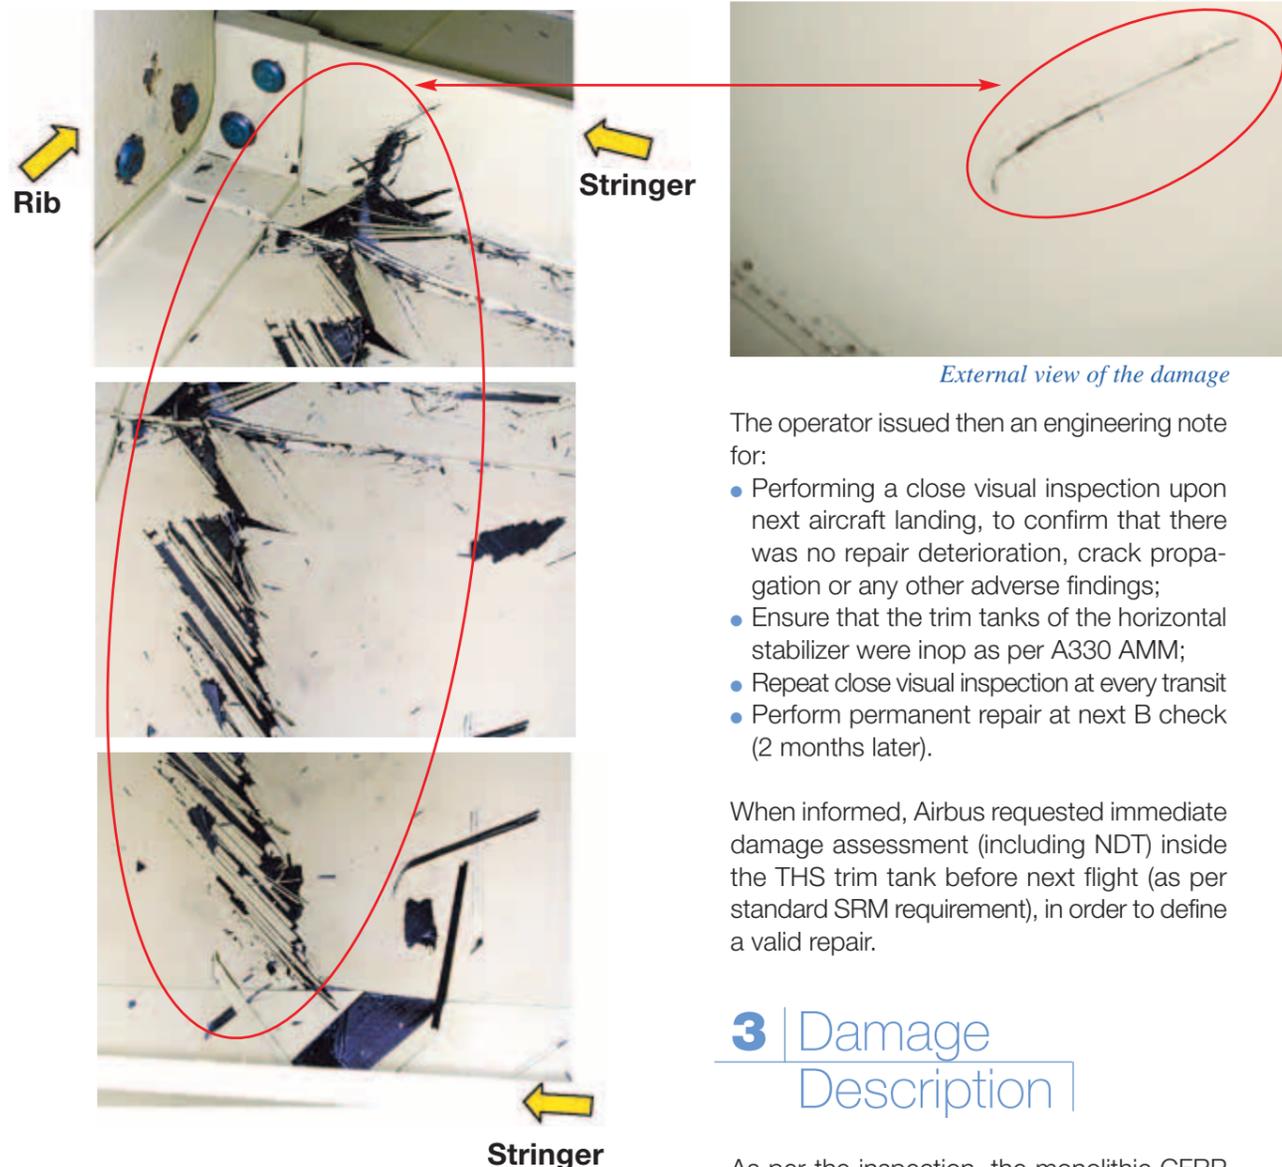
External view of the damage

A missing water servicing door (164AR) was suspected to have caused the damage. The damage was inspected externally only. The external cut was measured to be about 330mm length by 3mm width, in line of flight, located at the THS bottom skin panel, just behind second THS inboard handhole access panel.

The visible damage is shown on the picture: Based on external visual findings, the operator performed a temporary repair, by filling the damage

As per the inspection, the monolithic CFRP panel was found cracked throughout the cut length, with large delaminations in the surrounding area.

Two stringers located on the THS bottom skin panel had been severely damaged.

The aircraft required immediate appropriate repair, as the temporary repair did not restore the required structural integrity of the THS.

When informed, Airbus requested immediate damage assessment (including NDT) inside the THS trim tank before next flight (as per standard SRM requirement), in order to define a valid repair.

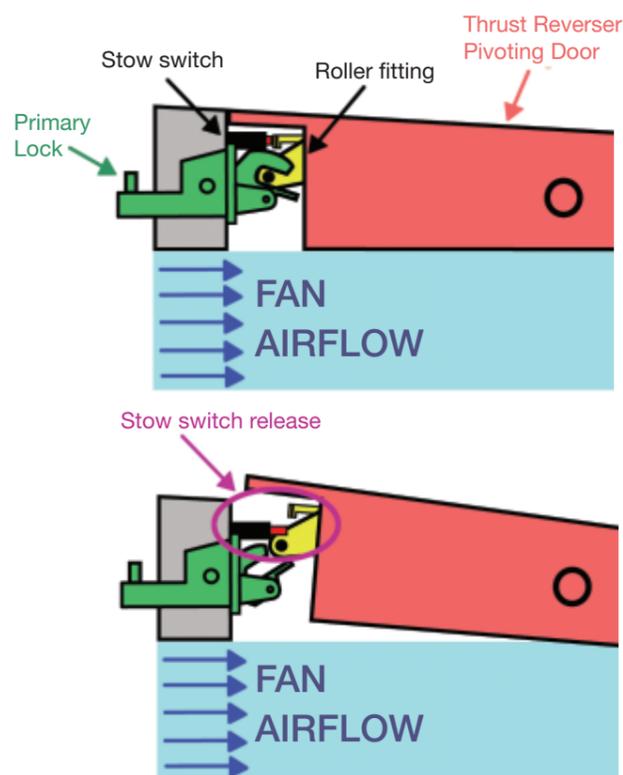
Fig 3: Release of the stow switch with Primary lock open

When the locking system is not pressurized, the secondary lock is engaged, ready to retain the actuator in its almost full-retracted position. If the primary lock fails, the door will extend slightly above the flush position before the secondary lock engages. In that case, the stow switch sensor is released (Fig 3), which leads to the generation of an “**ENG X REV UNLOCKED**” warning on the ECAM.

The above-described root causes usually lead to an unstable position of the primary lock between open and closed position. This unstable position switches to the open position (secondary lock activated) during the following flight due to engine acceleration/vibration. In most cases this happens during the takeoff run. An “**ENG X REV UNLOCKED**” warning is triggered and the crew performs a Rejected Take Off.

Maintenance will find a pivoting door ajar on the affected engine. Pushing the door back in its closed position will engage the primary lock and clear the issue for the next takeoff. But as the root cause has not been addressed it is likely that an “**ENG X REV UNLOCKED**” will appear after some thrust reverser actuations.

This is why troubleshooting has to be done in accordance with Ref. D or E in order to find the root cause and to apply the appropriate corrective action.
