The Airbus Safety Magazine

Edition July 2012

- ▶ Thrust Reverser Selection Means Full-Stop
- ▶ Transient Loss of Communication due to Jammed Push-To-Talk A320 and A330/A340 Families
- ▶ A380: Development of the Flight Controls - Part 2
- ▶ Preventing Fan Cowl Door Loss
- ▶ Do not forget that you are not alone in Maintenance

Issue **14**

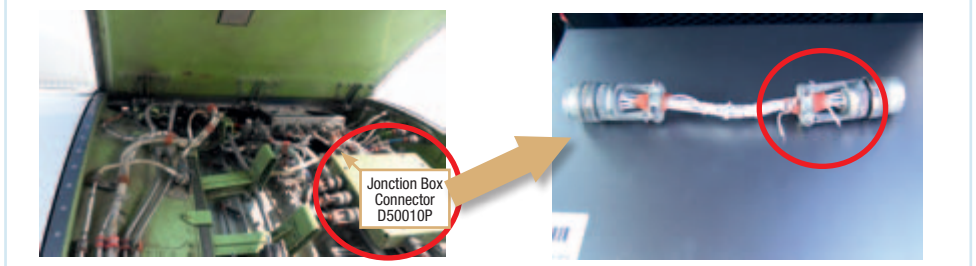
note 2

A defective pin at connector level (junction box D5010P) was at the origin of the electrical restow circuit failure.

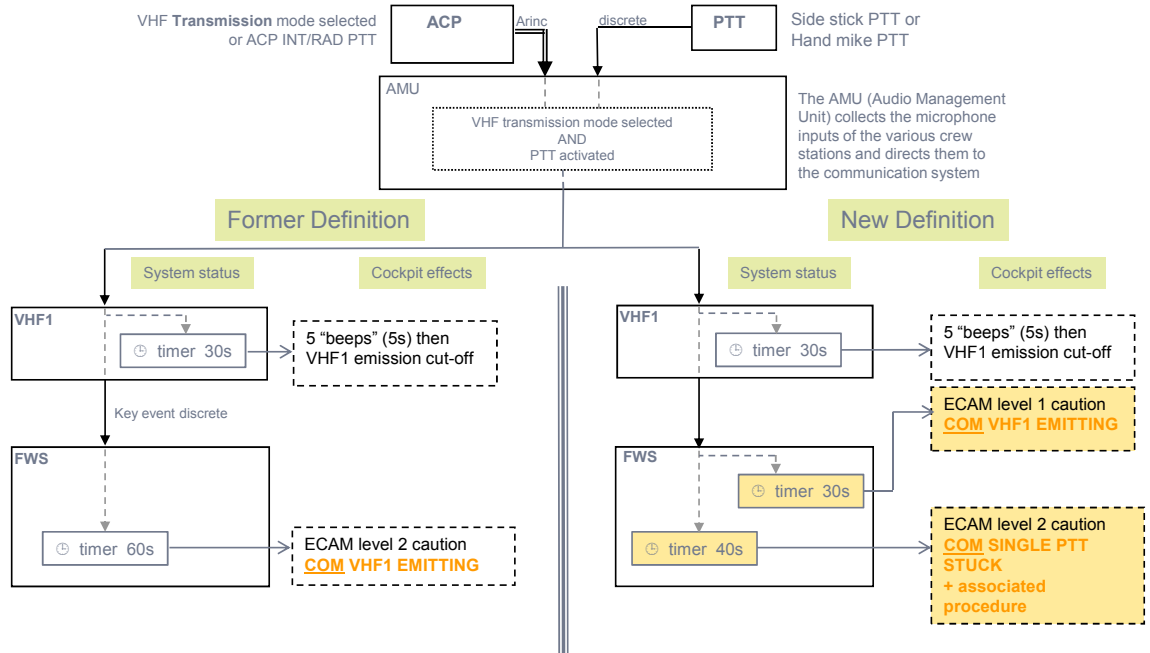
Figure 7
Current and future ECAM definition in case of PTT stuck (example for VHF1)

On the A330/A340, these improvements will be implemented on the FWC T5 standard (planned in January 2013) for the A330 and A340-500/600, and from the L13 standard (planned in August 2013) for the A340-200/300.

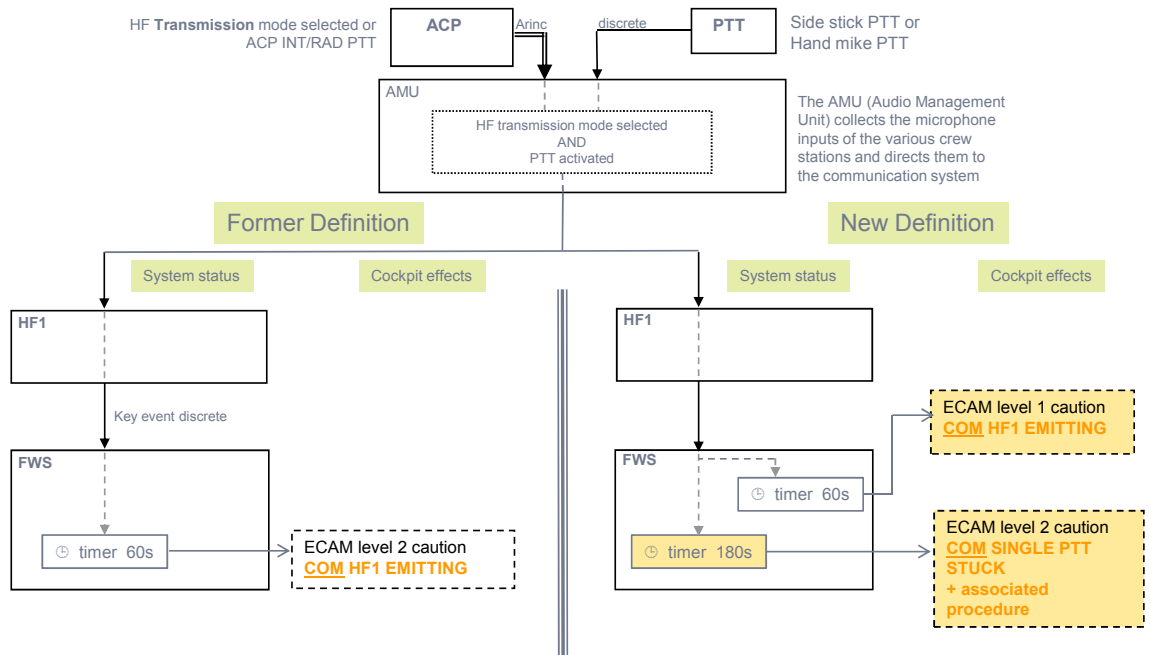
Figure 8
Current and future ECAM definition in case of PTT stuck (example for HF1)

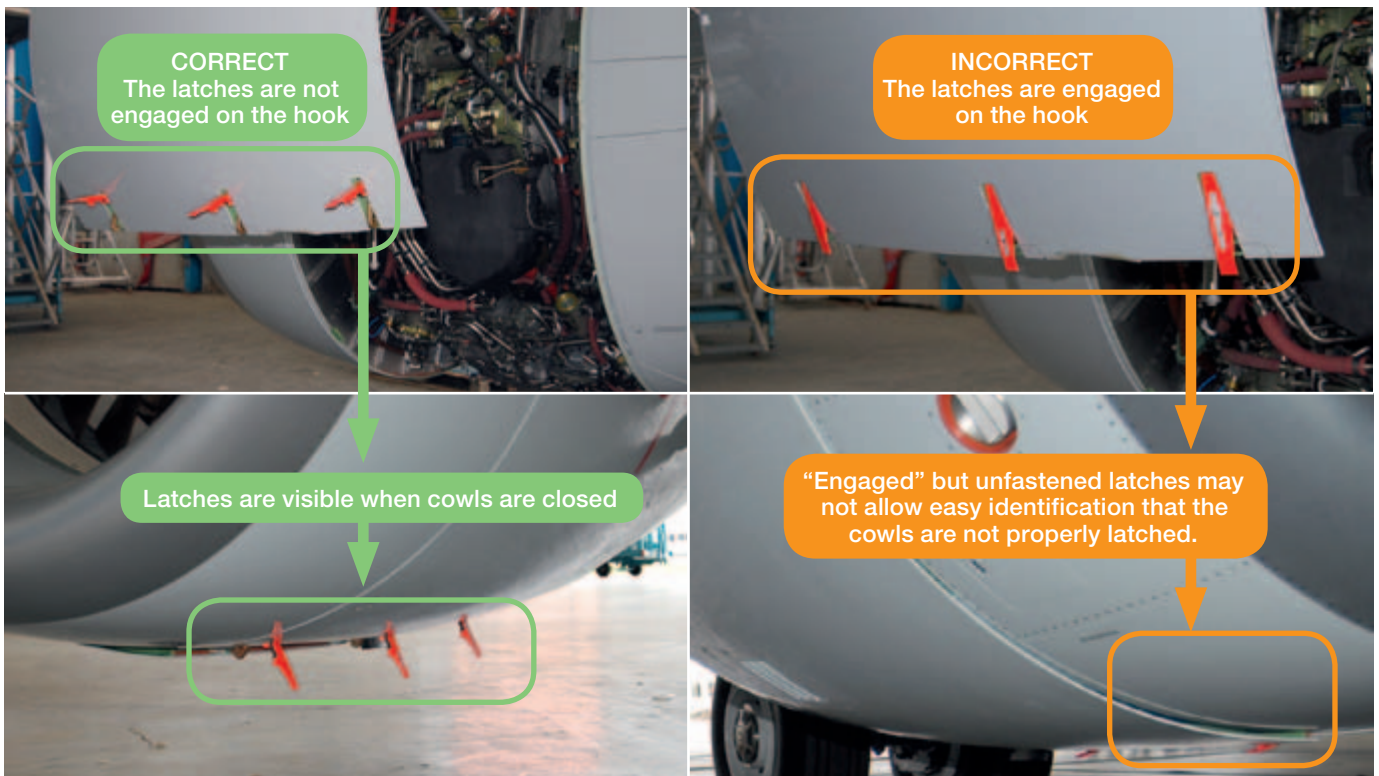
Figure 2
Latches on open doors should be left in the not engaged position

- ▶ Latches on doors in the fully open position should always be left in the horizontal (i.e. not engaged) position.
- ▶ Fan cowl doors should always be entirely latched when the cowls are being closed. Cowls must not be left in the closed position while not properly latched.
- ▶ During the exterior walk-around, the crew member has to visually check the correct closure/latching condition of the fan cowls. To do this correctly, the crew member must be positioned on the side of the engine and crouch.

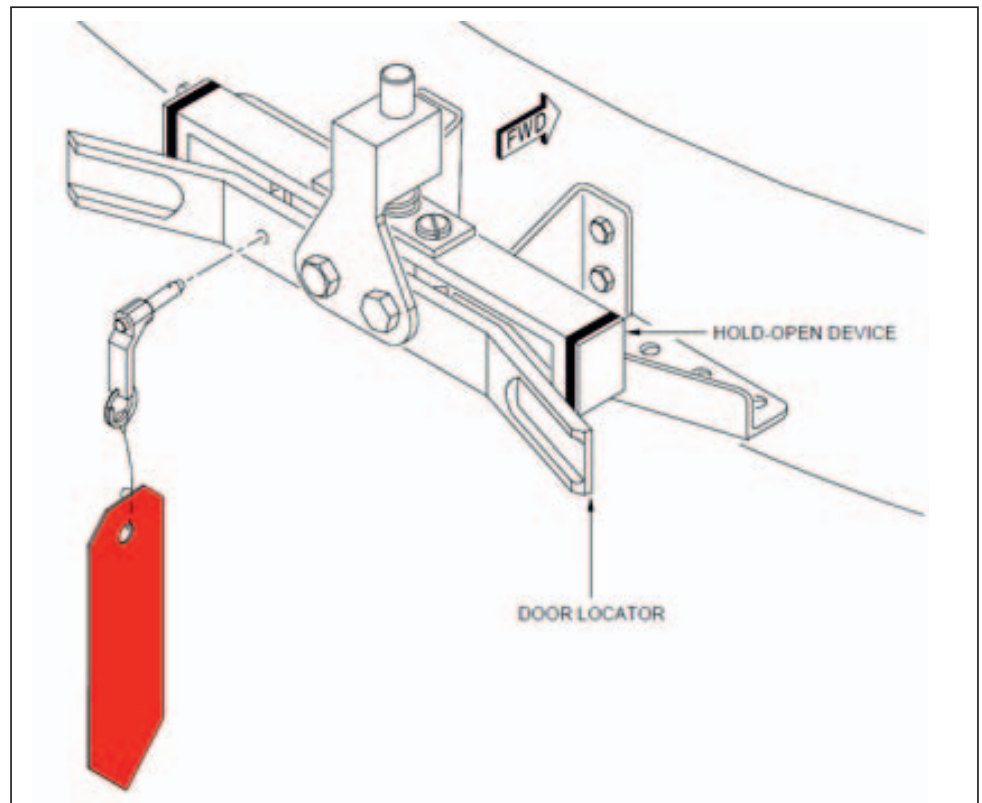
Figure 3
A320 red flag
on the IAE engine
Hold-Open device

The latest modification consists of the introduction of red flags, to improve the visibility of an unlatched condition of the cowls:

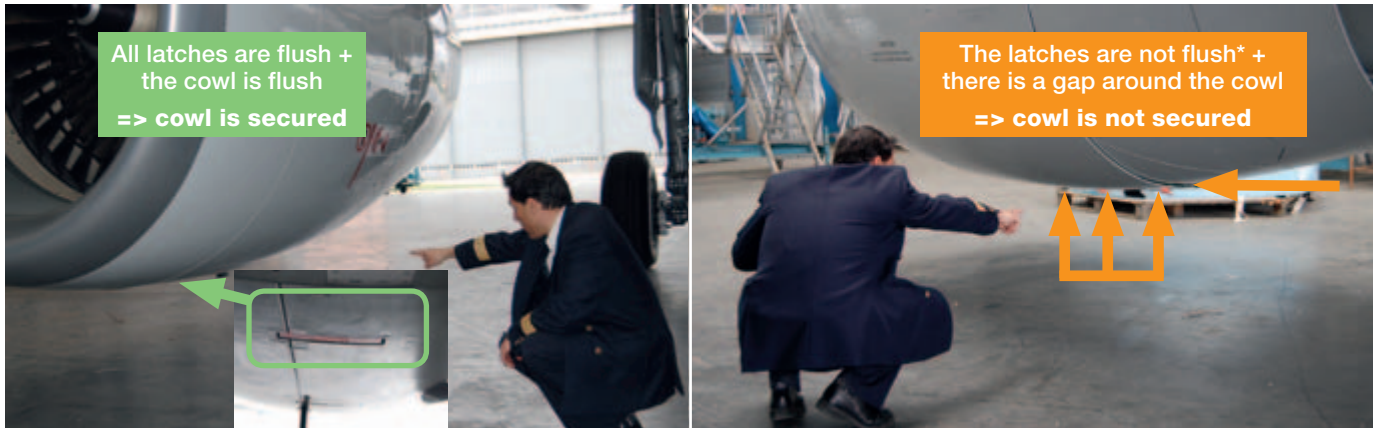
* This picture represents the worst case scenario, where the latches are engaged on the hooks, but unfastened

Figure 5
Proper walk-around check for secured fan cowl doors

As part of this inspection, it is essential that a flight crew member visually inspects the fan cowl doors prior to each flight to ensure that they are closed and latched (ref. 3, fig. 4).

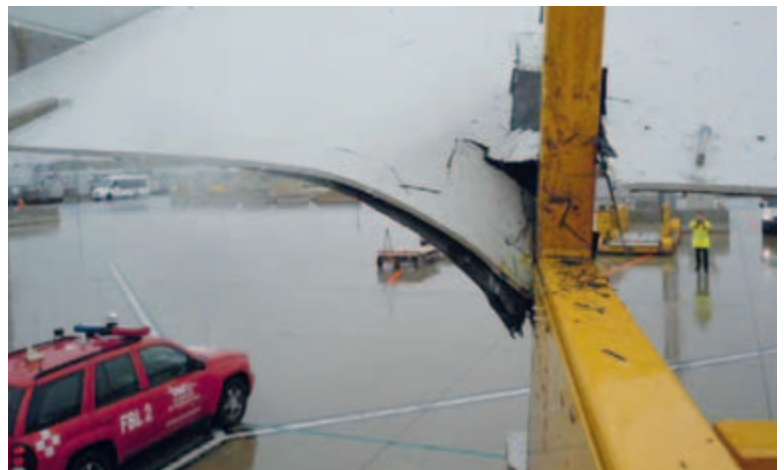
Figure 2
A possible consequence of the lack of awareness in the hangar
