Issue 169

British Airways Corporate Safety & Quality

Flywise

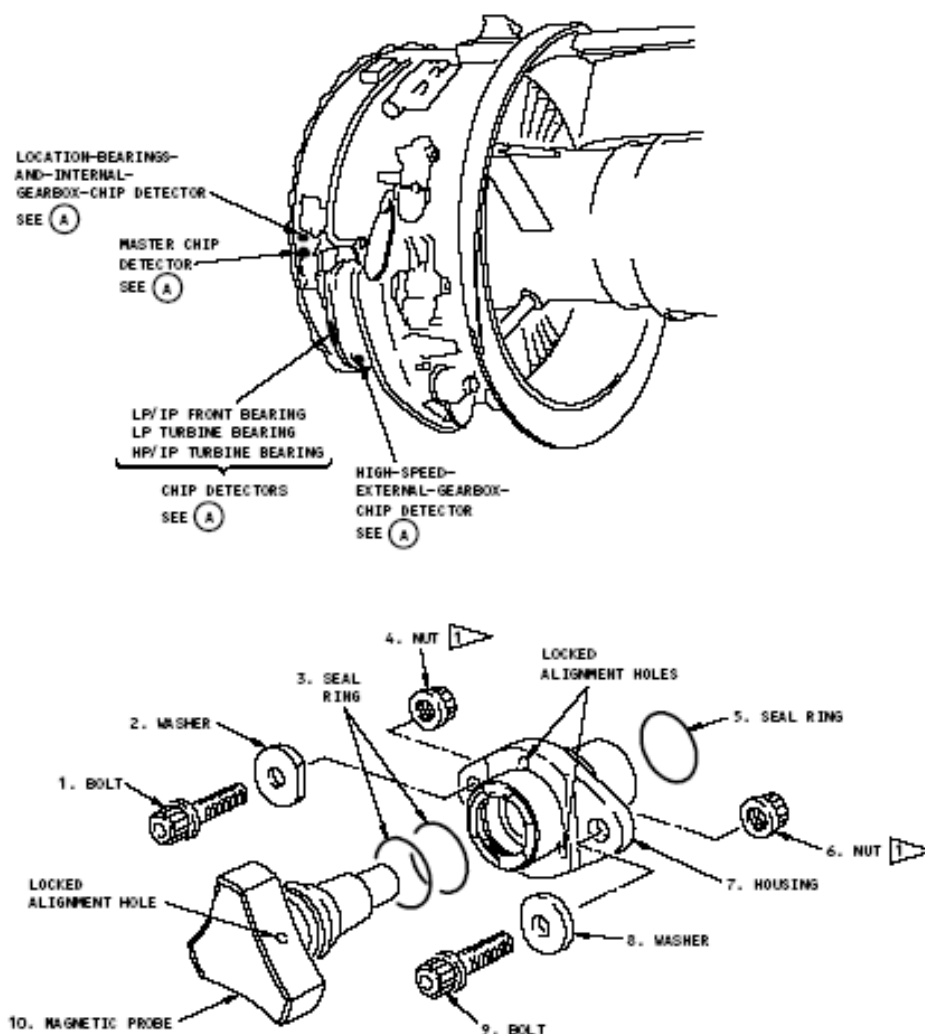
Figure 1

Initial investigations identified that the High Speed Gearbox Magnetic Chip Detector (MCD) was missing from its housing and subsequently found located in the fan cowls. The MCDs on the B767 are replaced as part of a 'weekly check' last actioned four days previous.

Master (Blue), Location (Yellow) and HSG (Silver). The MCD probe is installed in a MCD housing. It is locked into

the MCD housing with a quick-release type connector. The quick-release connector makes it possible to replace the MCD probe quickly. When the MCD probe is removed, the MCD housing seals automatically to prevent oil leakage. Seal rings must be installed on the MCD probe when it is installed in the MCD housing. The seal ring is installed to prevent oil leakage. The MCD housing prevents the installation of the MCD probe if the oil seals are not correctly installed.

The MCDs are replaced on the B767 as part of the 'weekly check'. Due to the fail safe design of the MCDs fitted to the RB211-524 series engine they have been classified as 'Non-Critical'. This requires different personnel to carry out MCD replacement on each engine followed by 'verification checks' on each engine to ensure correct fitment and sealing of the MCD in the housing.

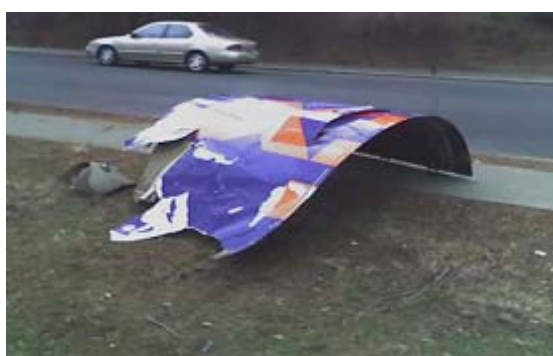
DC10-30F
New York-Newark
28 March 2006

During the initial climb a section of the No.2 engine cowling detached from the aircraft and fell into a residential neighbourhood. No injuries resulted or property damage caused. The aircraft continued its flight and landed at Oakland without further incident.

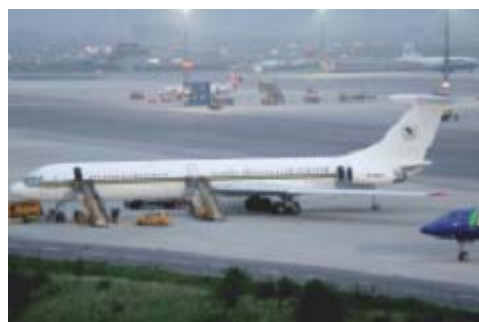
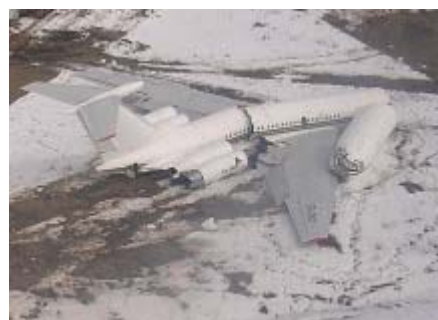
IL62
Domodedovo, Russia

After landing in darkness the aircraft veered off the side of the runway. The aircraft ran over uneven ground before coming to rest 400 metres past the end of the runway where it broke into three parts. Two crew members suffered light injuries. At the time of the accident visibility was 100 metres in fog.

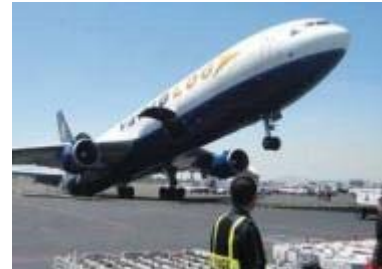
**DC10-30F
Mexico City, Mexico
13 April 2006**

While the aircraft was being unloaded the centre of gravity shifted resulting in the aircraft tipping on its tail causing minor damage. A member of the ground staff was injured.

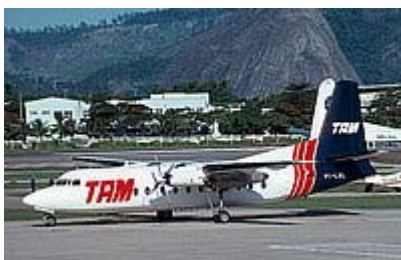
**Fokker Friendship F27
Guayaramerin, Bolivia
16 April 2006**

The aircraft ran off the runway in heavy rain causing extensive damage to the wings and landing gear. No one was injured, however, one elderly passenger died of a heart attack several hours after the accident.

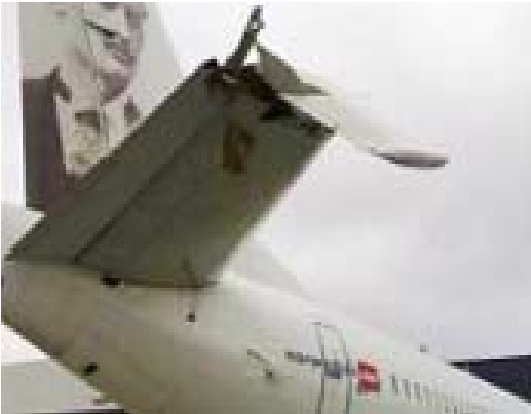
B737-300
Stavanger, Norway
26 April 2006

During overnight parking the aircraft rolled backwards until its right elevator struck the terminal building. The right elevator and control surfaces suffered substantial damage. On investigation the park brake was found not set nor were chocks inserted.
