# **Final Report**

**of AFRIQIYAH Airways Aircraft  
Airbus A330-202, 5A-ONG Crash  
Occurred at Tripoli (LIBYA)  
on 12/05/2010**

**Published February 2013**

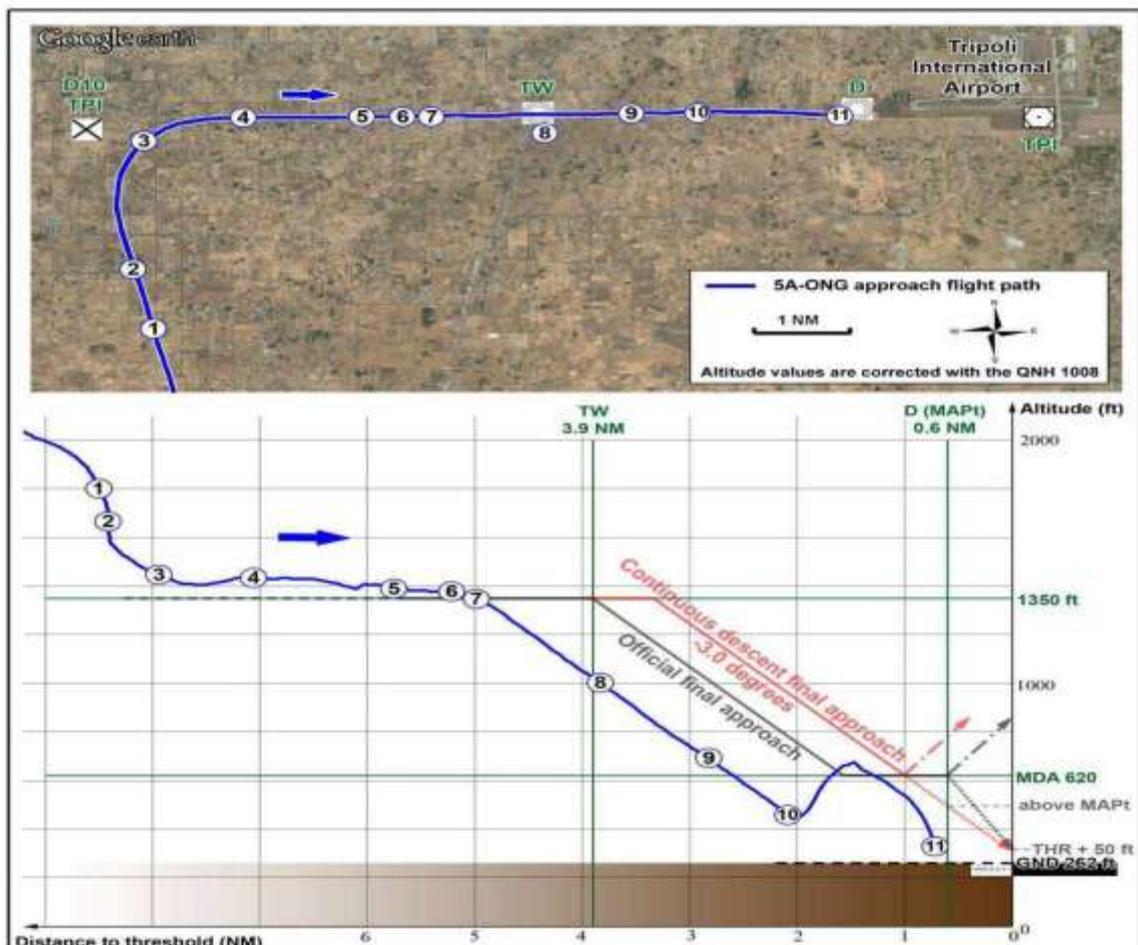
From 04 h 01 min 07 onward, the TAWS “DON’T SINK”, “TOO LOW TERRAIN” and “PULL UP” warnings respectively were recorded by the SSCVR.

*End of the flight path of 5A-ONG*

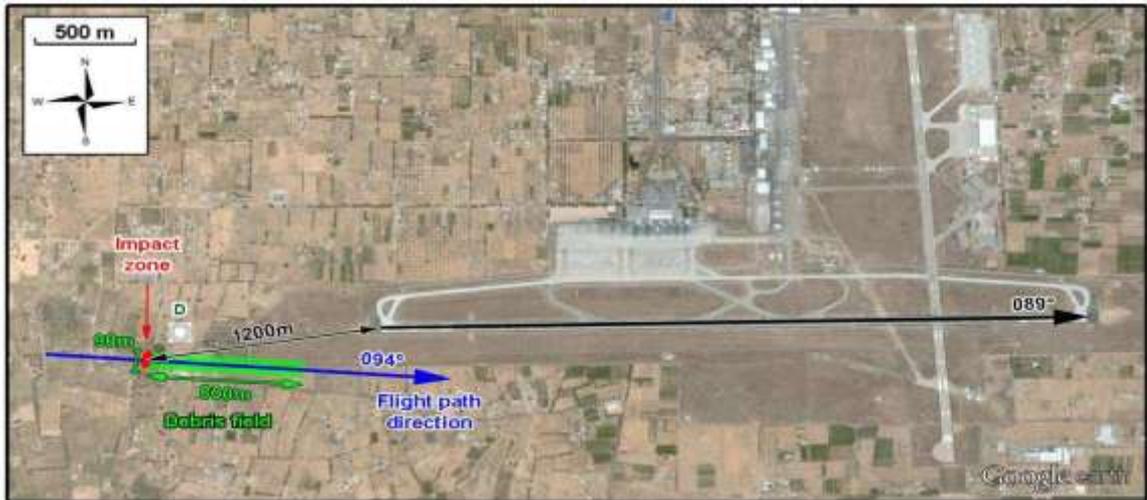
The impact site was located on a sandy plain dotted with trees, 1,200 m from the threshold of runway 09, at an altitude of about 260 feet, outside the airport. The wreckage was spread over a rectangular area of 800 m long and 90 m wide, oriented 94 degrees, and some debris was found within the airport.

*Location of crash site*

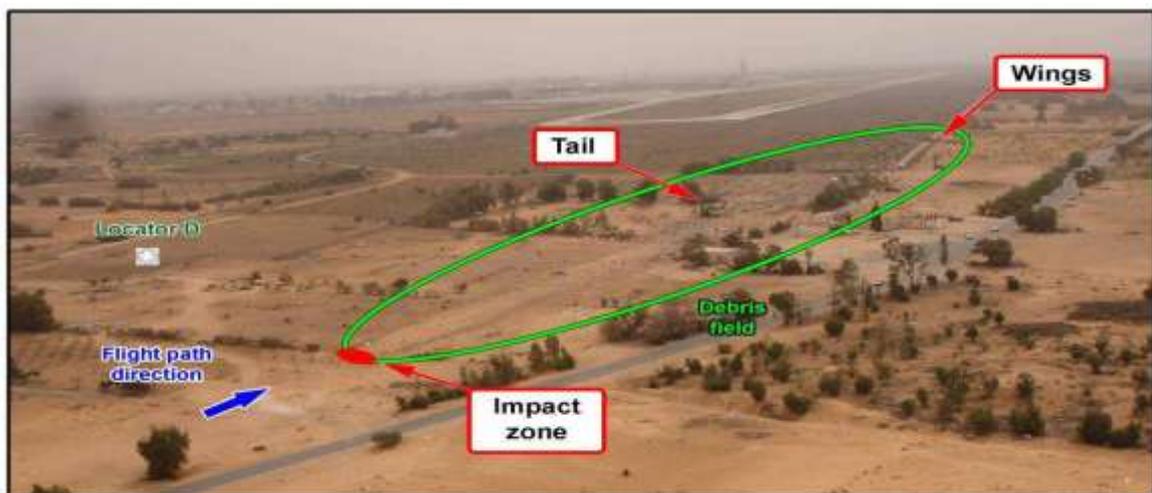
*Aerial view of the debris field*

Many small fragments belonging mainly to the mid and aft sections of the fuselage were distributed eastwards from the impact zone; pieces from the front section of the fuselage were found 180 m from the impact zone.

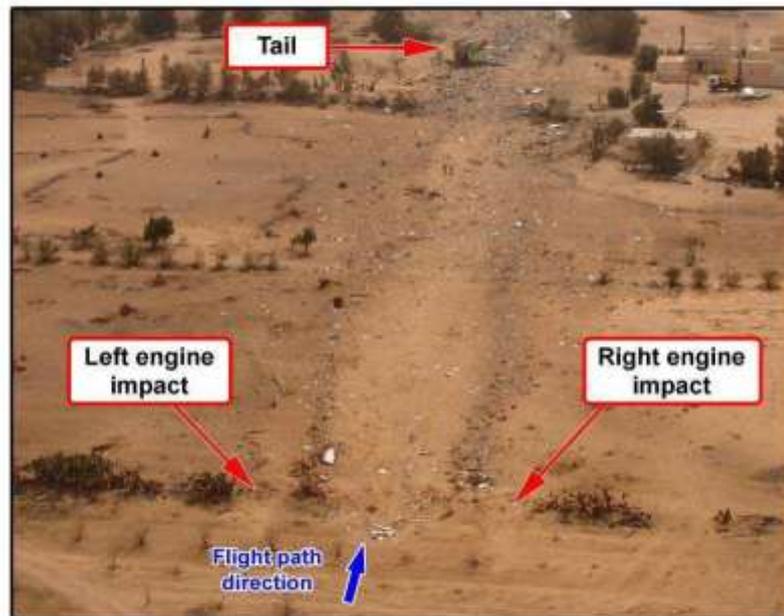
Initial observations show that the aircraft struck the ground with high energy and high longitudinal velocity.

*Aircraft ground impact*

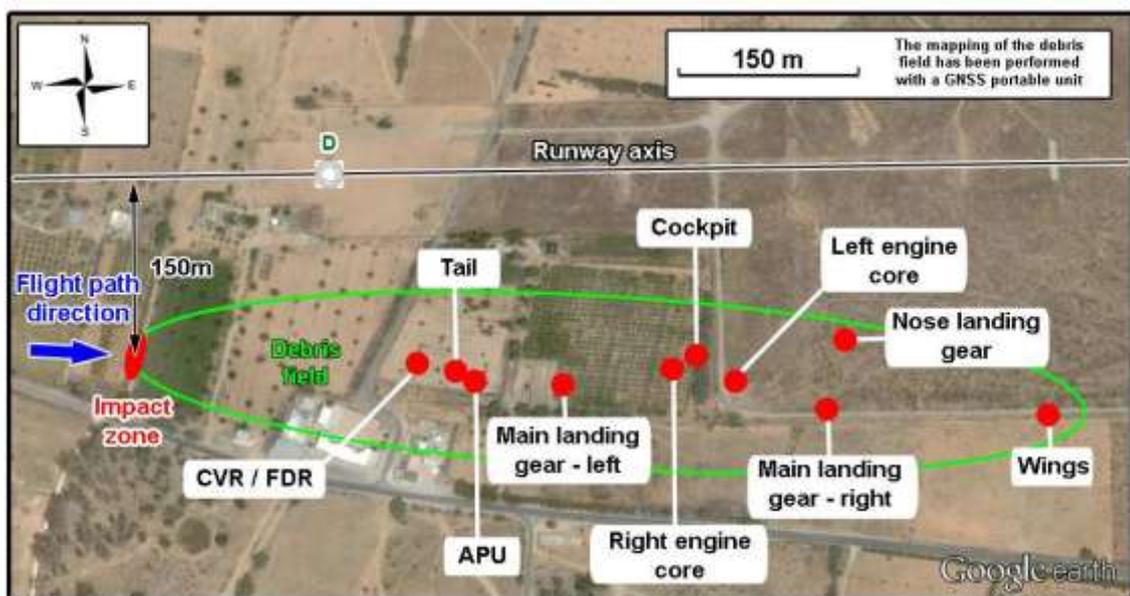
The first large items from the wreckage were distributed 270 m from the impact zone: the vertical stabilizer, the left Main Landing Gear (MLG), engine #1, the cockpit, engine #2, the right MLG, the nose gear, and finally the wings in the eastern part of the debris field. The latter bore significant fire marks.

*Distribution of the debris field*
