1 USE OF A PREDICTIVE MODEL TO AVALUATE SLEEP: ANALYSIS OF THE A330 5A-ONG ACCIDENT

RATIER-FIGEAC
Design-office

RAPPORT D'INVESTIGATIONS N°41 - DAI – 12	OT N°5739
Objet : Airbus 330 immatriculé 5A-ONG – accident survenu à Tripoli le 12/05/2010 – Analyse de dépôts ou particules observés sur un bouton de prise de priorité du mini-manche (Disconnect & Priority Switch)

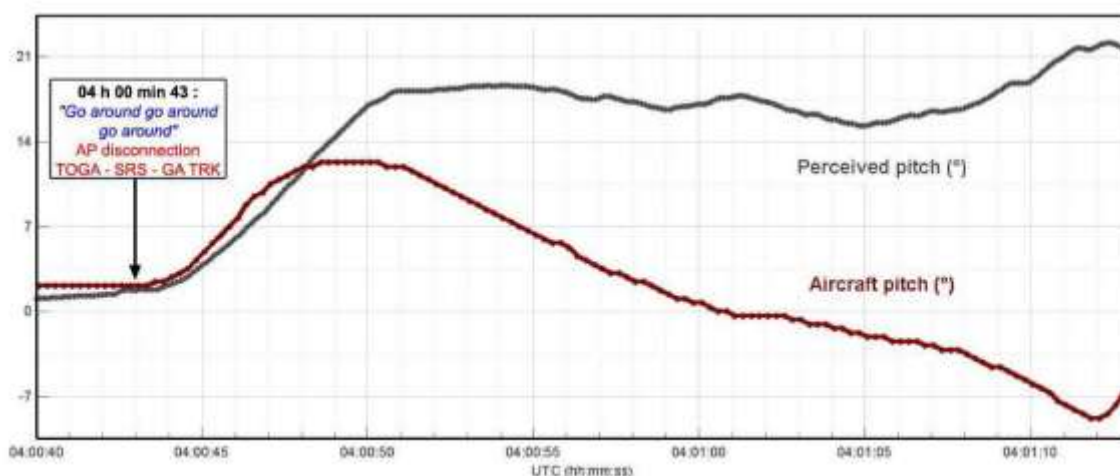
Real and perceived pitch attitudes during the missed approach

As part of the investigation, the model for estimating the perceived orientation was used with SSFDR parameters. The figure below shows that at the time of the missed approach, the attitude perceived by a pilot, provided that his perception is based exclusively on the interpretation of vestibular inputs (without external visual reference and without monitoring the artificial horizon), is initially close to the real attitude. It then deviates from the actual attitude from about 11 degrees to increase and remain between 15 and 22 degrees nose up. The first nose-down inputs recorded for the co-pilot's side stick occur at a moment corresponding to this deviation. The difference observed between the actual attitude and estimation of the perceived attitude may be related to the occurrence of a somatogravic perceptual illusion.

The following diagram shows the aeroplane pitch attitude against perceived pitch estimated by the model. It is taken from a plate that is included in appendix 10.

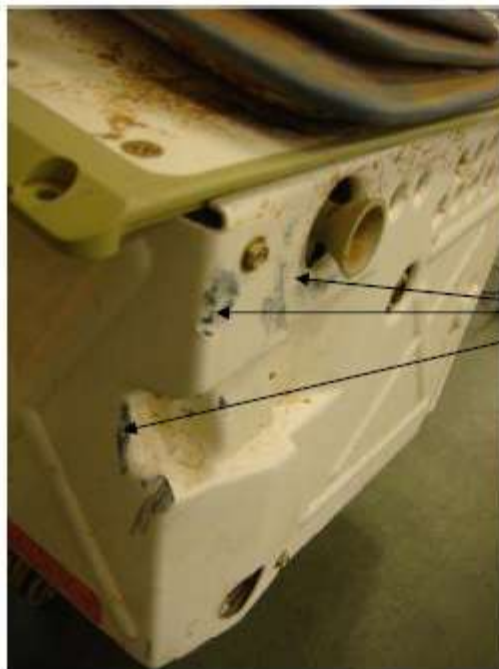
Evidences of dried liquid

Brown tracks = track of sand/dust on the covers, below, grip.

Black tracks = friction tracks

Partial conclusion: tracks of brown sand/dust and of friction

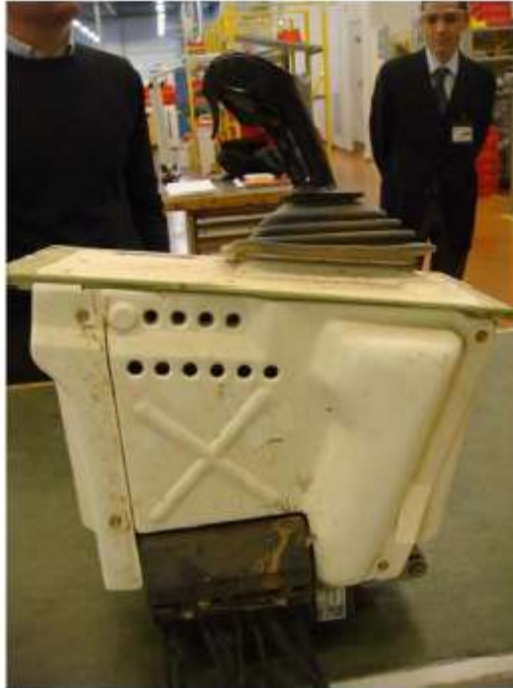
- View looking inboard

Evidences of dried liquid

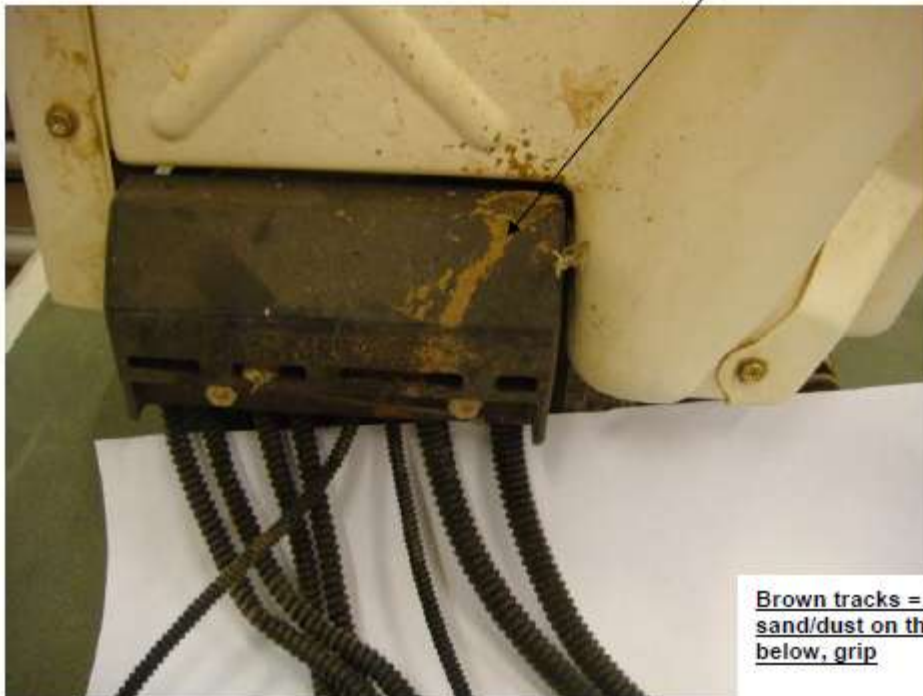
Brown tracks = track of
sand/dust on the covers,
below, grip

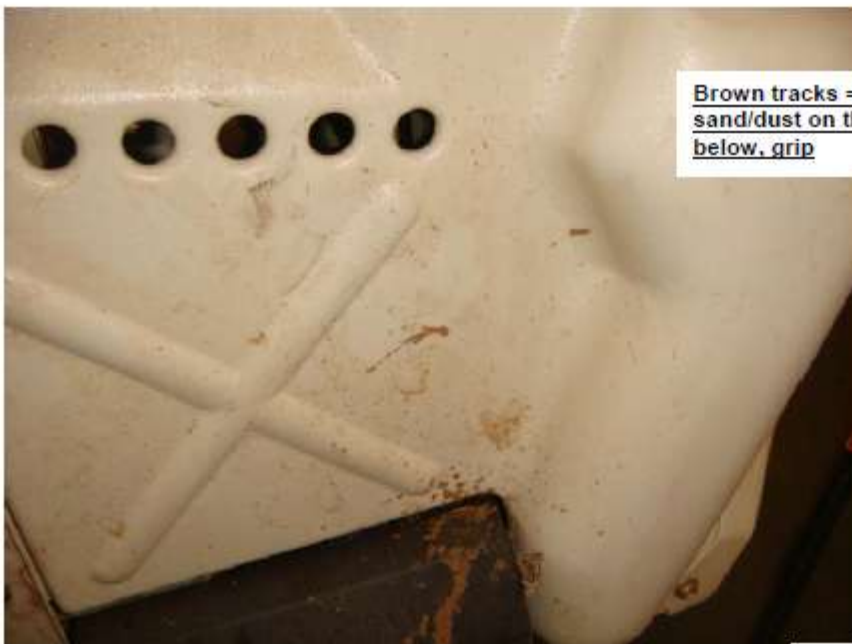
Brown tracks = track of
sand/dust on the covers,
below, grip

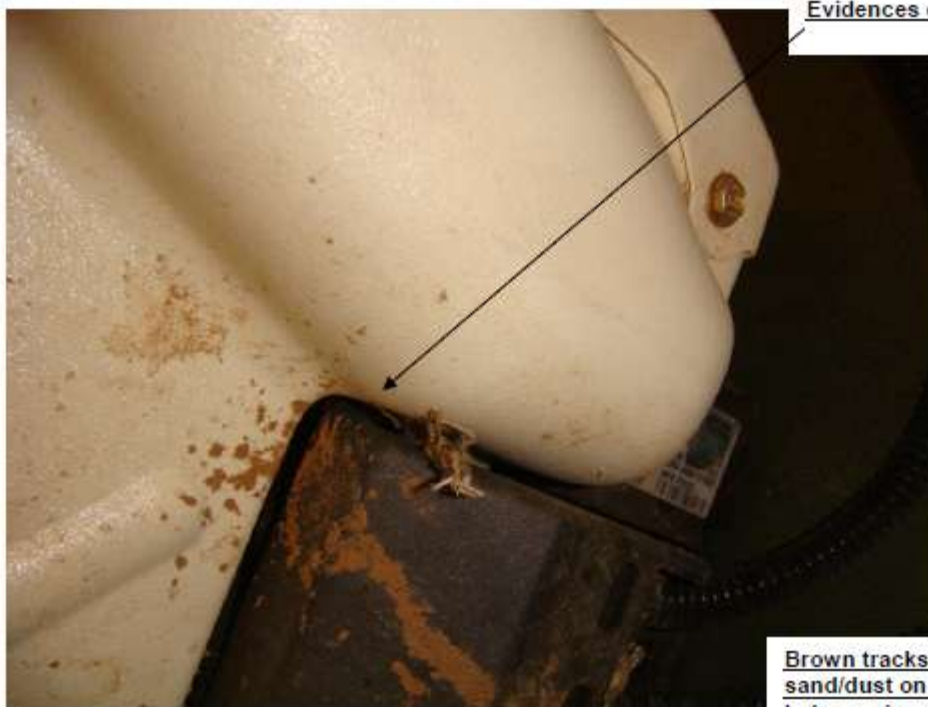
Evidences of dried liquid

Brown tracks = track of
sand/dust on the covers,
below, grip

Partial conclusion: tracks of brown sand/dust

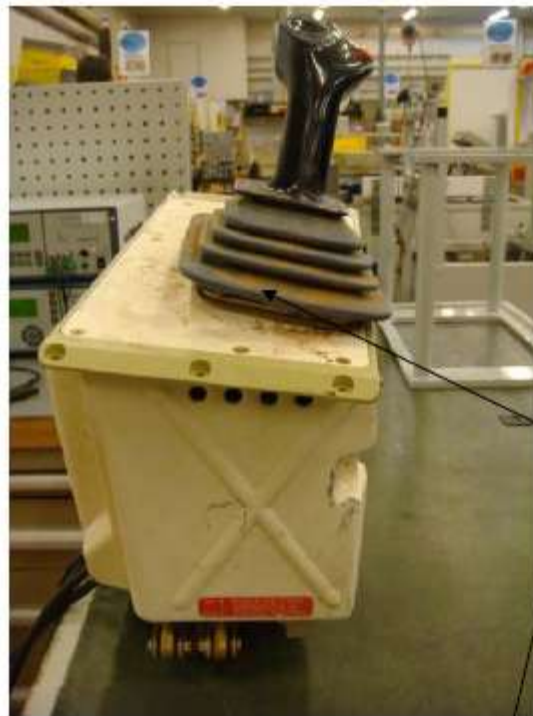
- View looking forward

Brown tracks = track of sand/dust on the covers, below, grip

Torn below in its rear part

Evidences of dried liquid

Partial conclusion: tracks of brown sand/dust. Torn below and of friction

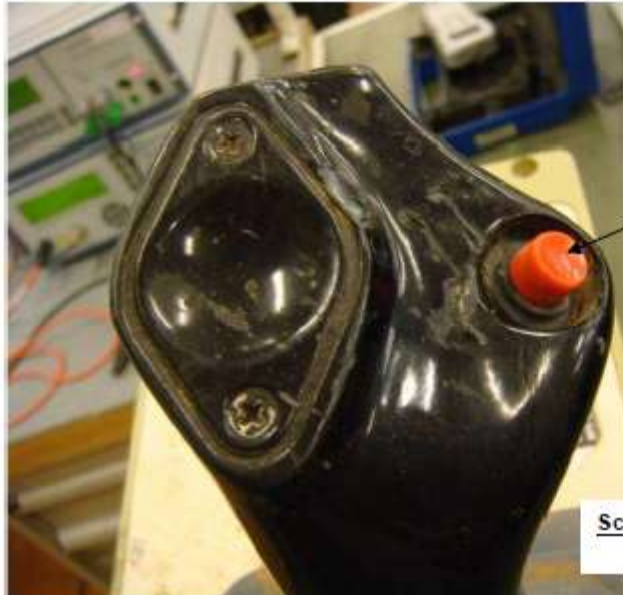
Scratches on the grip

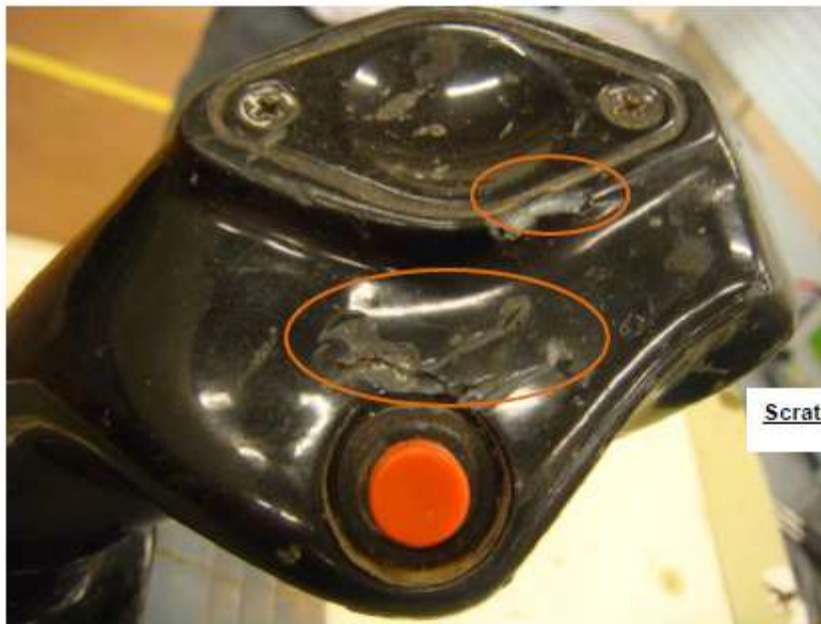
Scratches on the grip

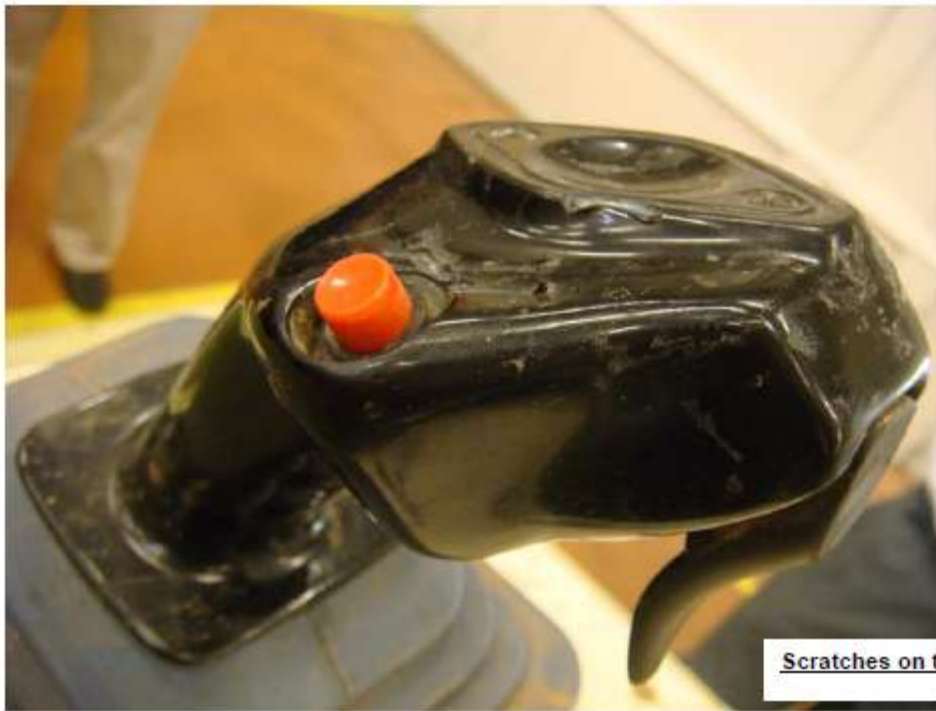
Scratches on the grip

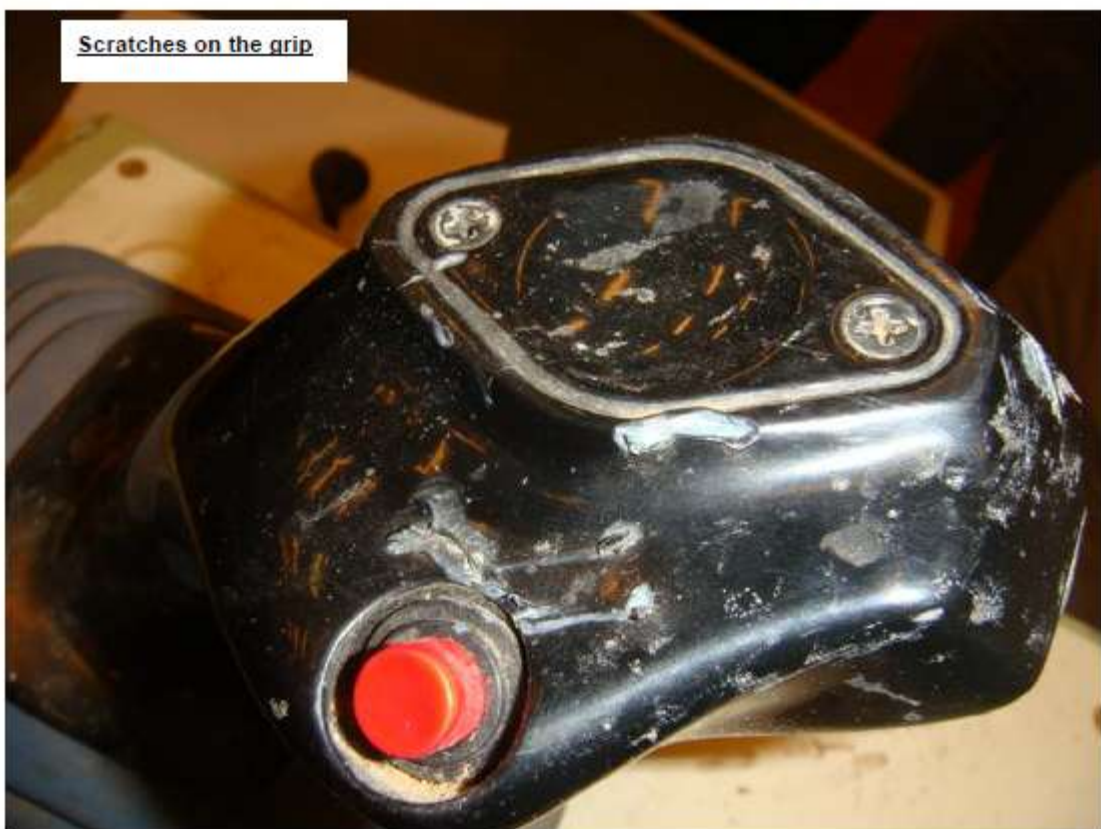
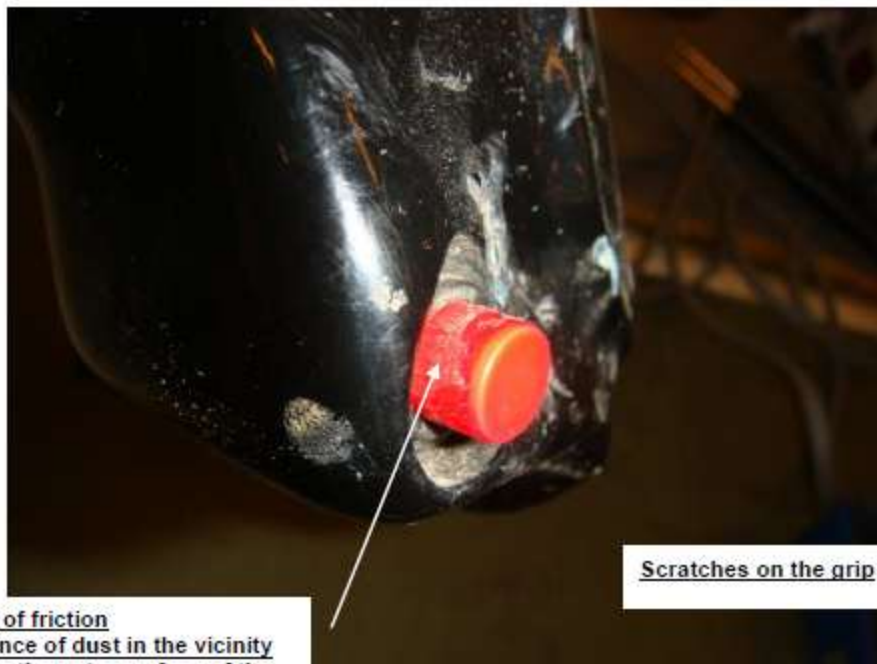
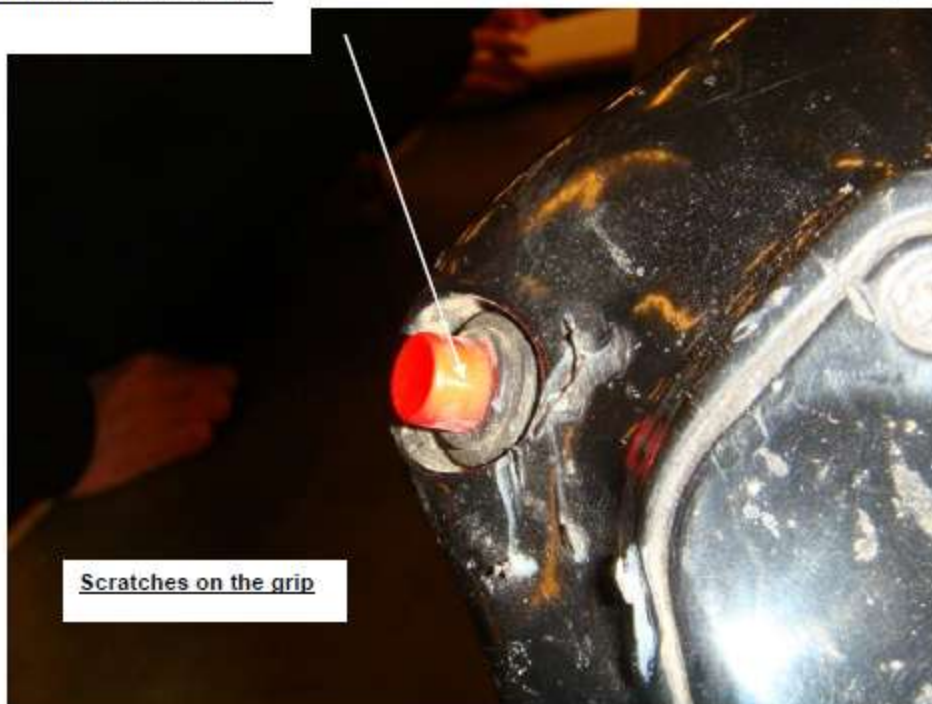
Scratches on the grip

Partial conclusion: numerous scratches on the grip. Track of friction on the side of the button.

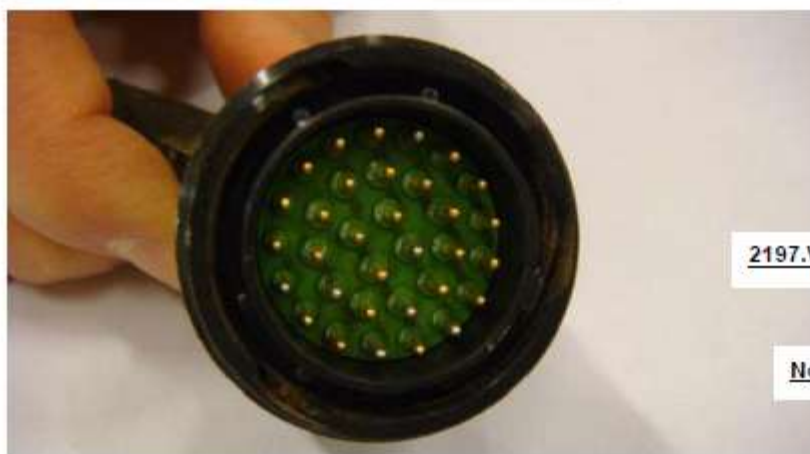
2197.VCA connector

No pin damaged

Partial conclusion: scratch on 2199.VCA connector. No cable damaged. No pin damaged.

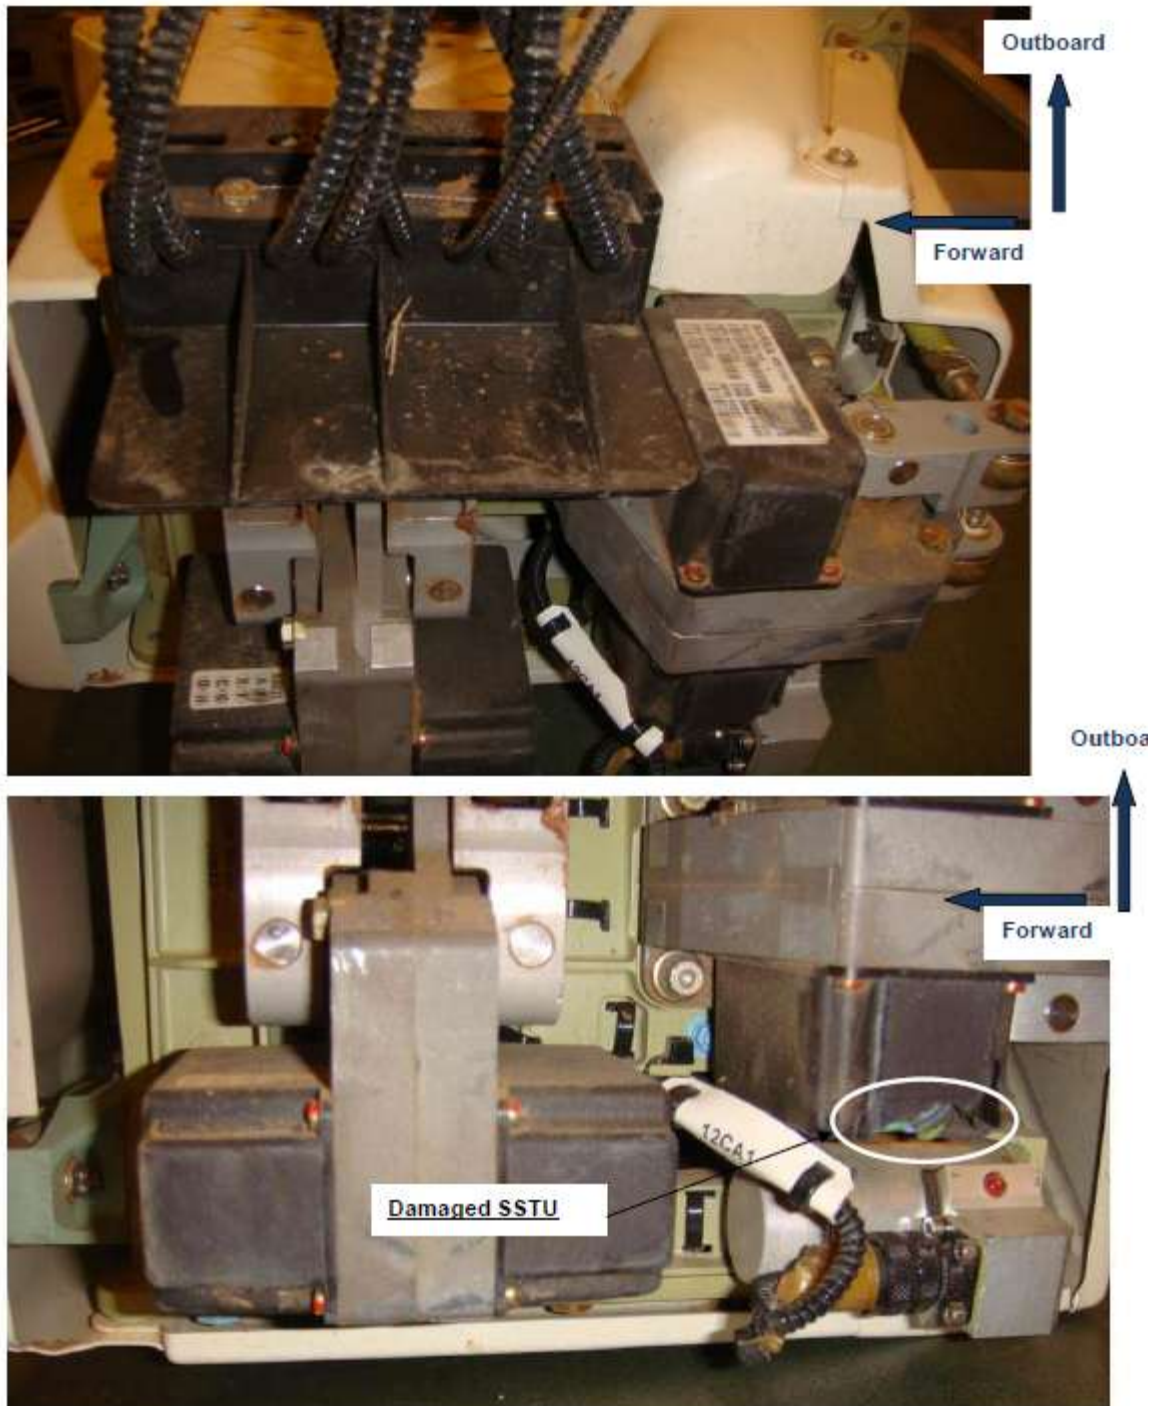
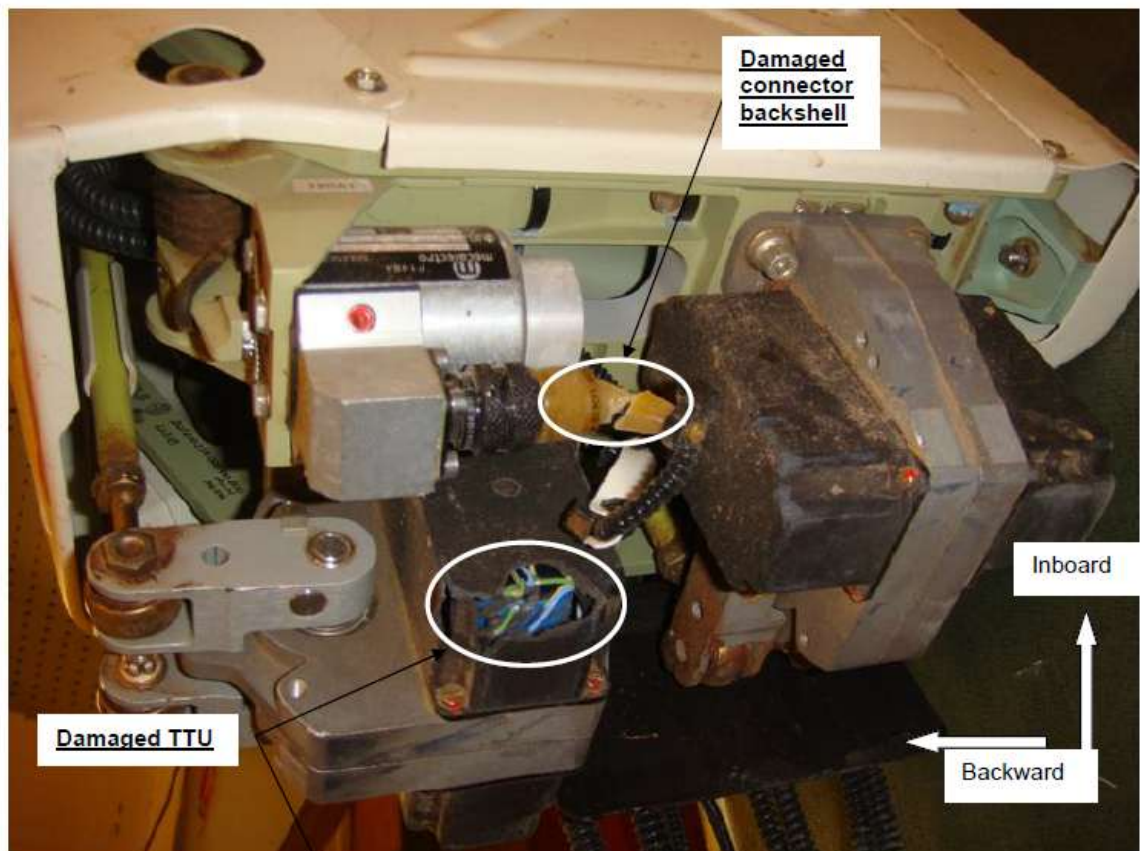
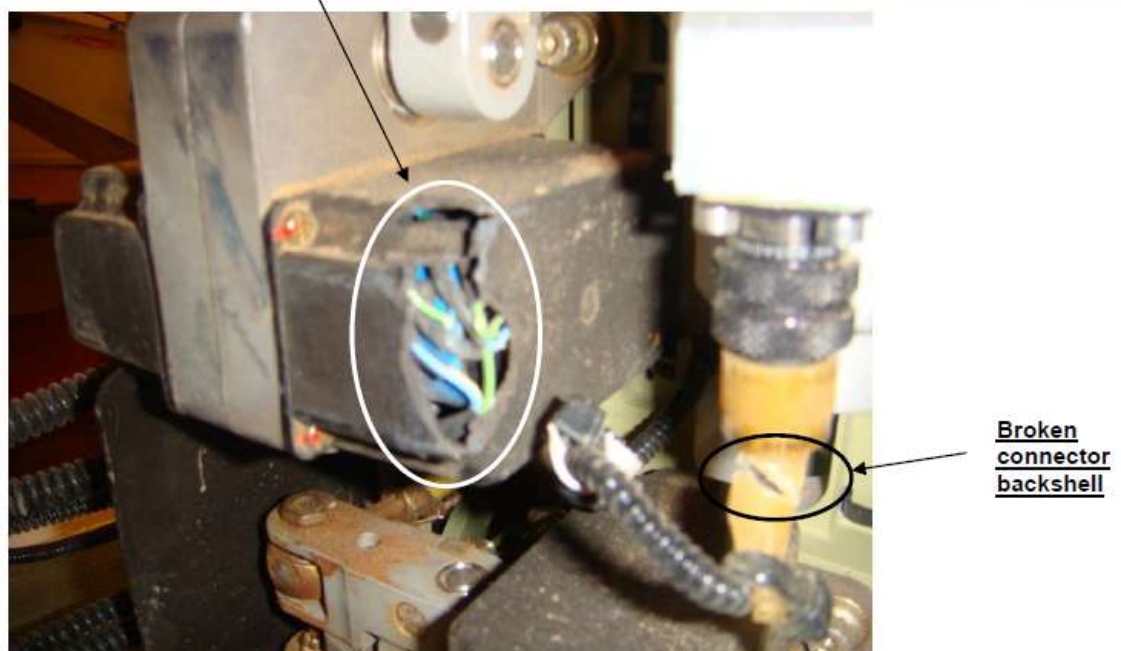
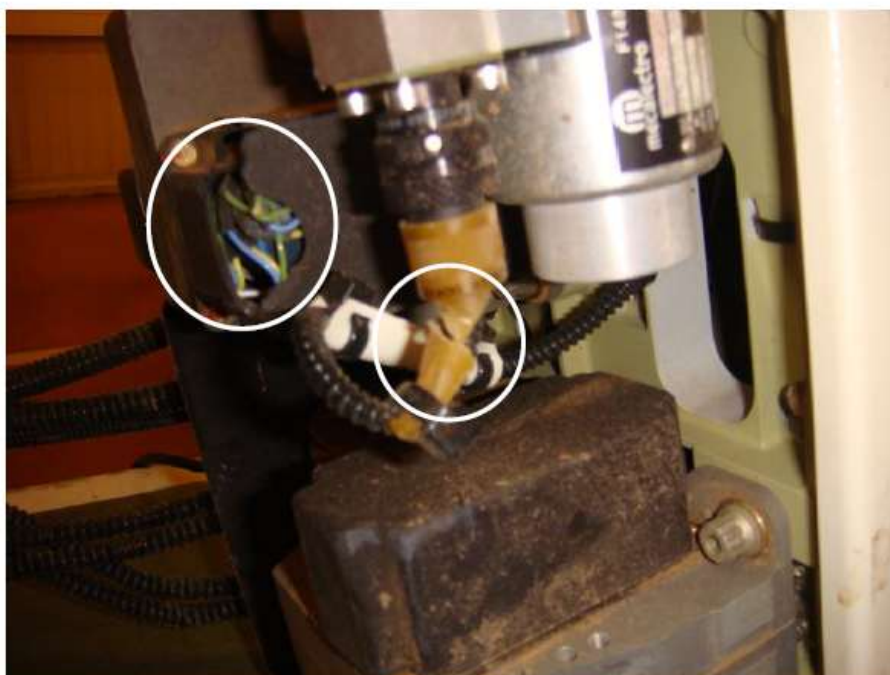
- Bottom view

Partial conclusion: track of brown sand / dust inside the SSU. One TTU cover damaged. Connector backshell of the solenoid is broken.

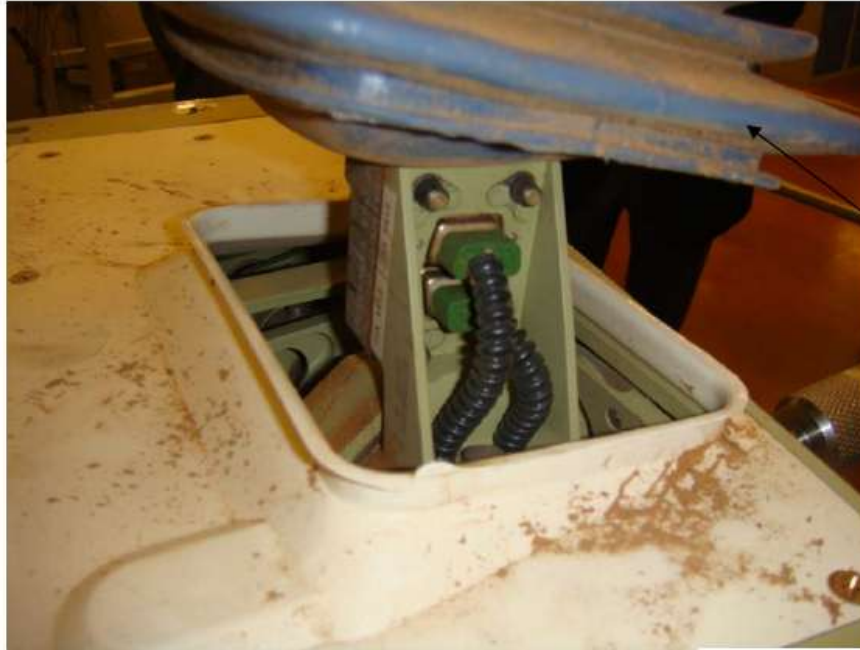
Below

Brown tracks = track of sand/dust

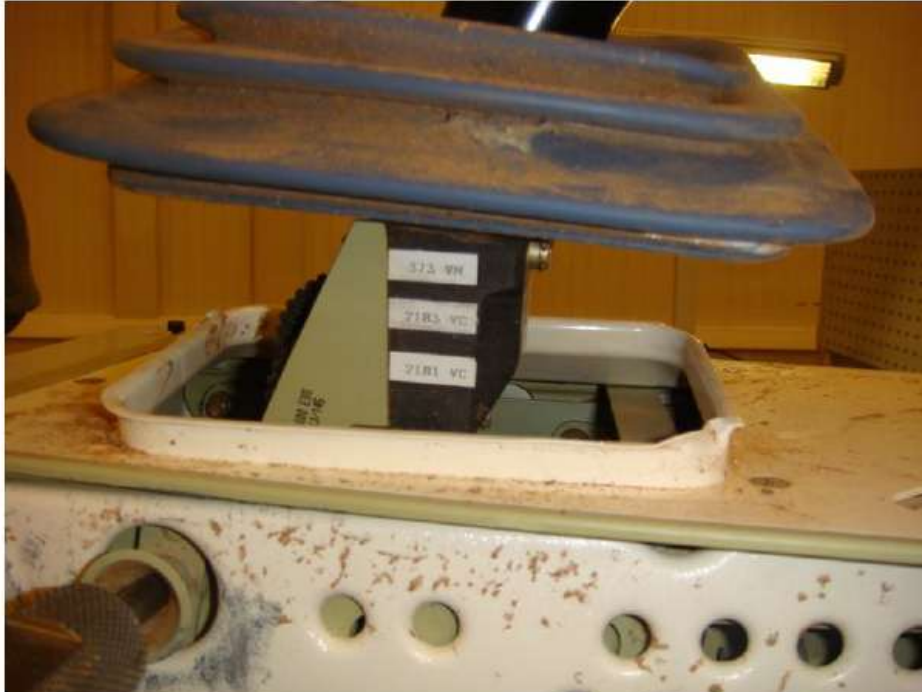
- View looking outboard

Brown tracks = track of sand/dust

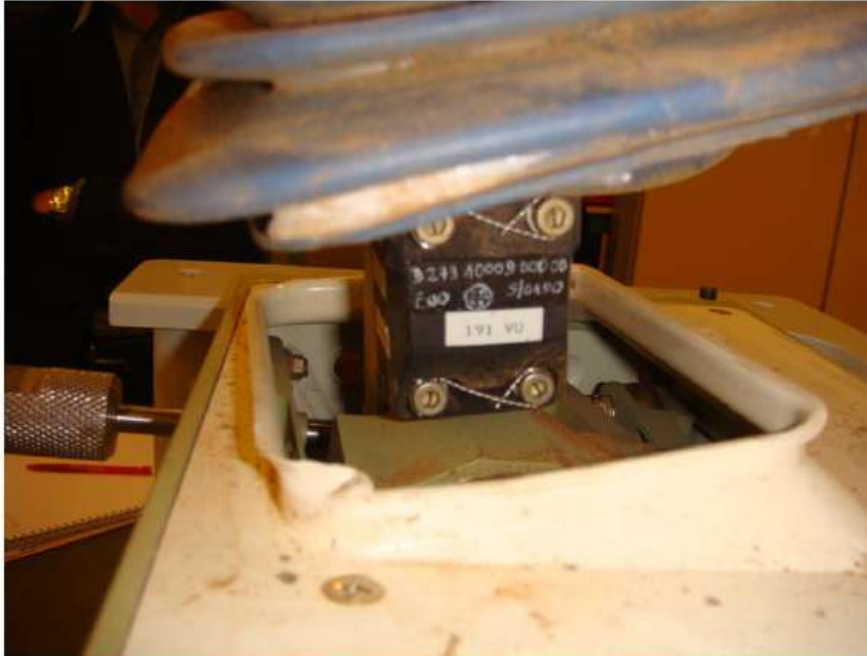
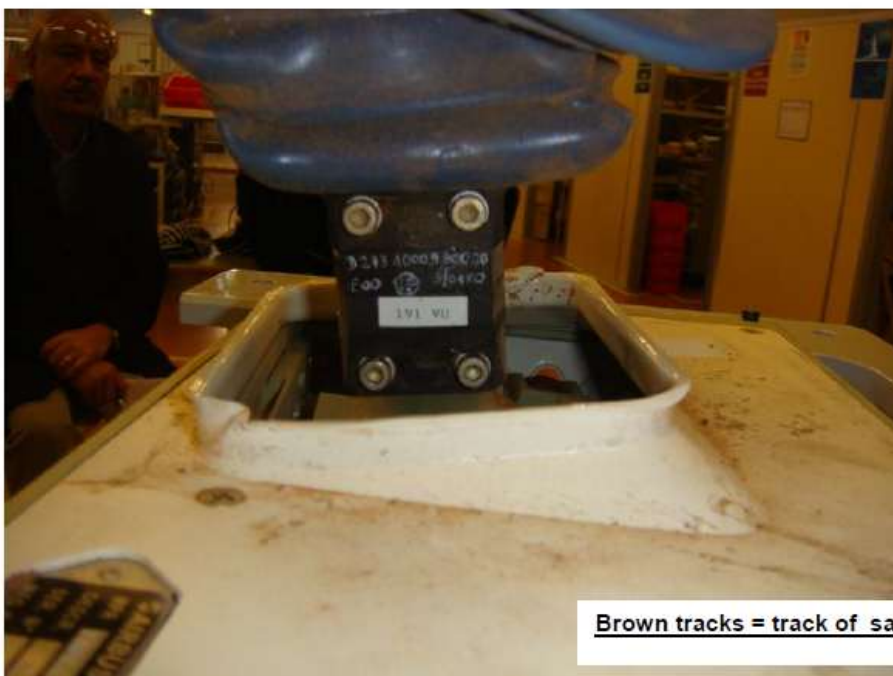
- View looking backward

Partial conclusion: numerous tracks of brown sand / dust inside the SSU.

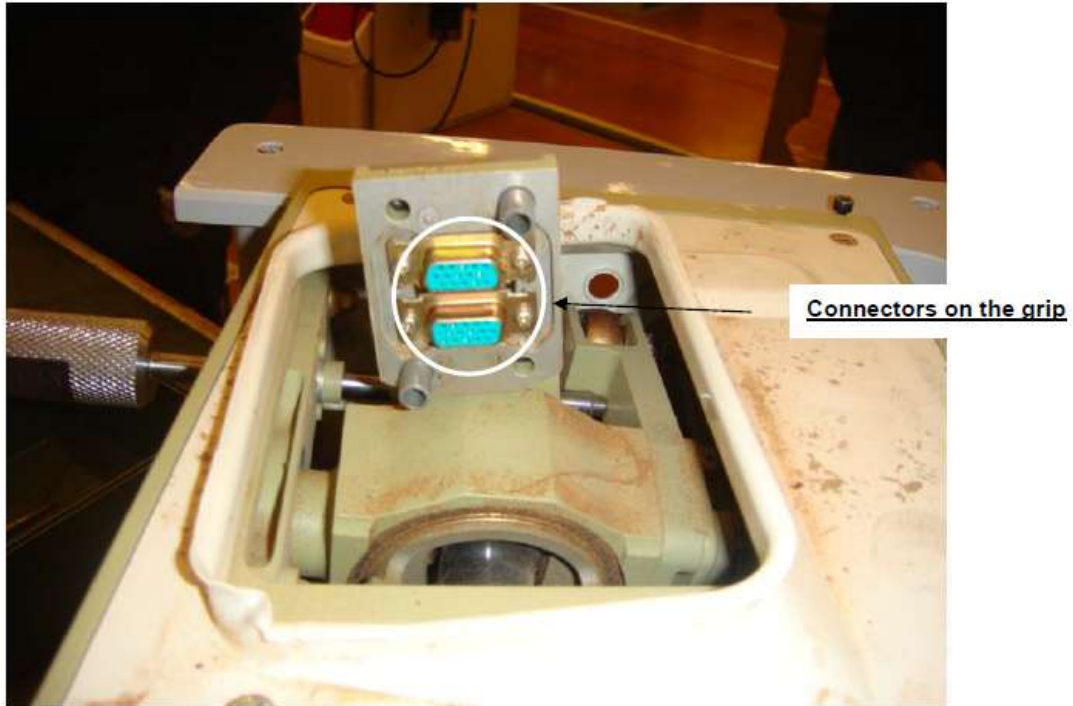
Brown tracks = track of sand/dust

Partial conclusion: numerous tracks of brown sand / dust inside the SSU

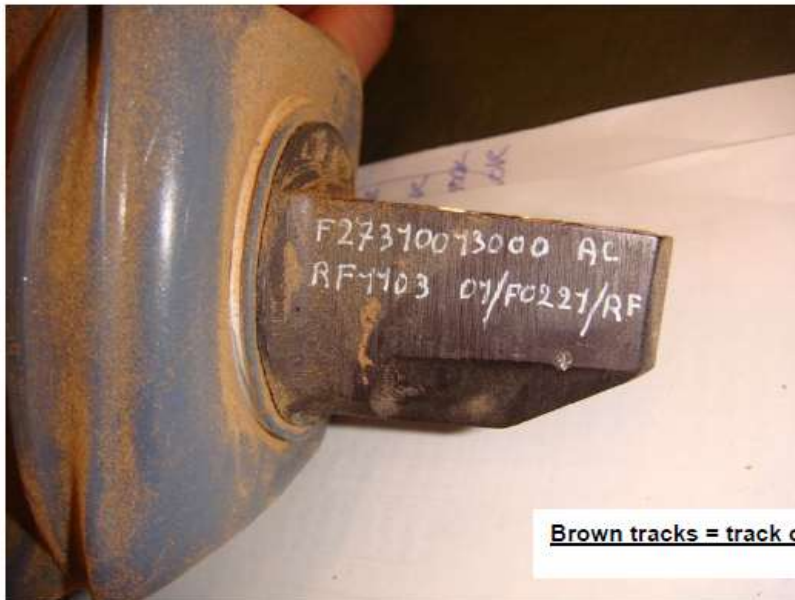
Brown tracks = track of sand/dust

Partial conclusion: numerous tracks of brown sand / dust inside the SSU

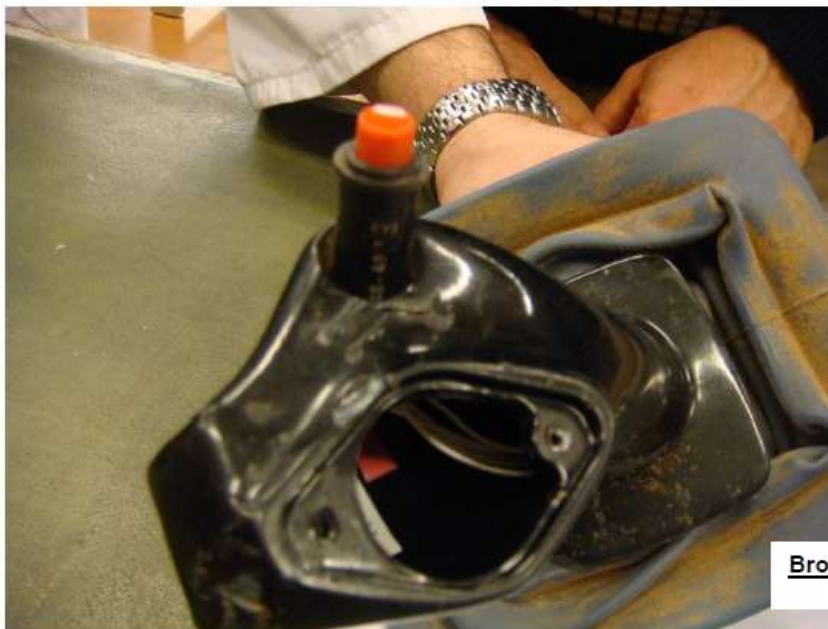
Brown tracks = track of sand/dust

Partial conclusion: numerous tracks of brown sand / dust inside.

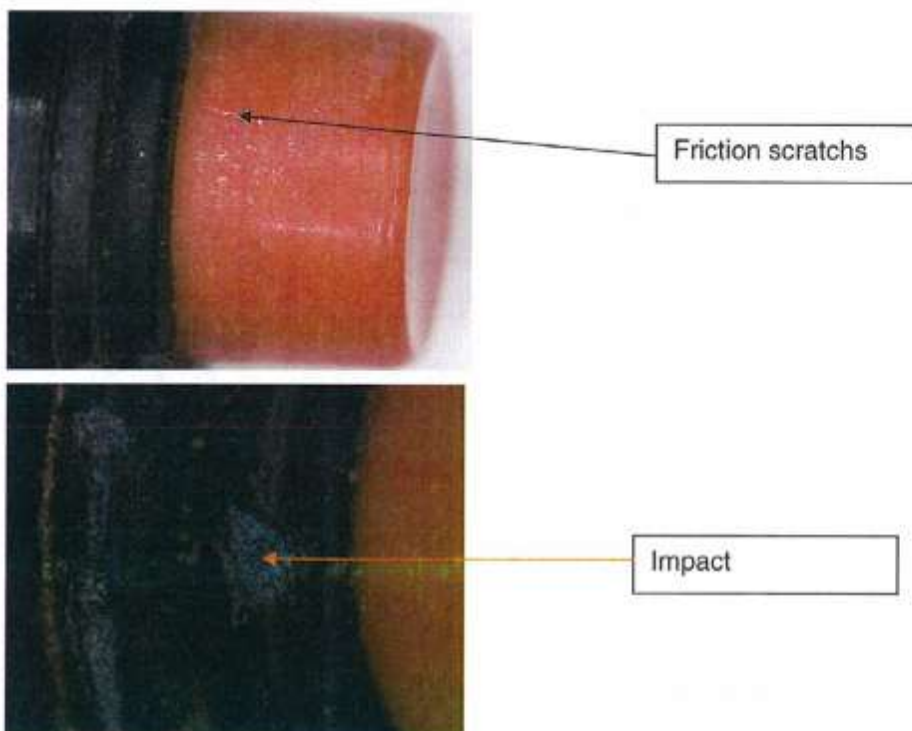
Weight 12, 34 g with pin crimped on the wires

Partial conclusion: Scratch and impact are visible under binocular. The plunger activation is normal .Weight conform to ATP requirement

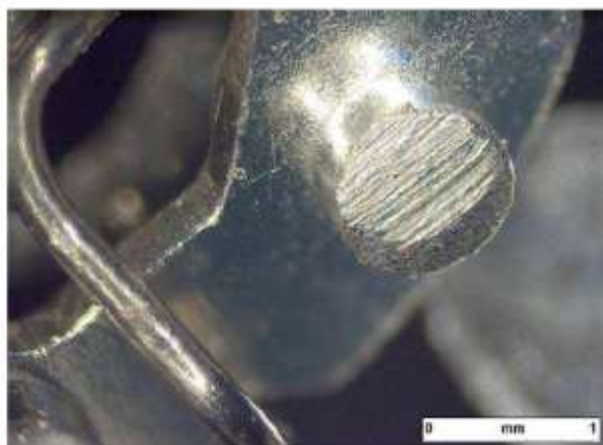
PLANCHE 3 : Clichés de plots de contact présentant des stries

Cliché 9 : Autre plots de contact
Exemple de stries observées»
