**AIRCRAFT ACCIDENT REPORT 2/2013**

**ACCIDENT INVESTIGATION DIVISION**

**Report on the accident to Airbus A330-342  
B-HLL operated by Cathay Pacific Airways Limited  
at Hong Kong International Airport, Hong Kong  
on 13 April 2010**

**Hong Kong  
July 2013**

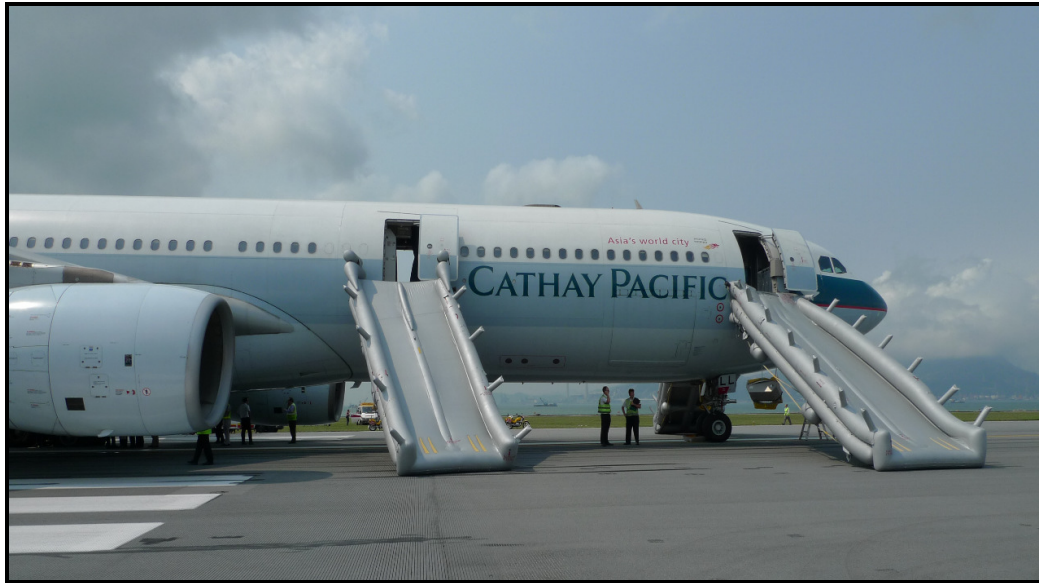
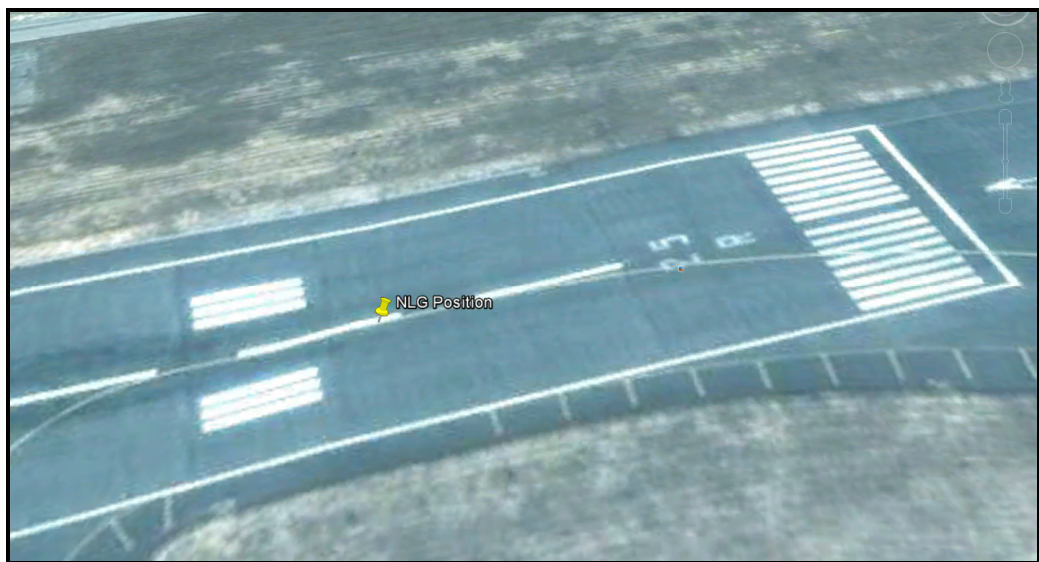
- a. The aircraft came to a complete stop on the runway at a position just passed Taxiway A10, with its nose wheel at about 309m from the end of Runway 07L. The total distance for stopping the aircraft from the initial touchdown was approximately 2,630m. Refer to Figure 1 for aircraft stopped position.

**Figure 1: The aircraft stopped on end of Runway 07L (upper photo) with its nose wheel at about 309m from the end of runway (lower photo)**

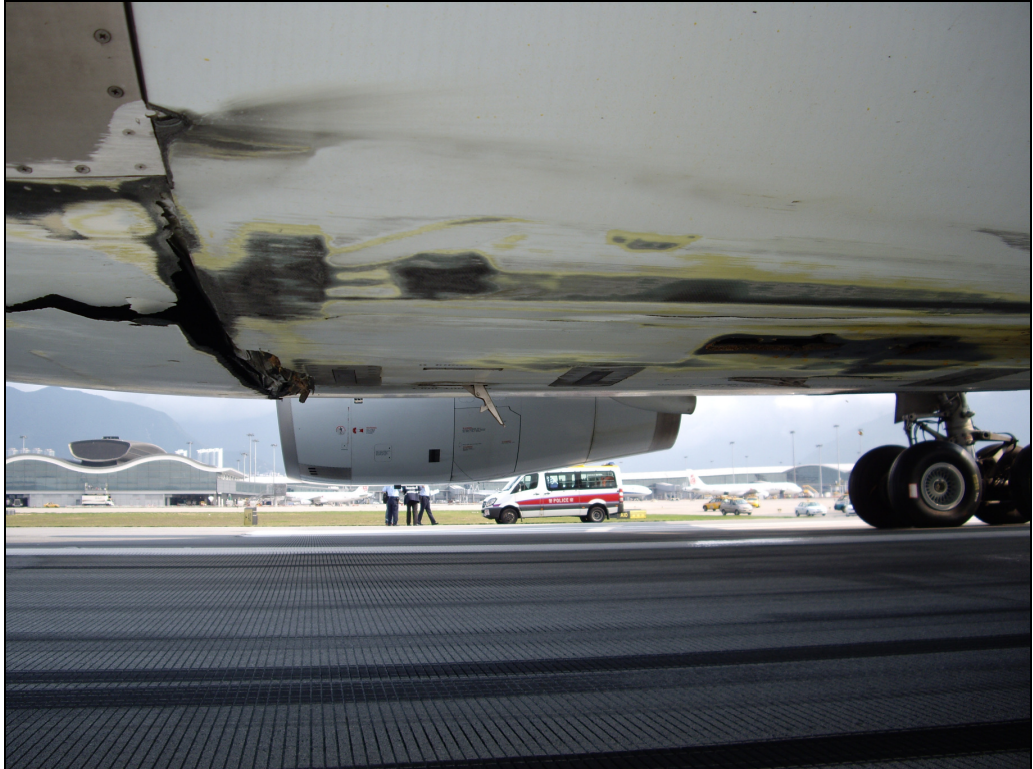
**a.** No. 1 engine (LH engine) cowl lower surface sustained impact damage as it contacted the runway surface during touch down causing consequential damage to the engine. There were engine fan blade tip rub marks at six and 12 o'clock positions on the fan case caused by deformation of the casing as the engine contacted the runway.

**Figure 19: Damage on No. 1 engine cowl lower surface**

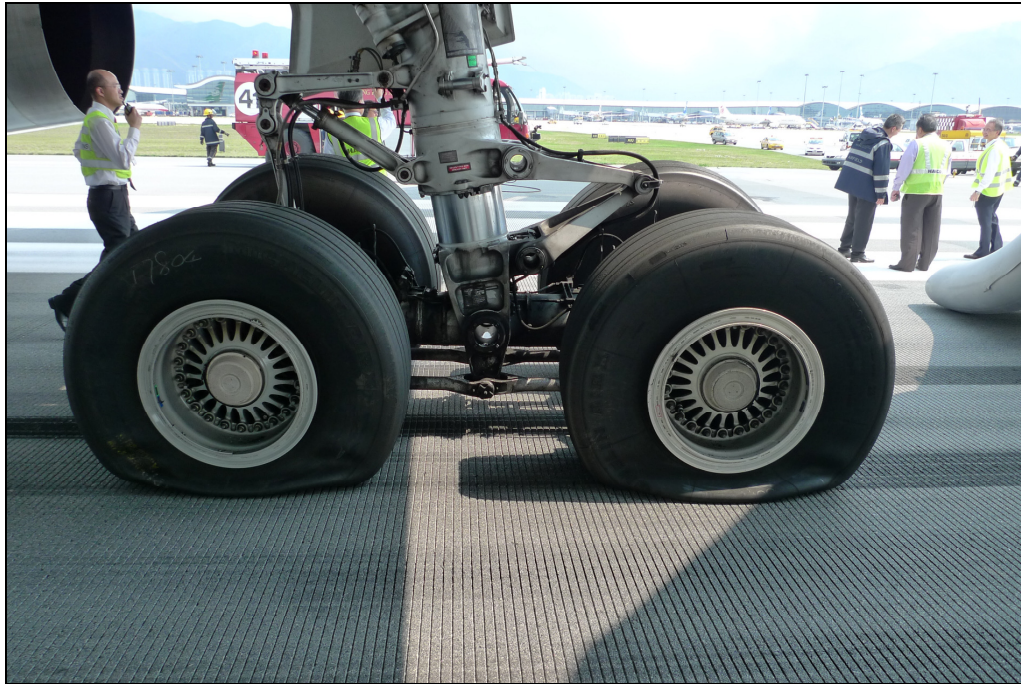
- b.** No. 1, 2, 3, 5 and 7 main wheel tyres deflated after the aircraft stopped. The associated thermal relief plugs installed on the wheels were found melted.

**Figure 20: The deflated No. 3 and 7 wheels**

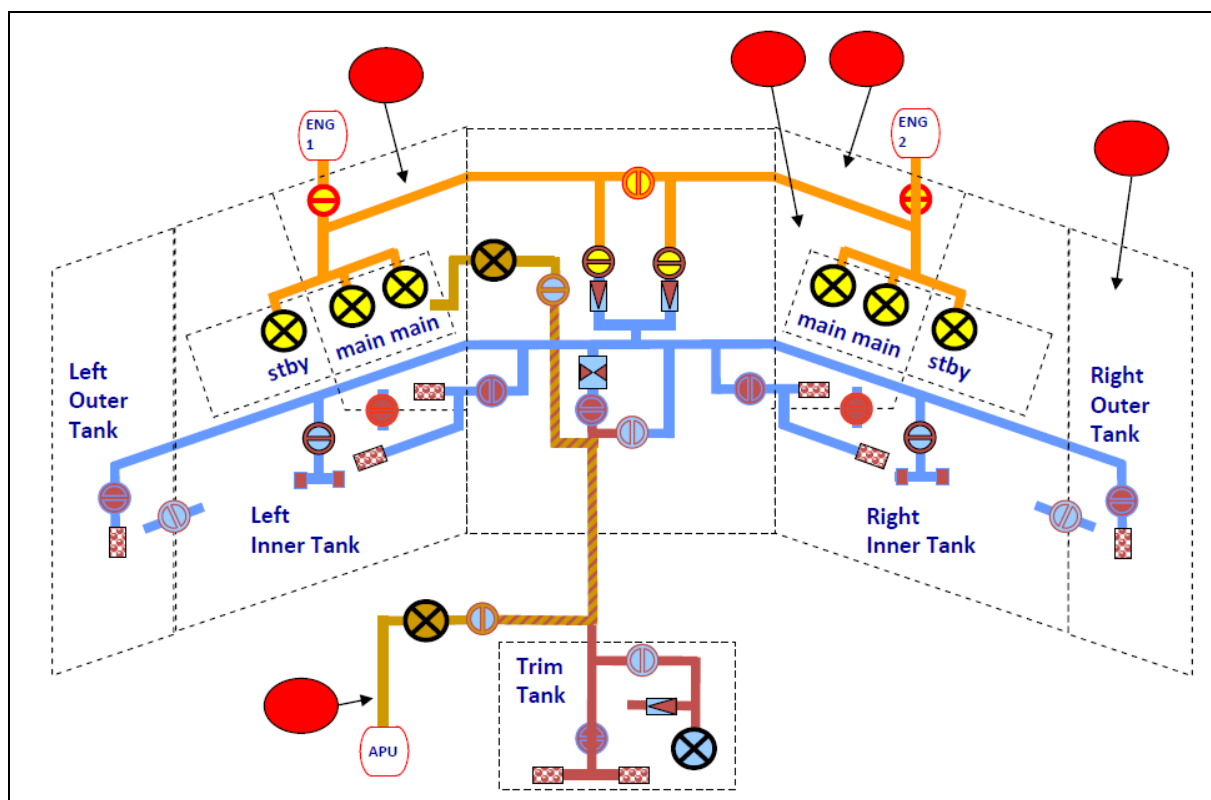
**b.** There were trace quantity of translucent spherical particulate matters in some fuel samples. As discussed later in this Sub-section, similar spherical particulate matters were also identified in other fuel samples and inside some engine components. The particulate matters were further examined and their structure and source were analysed. The results indicated that they were predominantly made up of carbon, oxygen, and sodium, with moderate amount of chlorine and sulphur, and were mainly sodium polyacrylate which was consistent with the super absorbent polymer (SAP) material used in the filter monitors installed in a fuelling dispenser. This particulate matter will be called “SAP sphere” in this Report and its structure and composition will be further discussed in this Sub-section.

**Figure 21: Aircraft fuel sampling locations.**  
**Red dots highlight those locations where the SAP spheres were present.**

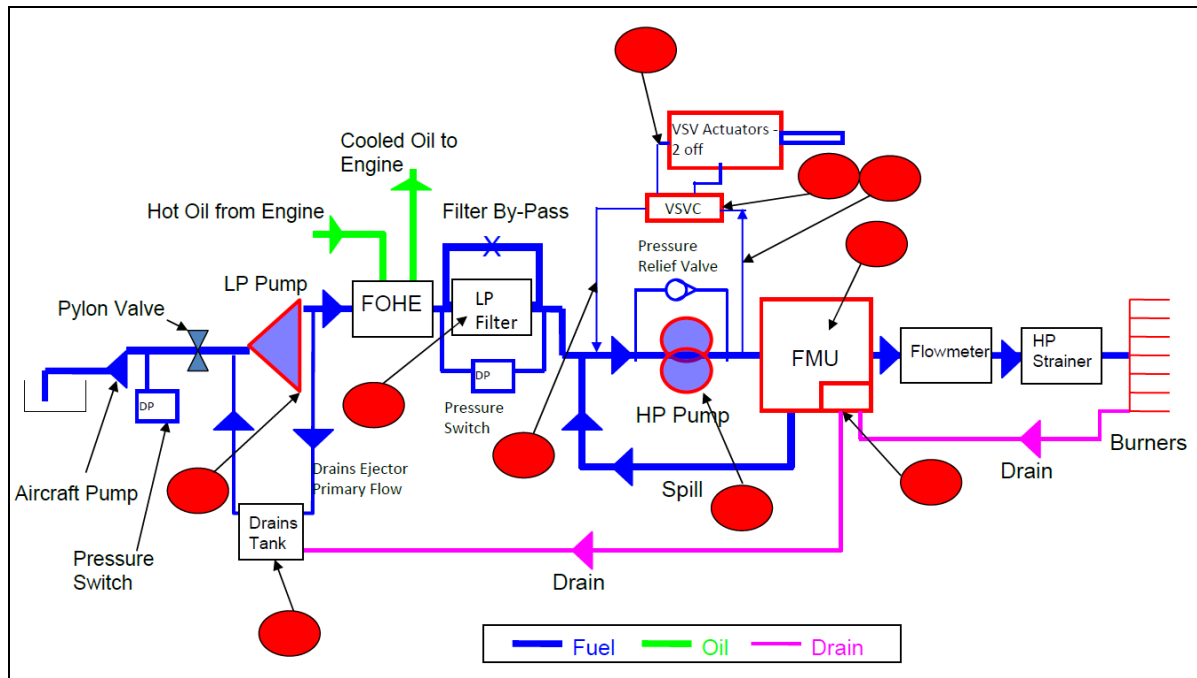
**Figure 24: Samples were collected from various locations of B-HLL No. 1 engine. Red dots highlight those locations where the SAP spheres were present.**

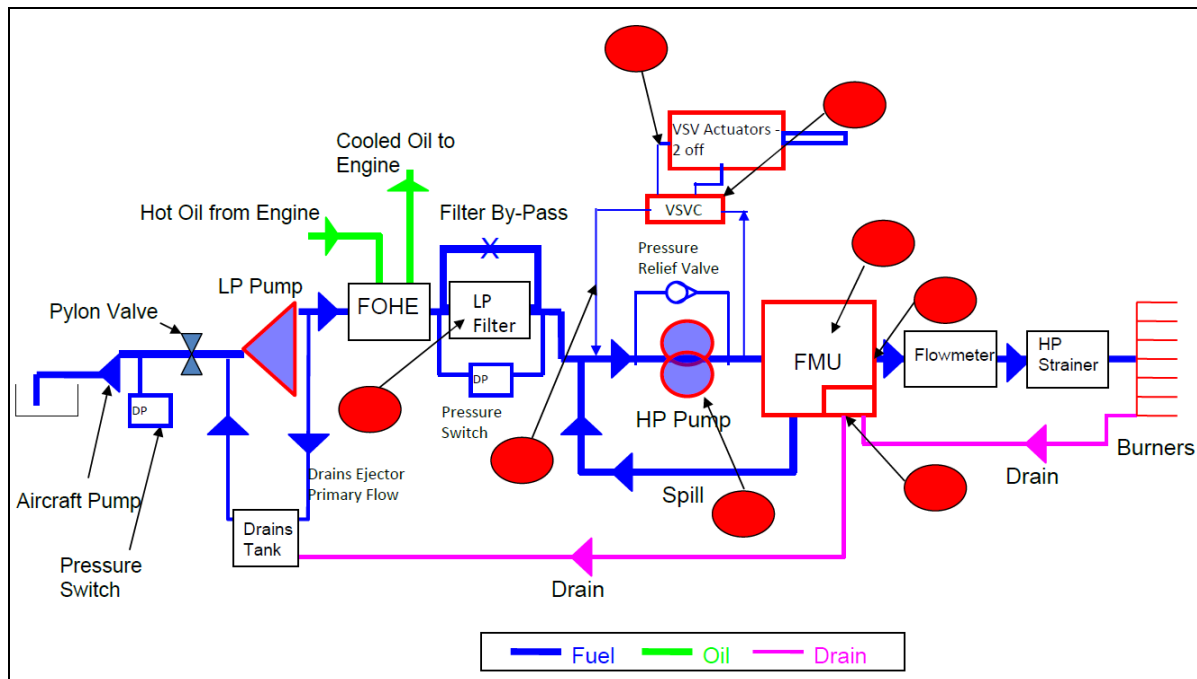
**Figure 25: Samples were collected from various locations of B-HLL No. 2 engine. Red dots highlight those locations where the SAP spheres were present.**

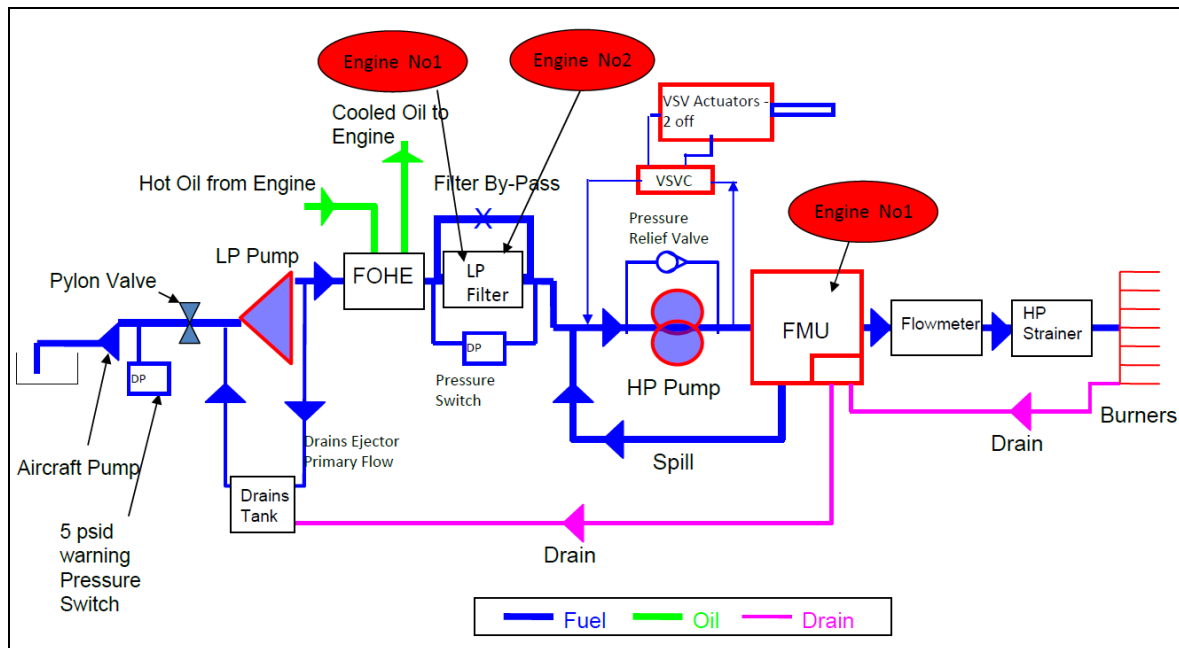
**Figure 26: Samples were collected from various locations of B-HLM engines. Red dots highlight those locations where the SAP spheres were present**

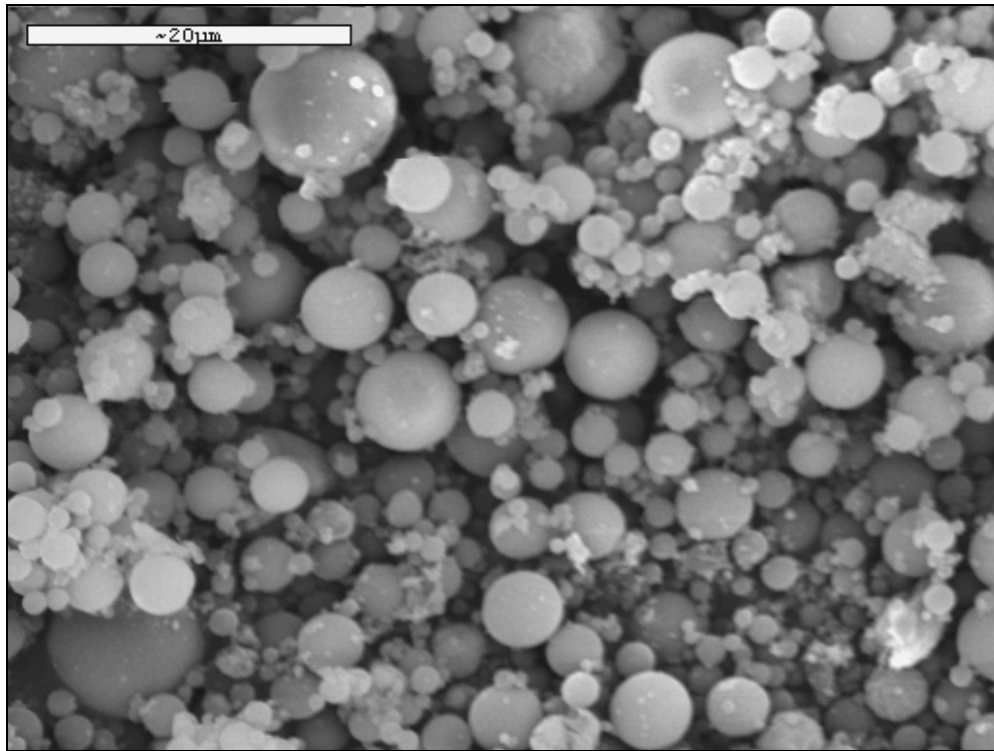
b. Detailed examination of filter media revealed the presence of SAP spheres ranging in size of up to 20µm (see Figure 27). Similar spheres were also found in the media of the LP filters fitted to the aircraft B-HLM engines.

**Figure 27: SAP spheres found in the engine LP fuel filter media**

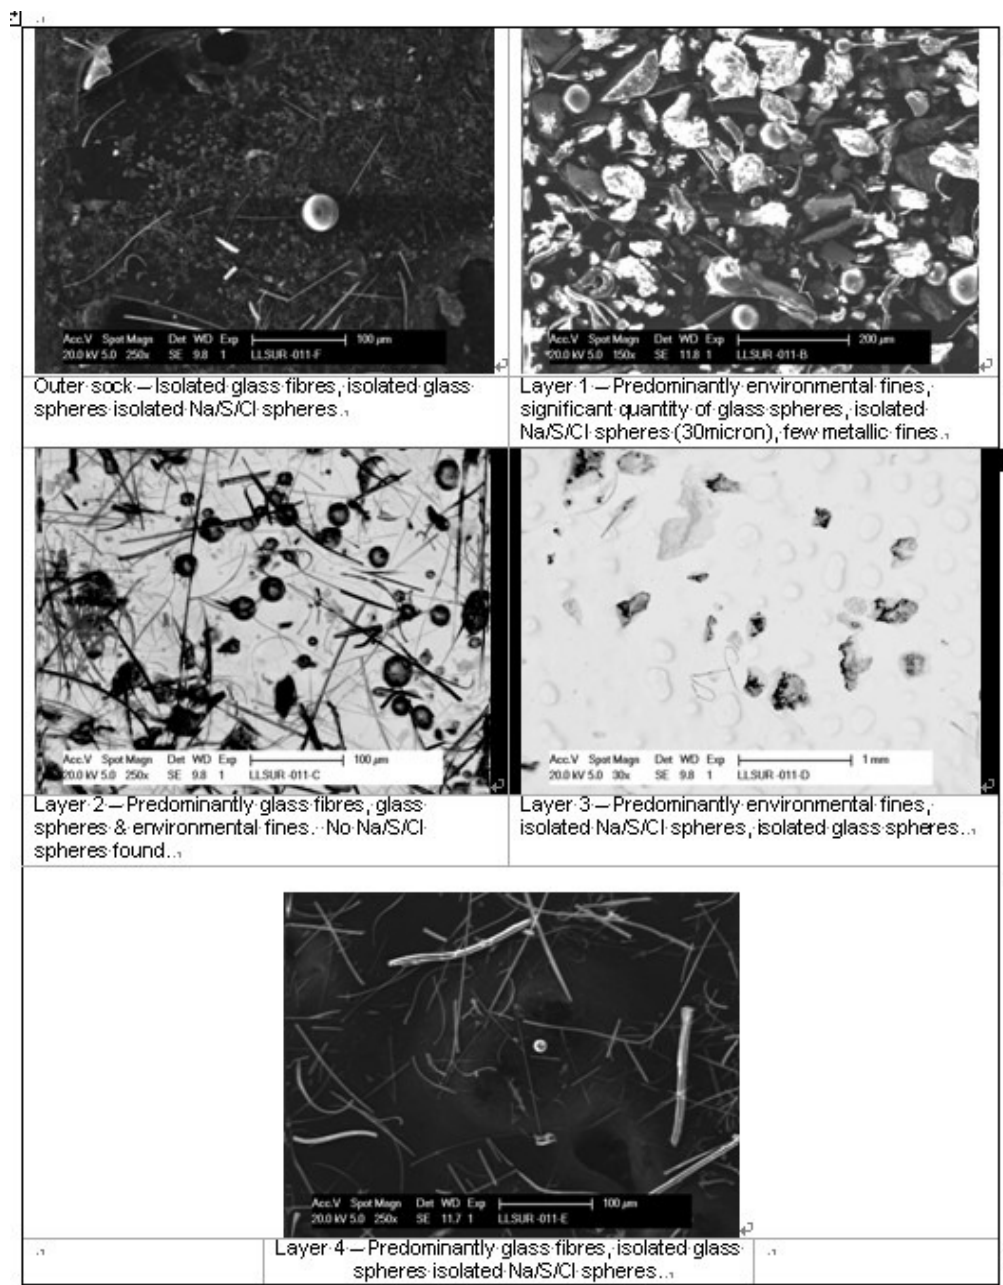
**Figure 33: Isolated SAP spheres (Na/S/Cl spheres) found in the media layers of the filter monitor.**

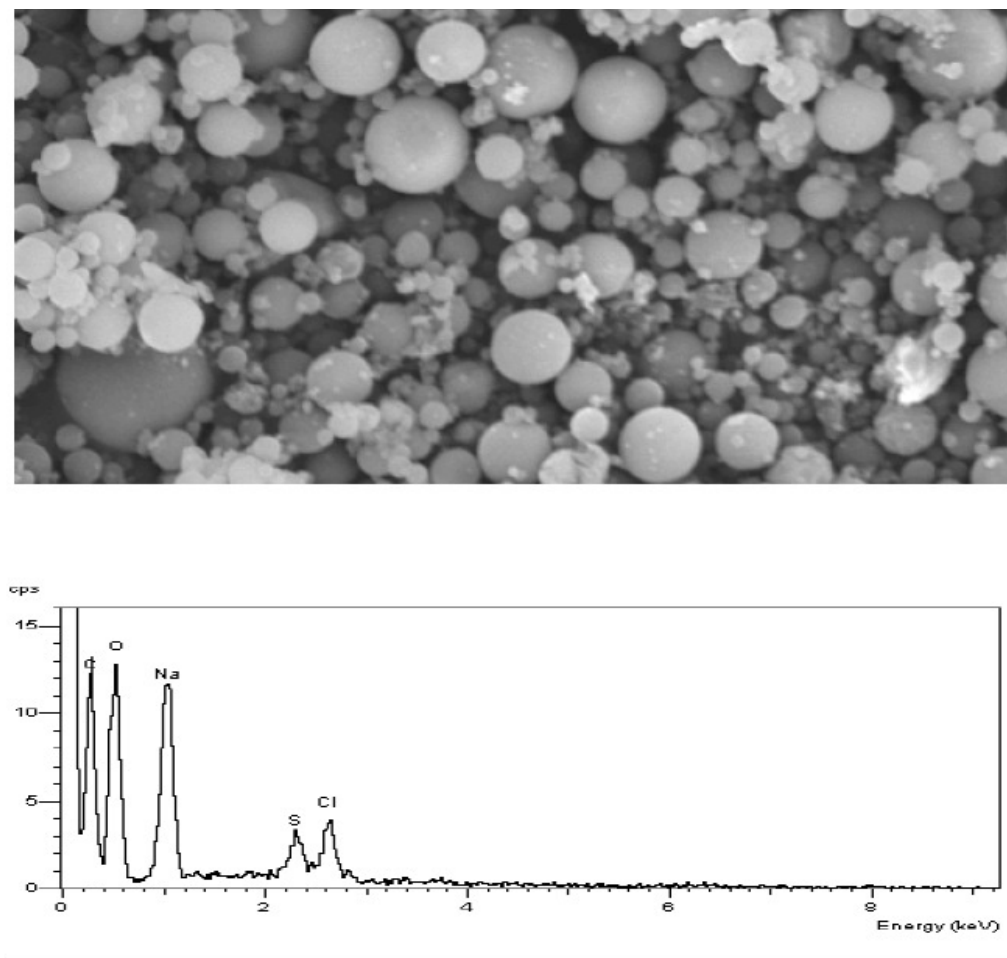
**Figure 34: Microscopic view of spheres and their composition under Scanning Electronic Microscope (SEM) analysis.**

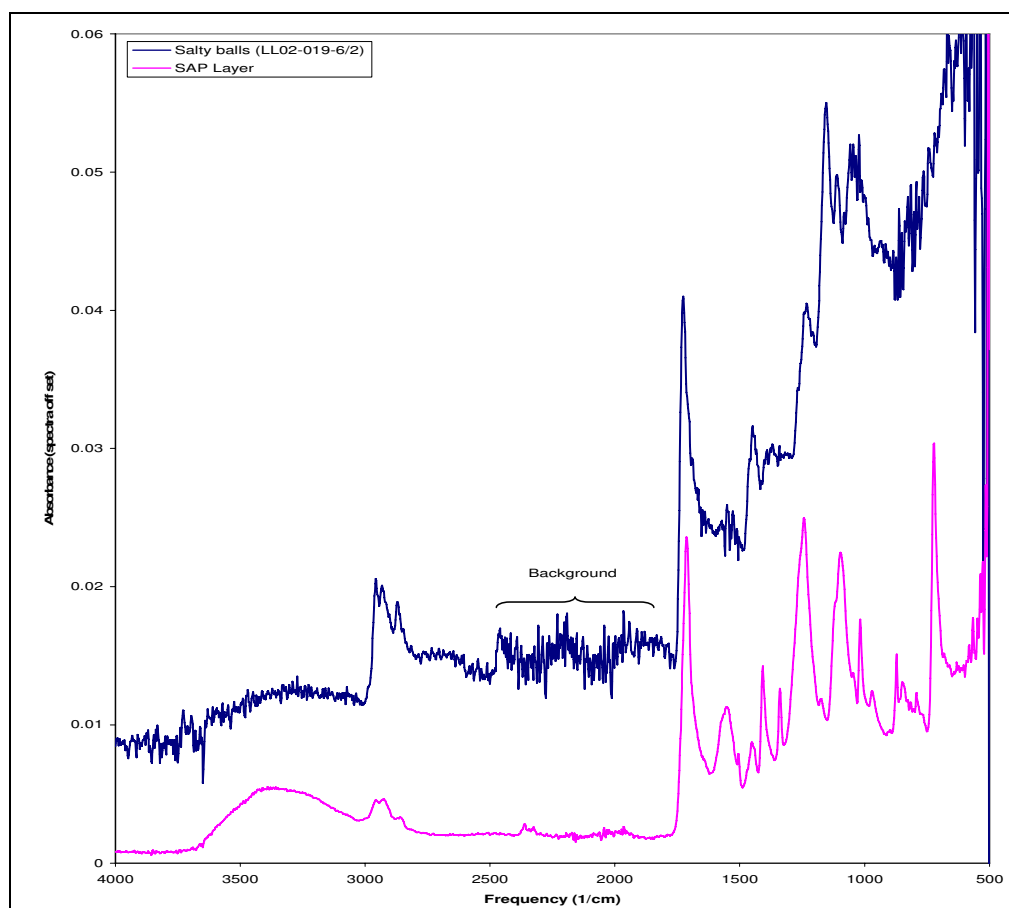
**Figure 35: FTIR spectrum obtained from the SAP Layer sample compared to a sample of Na/Cl/S spheres indicating similar composition.**

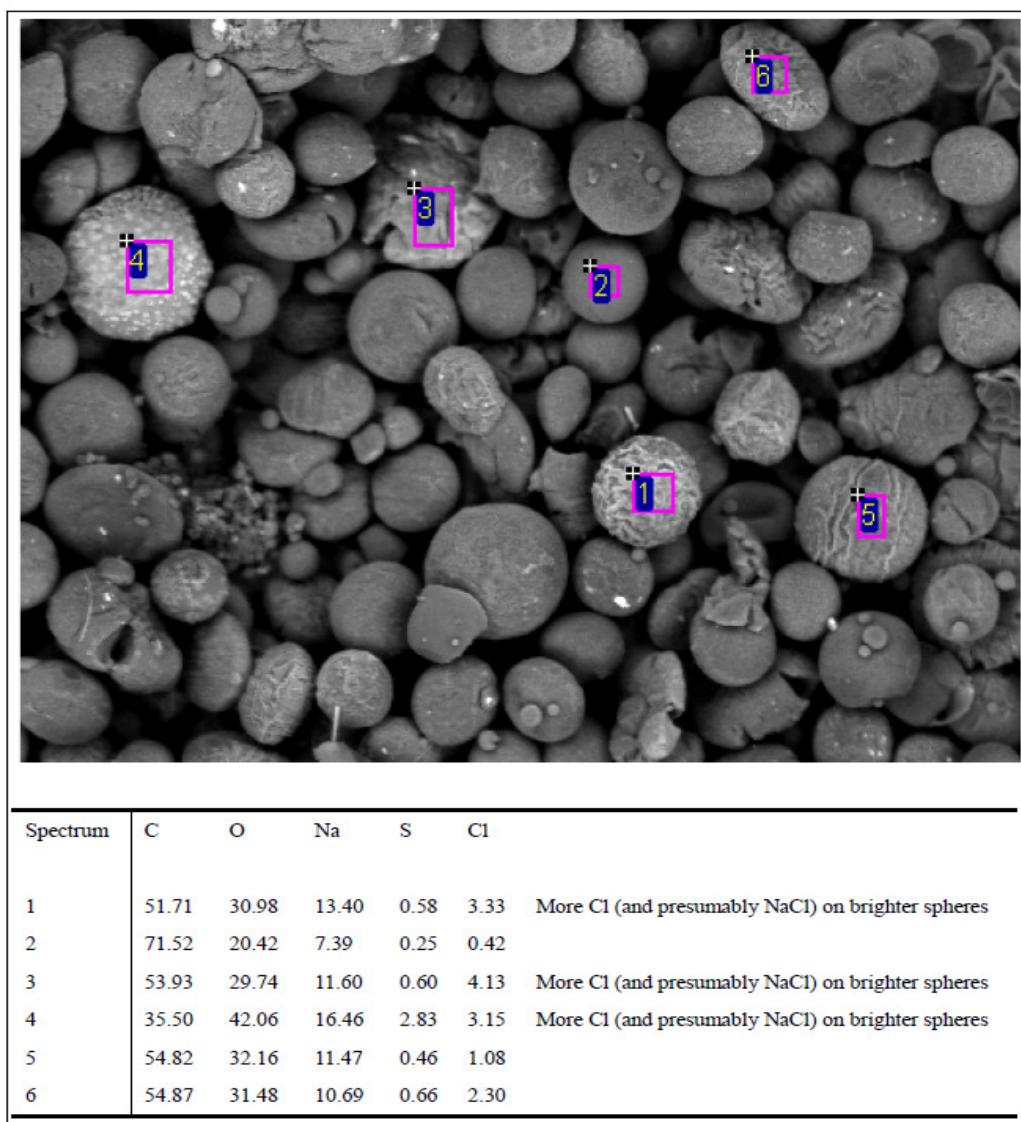
**Figure 36: The presence of crystalline sodium chloride on the surface of some spheres**

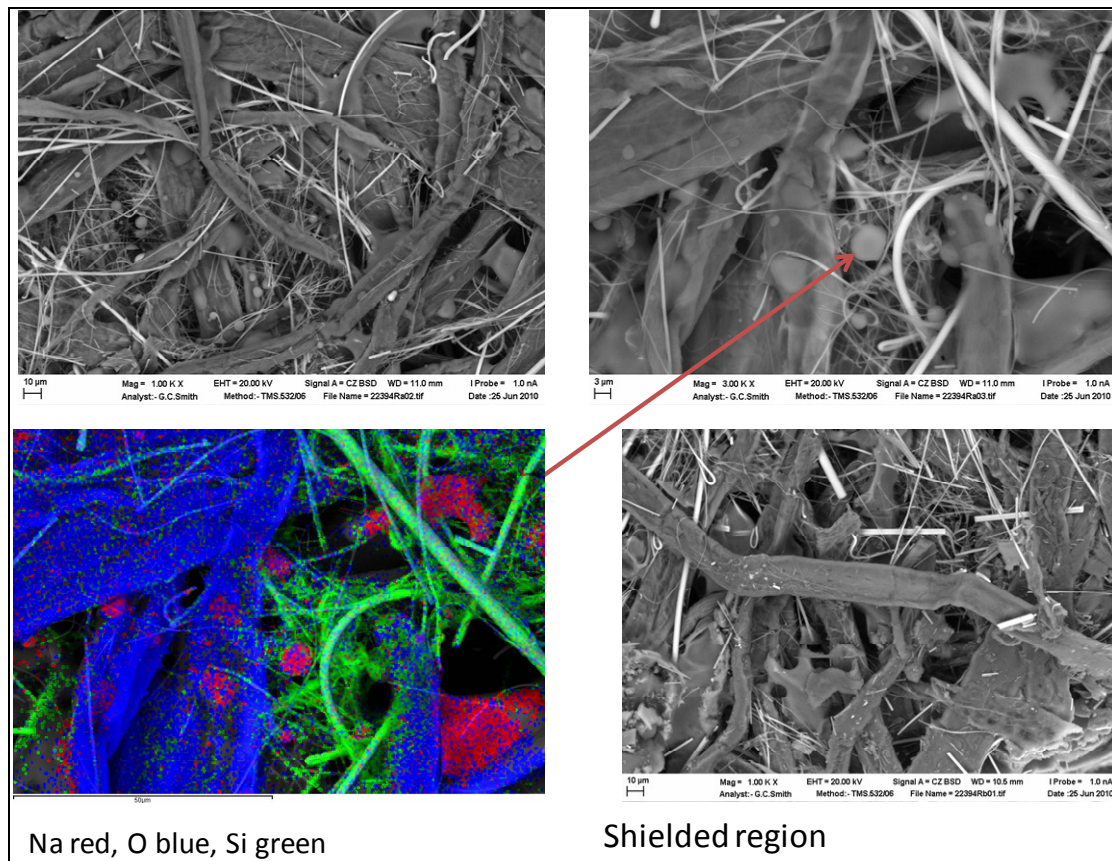
**Figure 43: Backscattered electron SEM images and element distribution map from the fuel impact region of the micro-filter. Arrow indicating the presence of a SAP sphere. Lower right is a reference image from the shielded area.**

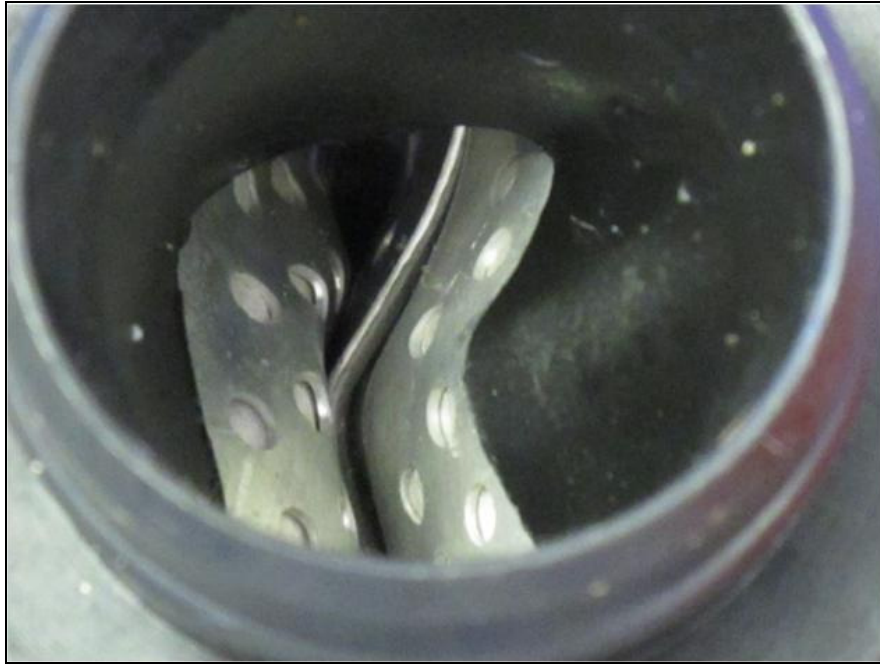
**Figure 46:**The centre aluminium core tube of the collapsed filter monitor was crushed

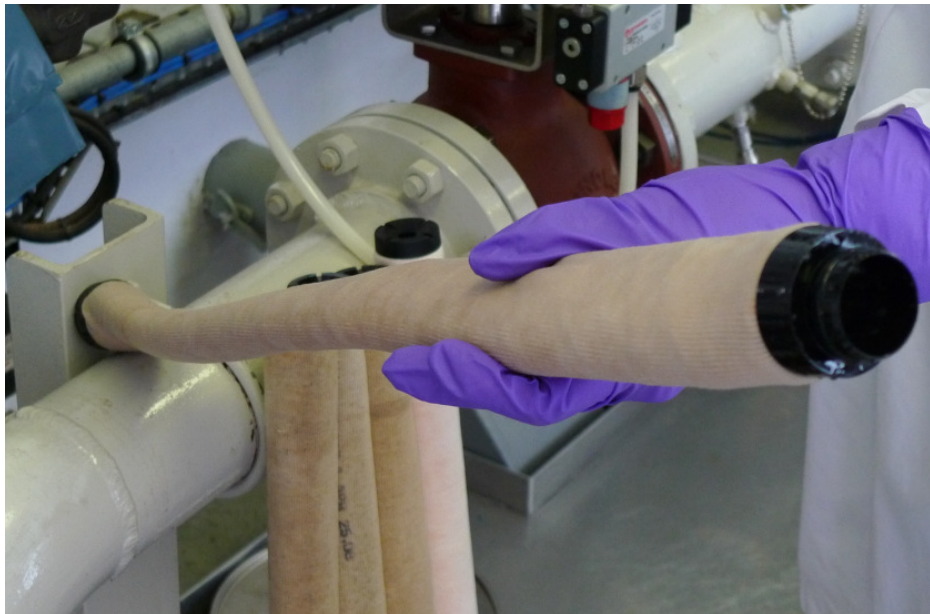
**Figure 47:** A collapsed filter monitor loss it structural rigidity

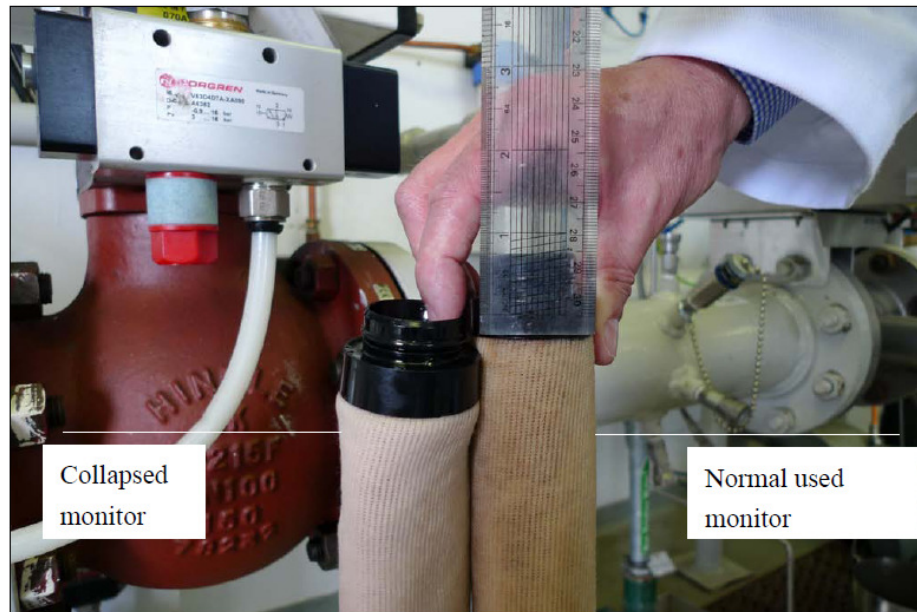
**Figure 48: The length of a collapsed filter monitor (left) is shortened**

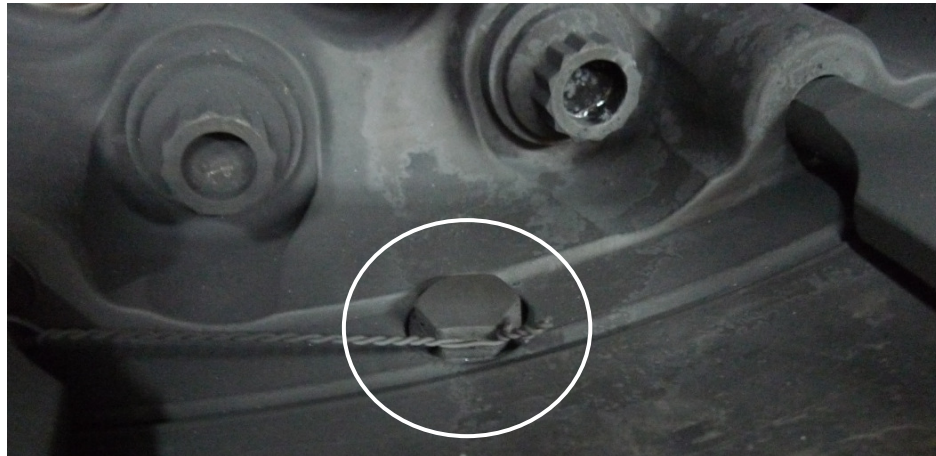
**Figure 49: One event fusible plug installed to the wheel showing the centre core was intact**
