Investigation report

C11/2010L

A330 Jetliners' Engine Bleed Air System Failures: Serious Incidents on 11 and 22 December 2010

AIRBUS A330-302

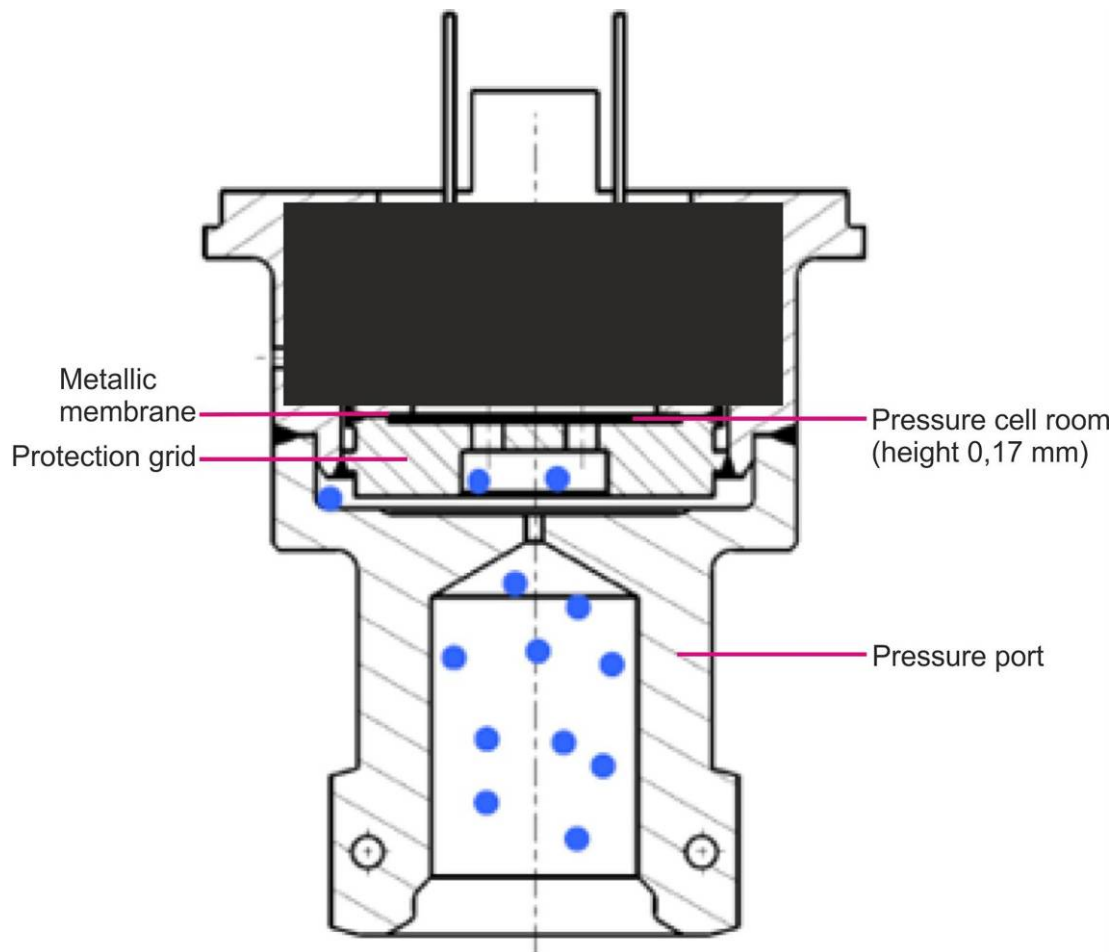
Figure 15. A cross-sectional view of the pressure port and pressure cell room of pressure transducer p/n ZRA380-00. The blue dots represent water droplets. Part of the pressure cell's design is masked on the request of the manufacturer. Source: Esterline-Auxitrol³.

No pressure transducer version prevents the accumulation of moisture inside the pressure cell room. Temperature changes and changes in humidity may cause moisture condensation in bleed air system's sense lines and pressure transducer's pressure ports. Condensed water droplets may travel to the pressure cell room and condensation may also directly occur in that space.

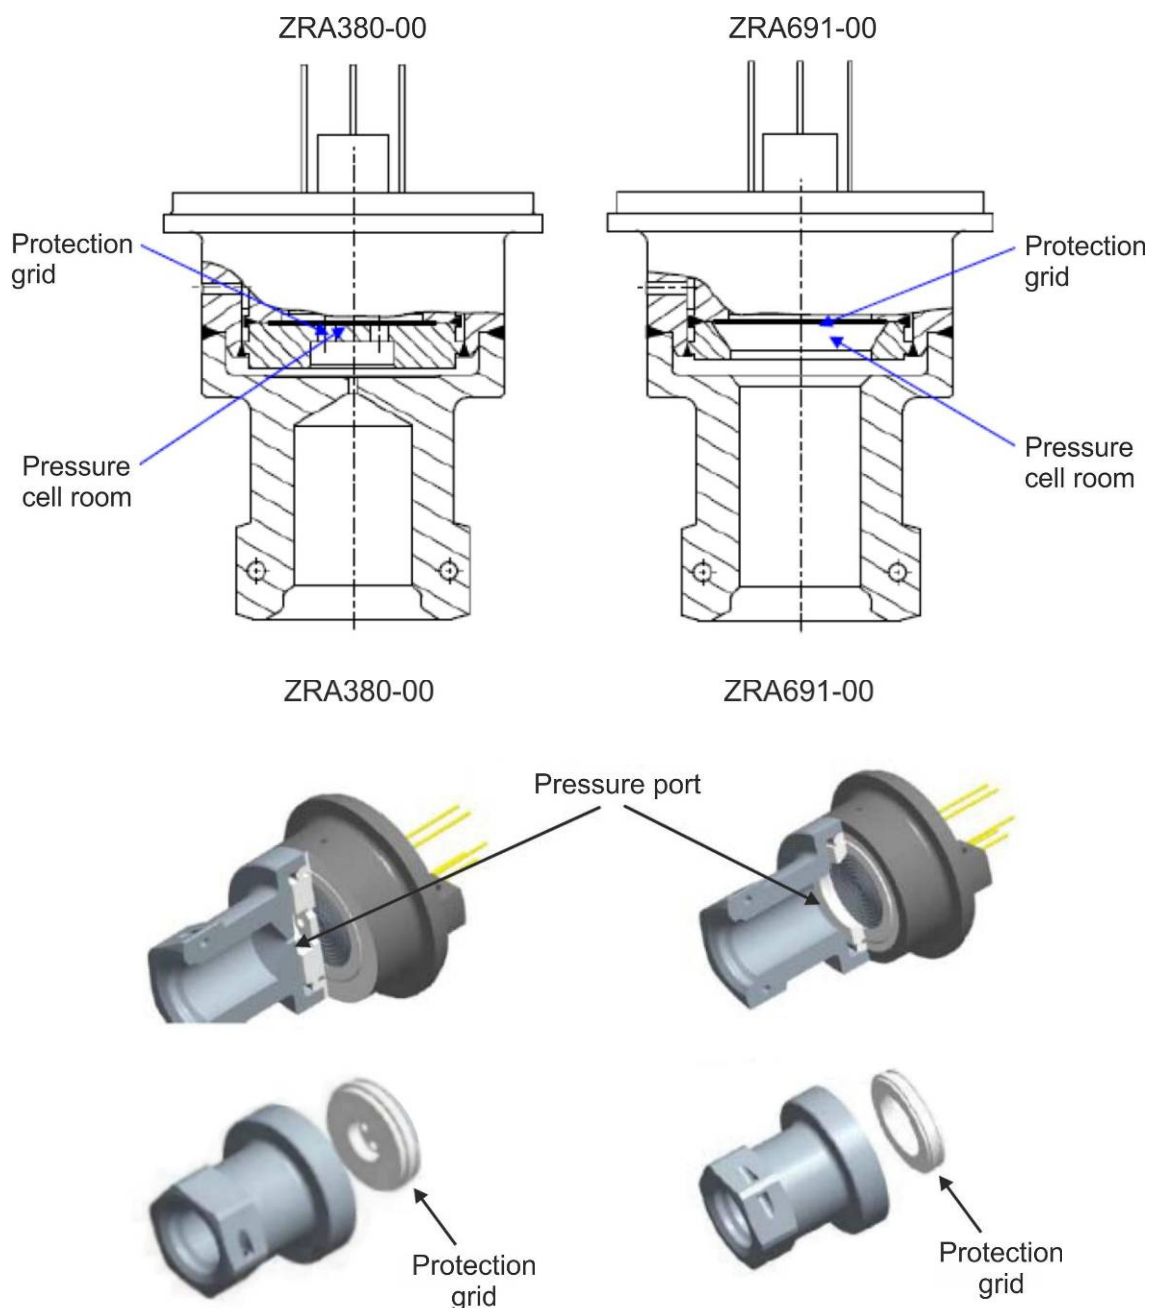
STRUCTURAL DIFFERENCES BETWEEN PRESSURE TRANSDUCERS P/N ZRA380-00 AND ZRA691-00

The third pressure transducer version, p/n ZRA691-00, was designed and manufactured by modifying p/n ZRA380-00, the second version. Their essential differences lie in the protection grid as well as the pressure cell room between the grid and the metallic membrane. In order to avert blockage caused by ice build-up, the four small holes in version no. 2 are no longer present in the third version. They are replaced by one large hole. Whereas the height of the second version's pressure cell room is 0.17 mm, it is 5.2 mm in the third version.

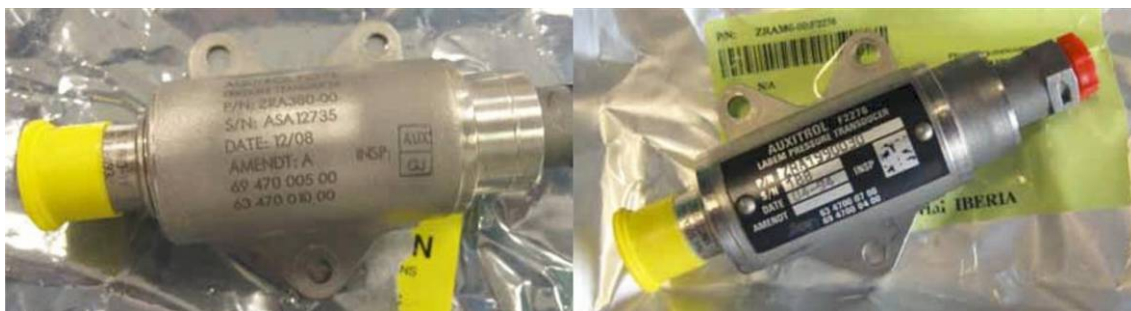
Pressure transducers removed from OH-LTO's left engine; s/n ASA12735 on the left and s/n 188 on the right.

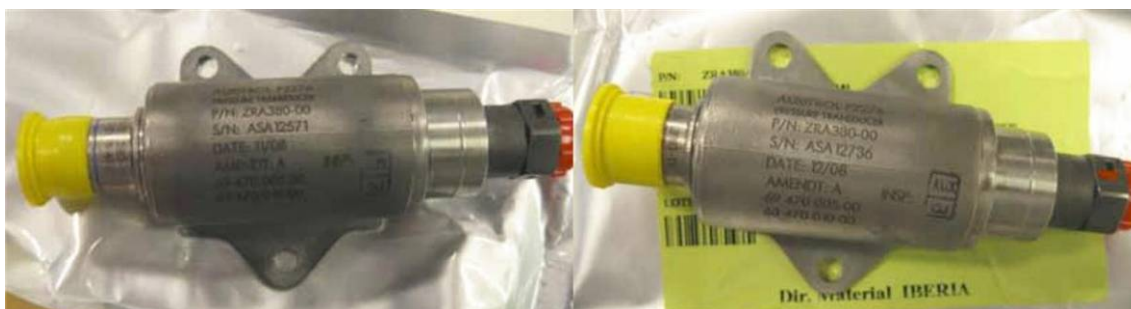
Pressure transducers removed from OH-LTO's right engine; s/n ASA12571 on the left and s/n ASA12736 on the right.

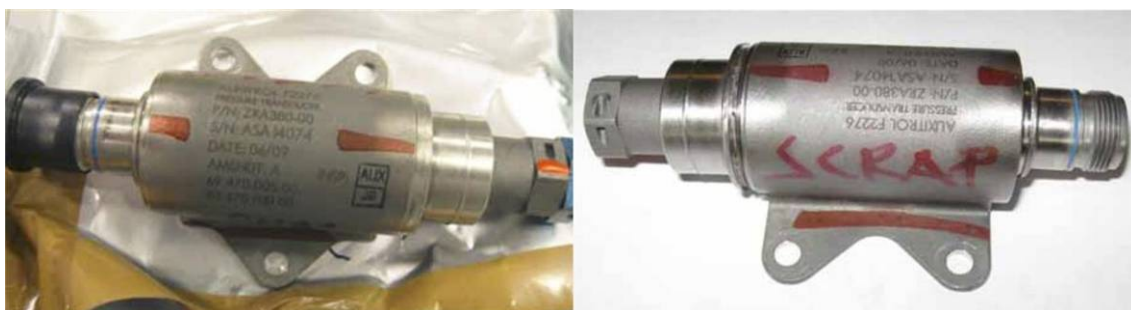
Pressure transducer s/n ASA14074 removed from OH-LTS's left engine.
