**National
Transportation
Safety Board**

Investigative Update of Battery Fire Japan Airlines B-787 - Jan 7, 2013

January 24, 2013

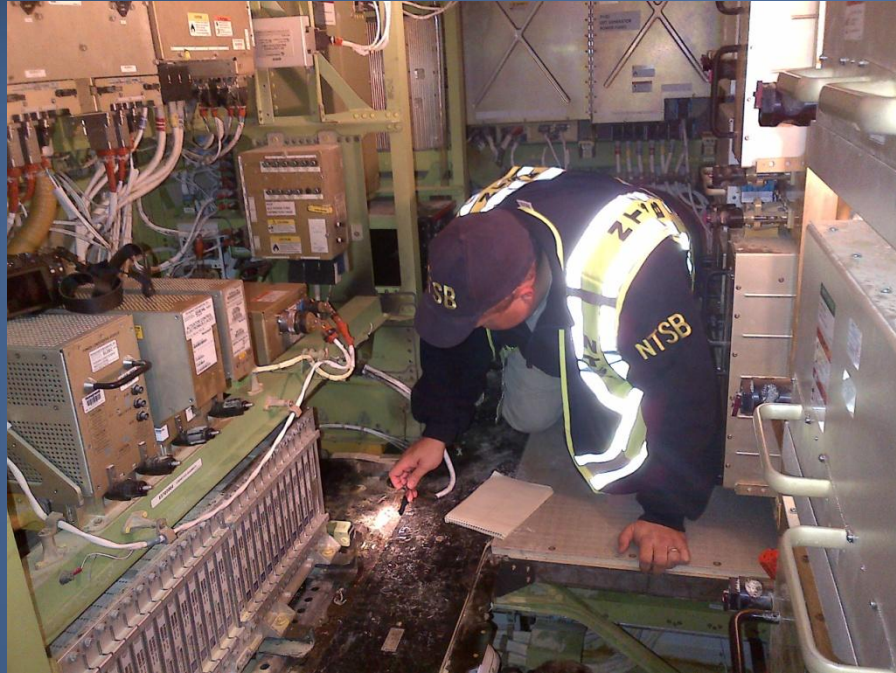
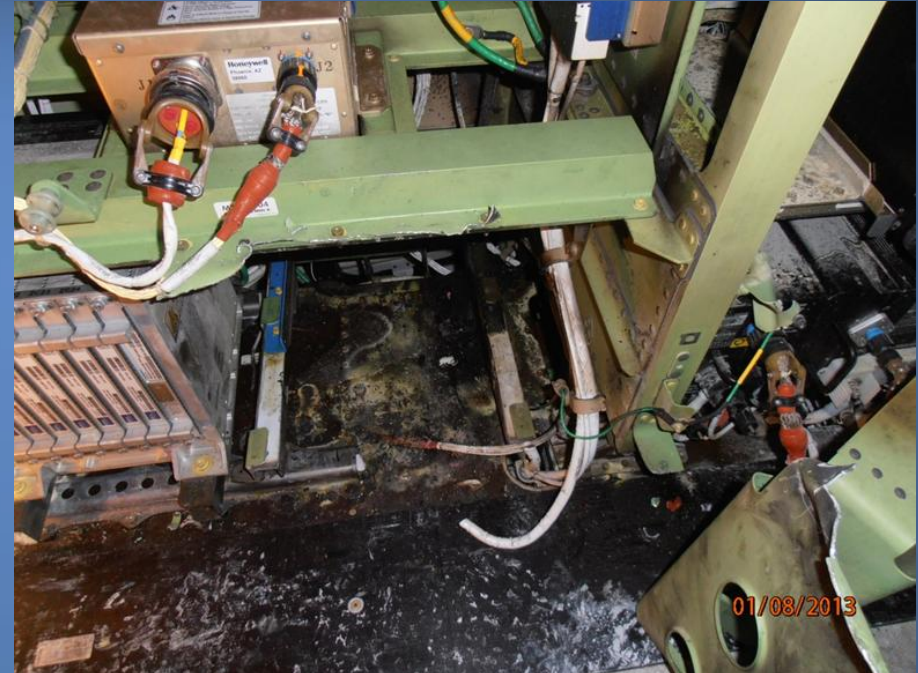
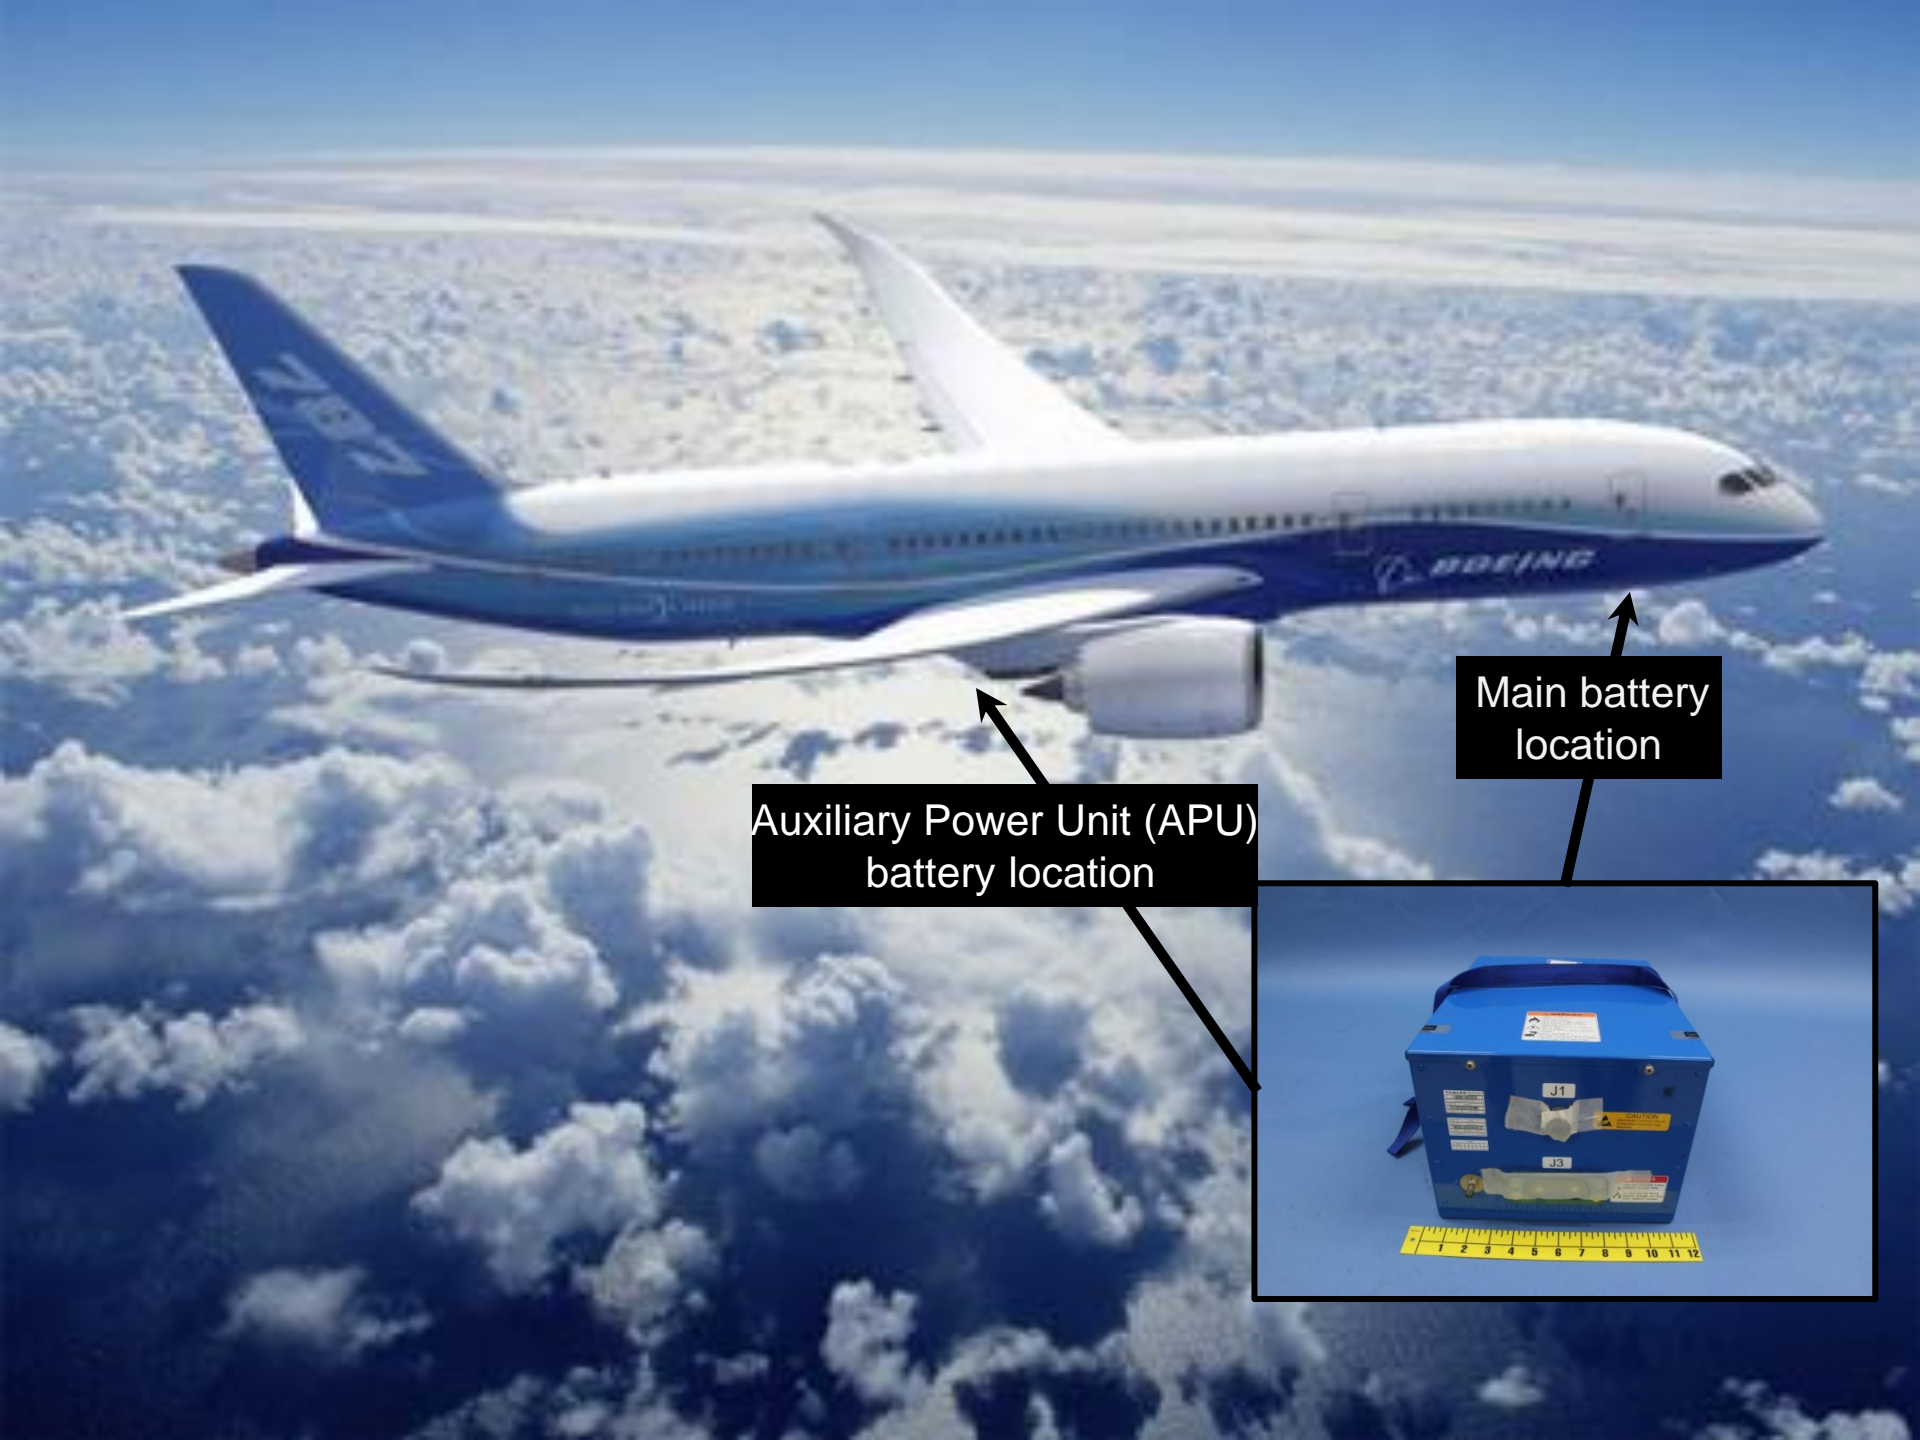
Damage to Aft Electronics Bay

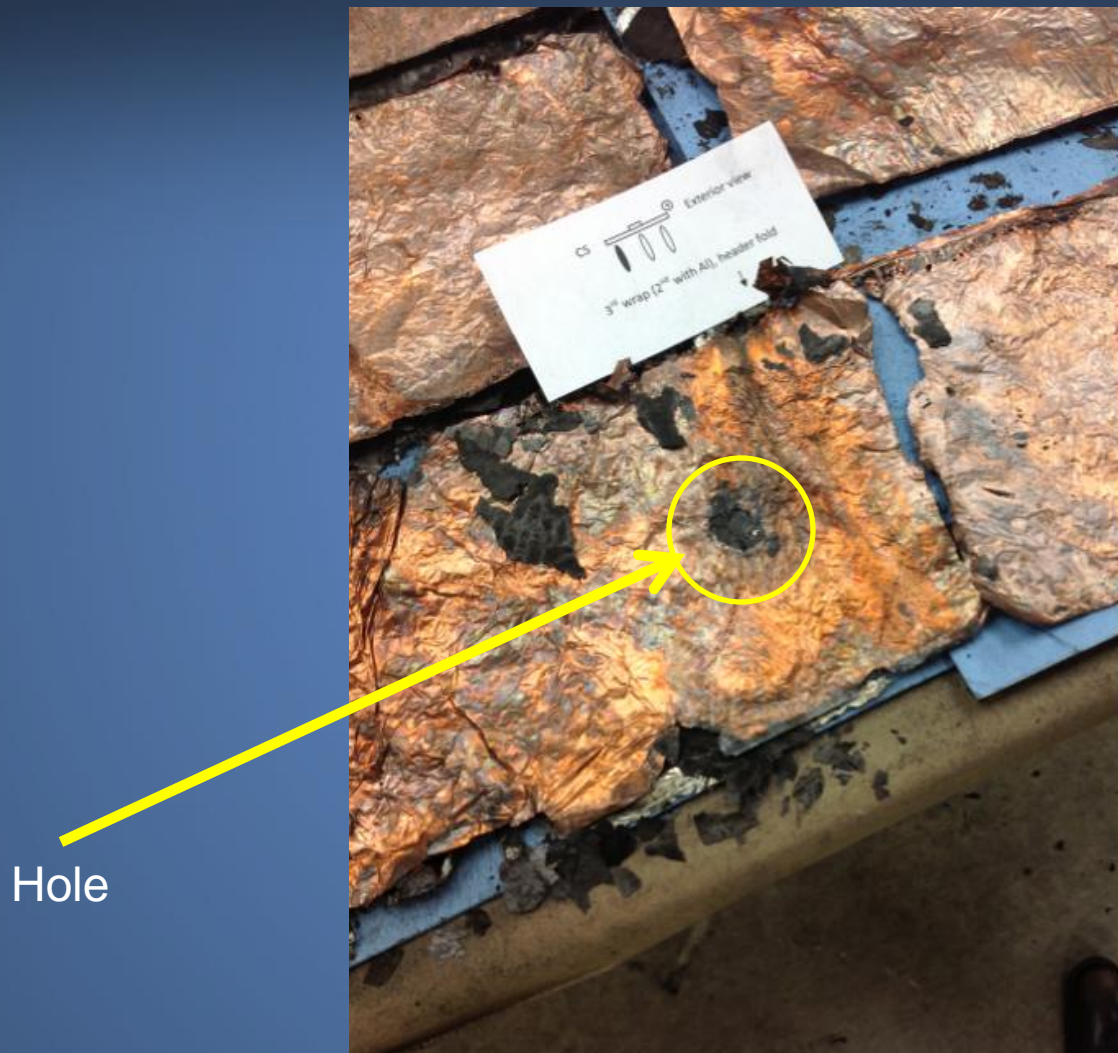
Damaged Electrode - Internal Short Circuit

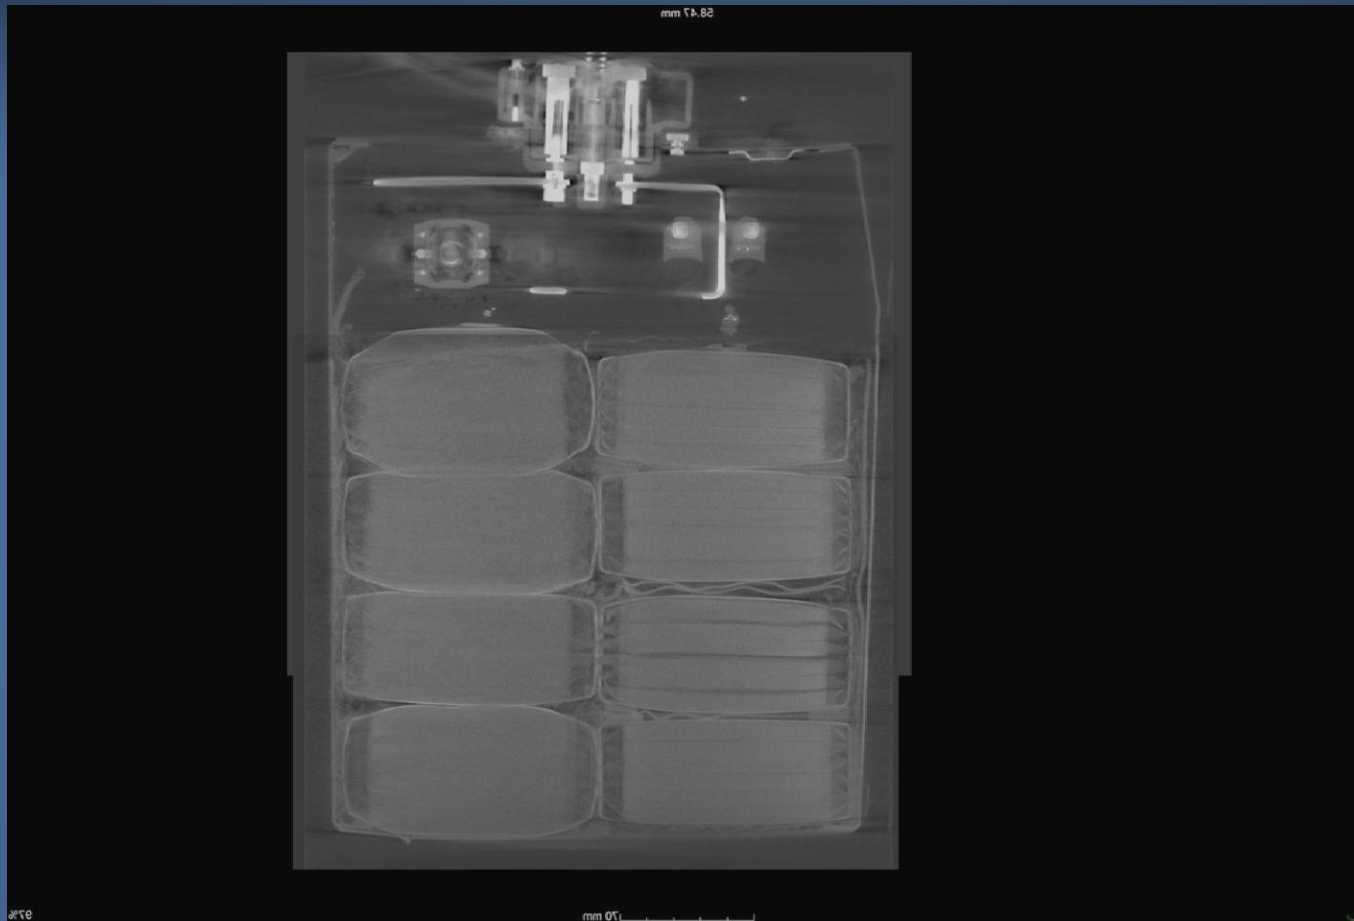
CT Scan of Battery

- Fire was present
- Signs of thermal runaway
- Signs of electrical short circuiting
