AAIB Bulletin S3/2013

SPECIAL

ACCIDENT

Aircraft Type and Registration:	Airbus A319-131, G-EUOE
No & Type of Engines:	2 x IAE V2522-A5 turbofan engines
Year of Manufacture:	2001 (Serial No 1574)
Date & Time (UTC):	24 May 2013 at 0716 hrs
Location:	London Heathrow Airport
Type of Flight:	Commercial Air Transport (Passenger)
Persons on Board:	Crew - 5 Passengers - 75
Injuries:	Crew - None Passengers - None
Nature of Damage:	Fire damage to the right engine; mechanical damage to: fuel and hydraulic pipes, slats, flaps, horizontal stabiliser, landing gear and fuselage skin
Commander's Licence:	Airline Transport Pilot's Licence
Commander's Age:	50 years
Commander's Flying Experience	14,337 hours (of which 8,036 were on type)
Information Source:	AAIB Field Investigation

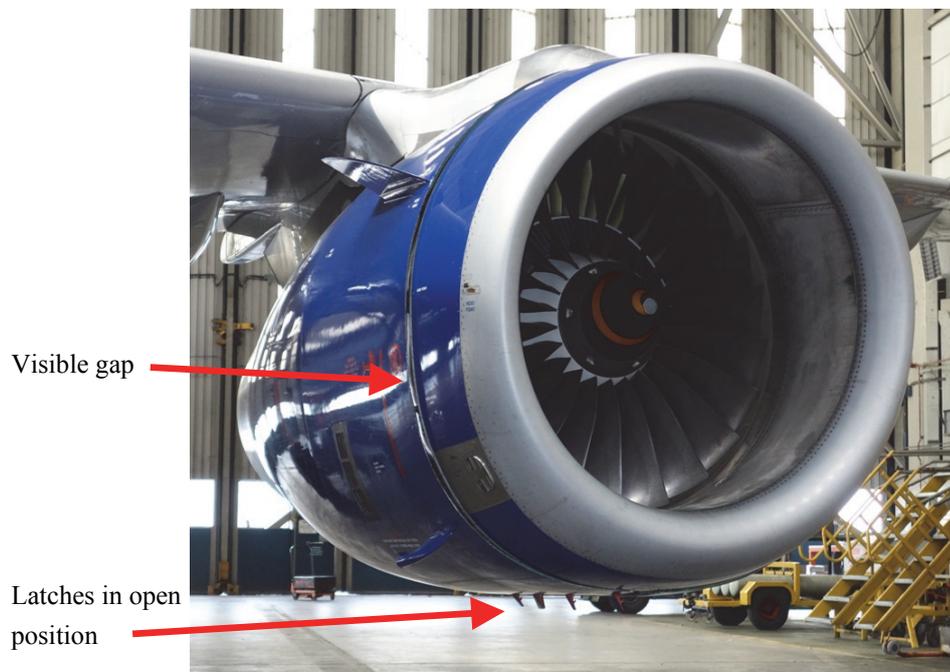
Figure 1

Subsequent investigation revealed that the fan cowl doors on both engines were left unlatched during maintenance and this was not identified prior to aircraft departure.

The fan cowl doors can be propped open by two stays mounted on the inside of each door, to allow access for servicing. When the doors are lowered from the propped-open position, a 'hold open' device on the bottom of the fixed engine inlet cowl prevents the fan cowl doors from closing fully under gravity. In this condition the fan cowl doors stand slightly proud of the nacelle (Figure 1), to provide a visual cue that the doors are not latched.

Generic photograph showing fan cowl doors in the unlatched condition

Following the event photographs of the aircraft, taken prior to pushback, were provided to the AAIB. These photographs show the fan cowl doors unlatched on both engines.

It is recommended that Airbus formally notifies operators of A320-family aircraft of the fan cowl door loss event on A319 G-EUOE on 24 May 2013, and reiterates the importance of verifying that the fan cowl doors are latched prior to flight by visually checking the position of the latches.
