PRELIMINARY REPORT

Classification:	Accident
Aircraft type and registration:	Boeing 737-800, TC-JGE
Number and type of engines:	2 CFM-56-7B26 turbofan engines
Year of manufacture:	2002
Date and time: ¹	25 February 2009, 10.26 hrs
Location:	1,5 km North of runway 18R "Polderbaan" Amsterdam Airport Schiphol
Type of flight:	Commercial air transport (passengers)
Occupants:	crew - 7 passengers - 128
Fatalities:	crew - 4 passengers - 5
Injuries:	crew - 3 passengers - 83
Nature of damage:	Aircraft destroyed
Information source:	Dutch Safety Board

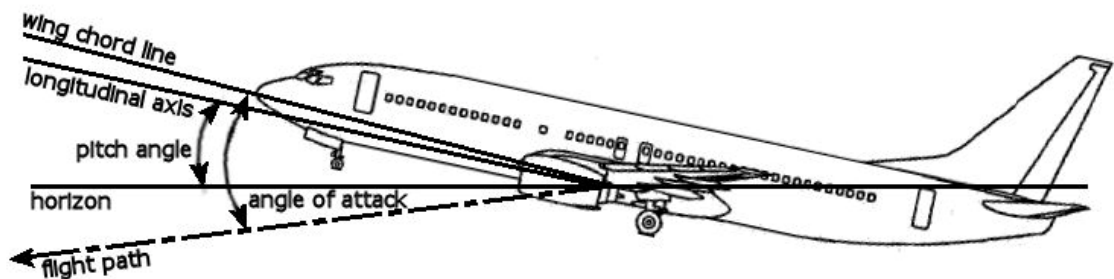
The stick shakers activated at approximately 460 feet, warning the crew that the angle of attack (AOA) was too high. The data of the digital flight data recorder show that the thrust levers were immediately advanced but moved back to idle. When the thrust levers returned to idle, the autothrottle was disengaged. Whether these actions were performed by the crew or automatically is still under investigation. At that moment, the speed was approximately 110 knots, the pitch angle was approximately 11° Aircraft Nose Up (ANU) and the recorded AOA was approximately 20°.

At 420 feet the autopilot was disengaged by the crew and attempts were made to recover. At 310 feet the pitch attitude had reached 8° nose down. Almost simultaneously the thrust levers were advanced to their most forward position after which the aircraft ascended somewhat and the pitch angle increased.

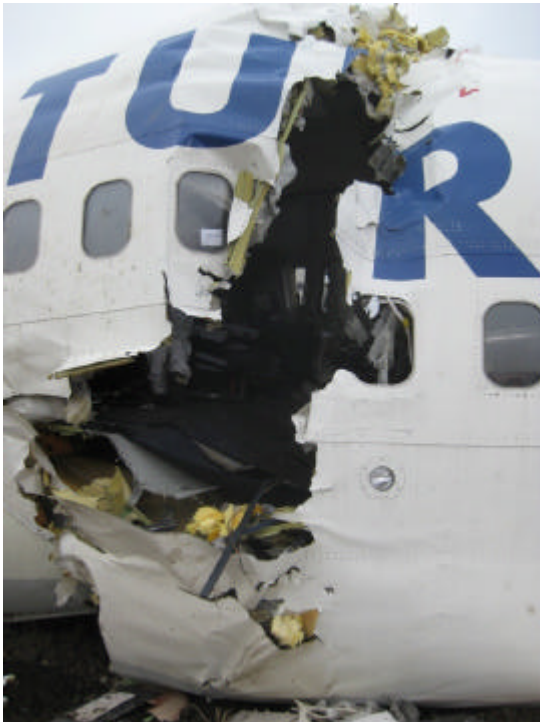
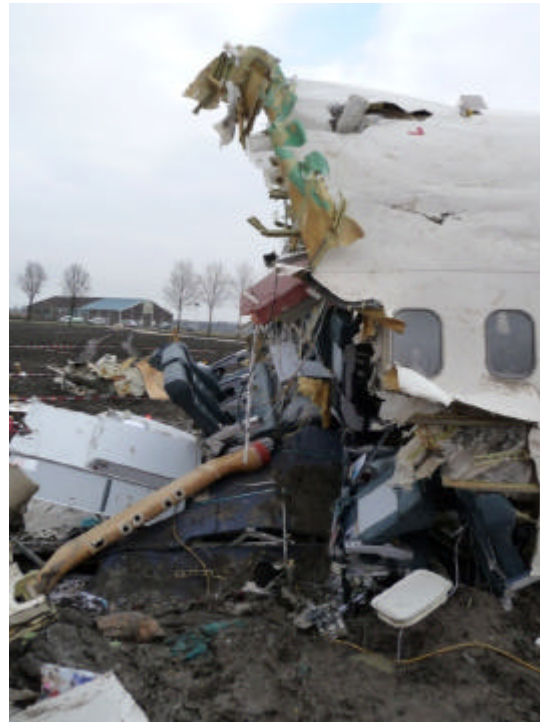
The aircraft impacted farmland 1.5 km north of the Runway 18R threshold. The wreckage trail was approximately 100 m long and along a heading of approximately 160° magnetic. The initial impact ground marks are consistent with the shape of the aft part of the fuselage.

The horizontal stabilizer and the main landing gear were separated from the aircraft and located near the initial impact point. The left and right engines had separated from the aircraft and were found some distance away. The aft fuselage, with vertical stabilizer, was broken circumferentially forward of the aft passenger doors and had sustained significant damage. The fuselage had ruptured at the right side forward of the wings. The forward fuselage section, which contained the cockpit and seat rows 1 to 7, had been significantly disrupted. The rear fuselage section was broken circumferentially around row 28 (the rear-most row of seats on the left-hand side of the aircraft. At the right-hand side at the rear is a row 29).
