Serious incident to the BOMBARDIER CL-600-2E25 (CRJ-1000) registered **F-HMLD**

on 20 October 2021

on approach to Nantes-Atlantique (Loire-Atlantique)

Altimeter setting (QNH) read-back error, triggering of a MSAW on final approach

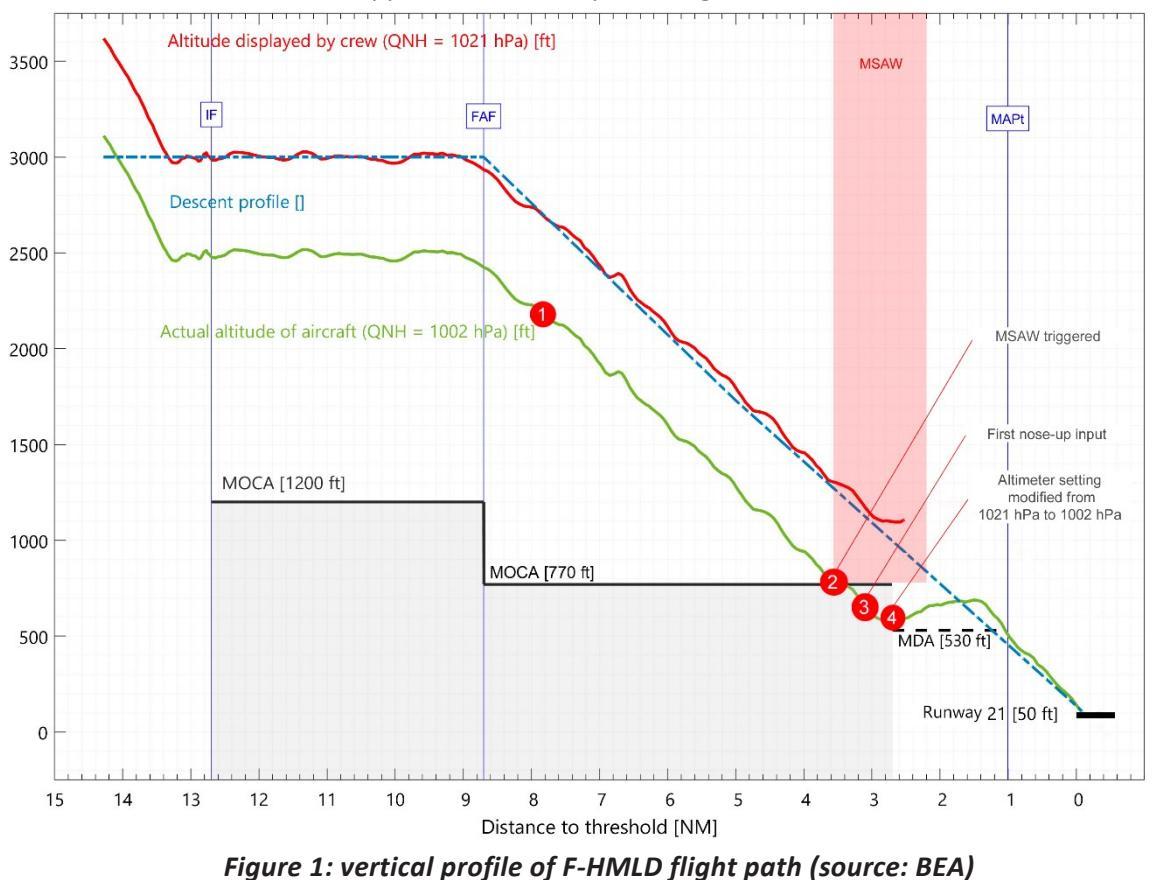
Nearly two minutes later, at 17:49:48, when the aeroplane flew through 788 ft³, a Minimum Safe Altitude Warning (MSAW) was triggered at the controller's position (point 2). The aeroplane entered an area where the minimum obstacle clearance altitude was 770 ft⁴. The controller informed the crew of the terrain alert, telling them to check their altitude ("Air France trente trois Charlie Whisky euh vérifiez votre altitude, al... alerte relief").

Simultaneously, at 17:50:02, the PF applied a nose-up input on the stick (point 3). A few seconds later, the descent rate decreased and stabilised at slightly negative values.

At 17:50:16, the controller gave the QNH again saying it was one thousand and two, one zero zero two ("*mille deux unité zéro zéro deux*"). Simultaneously, the crew corrected the setting on their altimeters (point 4) and corrected the path.

The MSAW stopped at 17:50:36, and the aeroplane joined the normal approach slope 12 s later, 1.7 NM from the threshold.

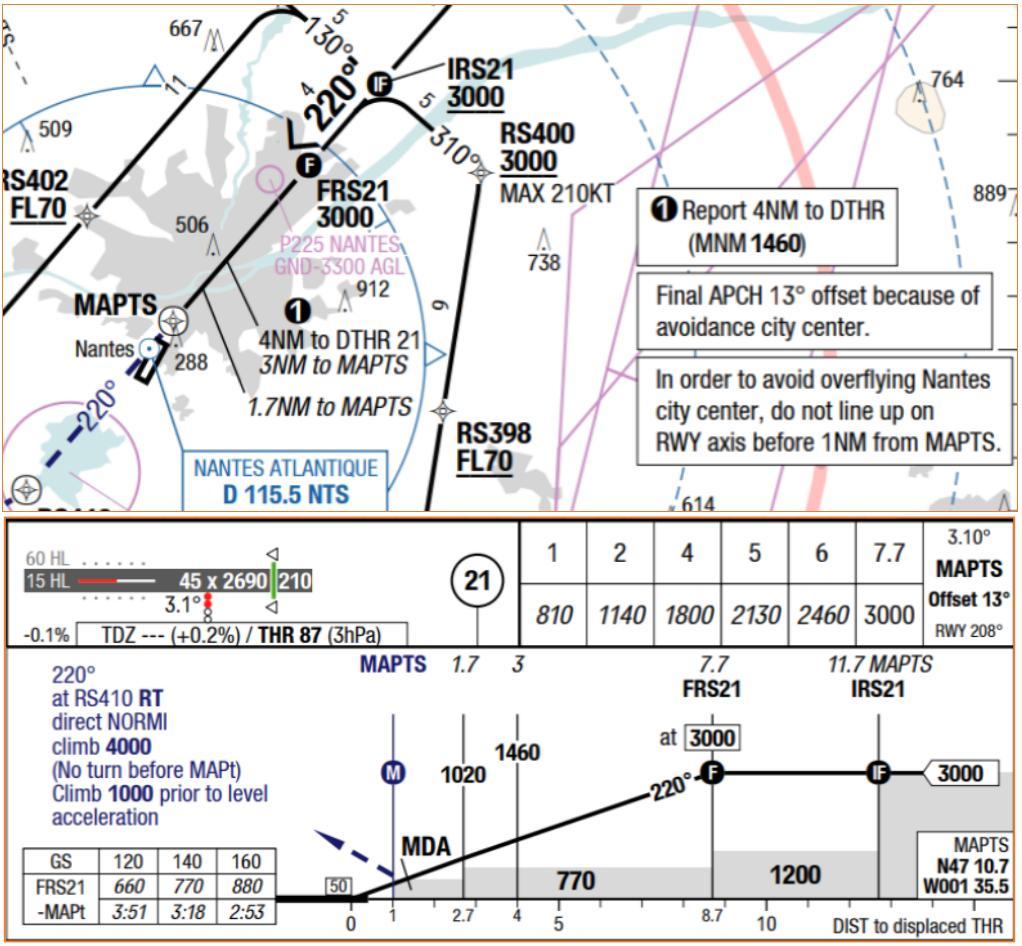
Figure 2: extracts from the approach chart used by the crew (source: Lido)

- one SDF located at 1,460 ft and 4 NM from the runway threshold: this fix is associated with the note "*Report 4NM to DTHR (MNM 1460*)" on the approach chart used by Hop! crews;
- one SDF located at 1,020 ft and 2.7 NM from the runway threshold.

The 506 ft-high obstacle shown on the chart in the vicinity of the approach path, nearly 4 NM from the threshold, determines the area's Minimum Obstacle Clearance Altitude (MOCA) of 770 ft between the FAF and the point located 2.7 NM from the threshold. It corresponds to the Brittany Tower⁶.

The Minimum Descent Altitude (MDA) is set at 530 ft for Category C aeroplanes, which includes the CRJ 1000. The missed approach point (MAPt, named "MAPTS" on the chart) is located 1 NM before the threshold of runway 21. The obstacle used to define this MDA value is an antenna of an altitude of 288 ft. It is shown on the chart, to the left of the approach path.

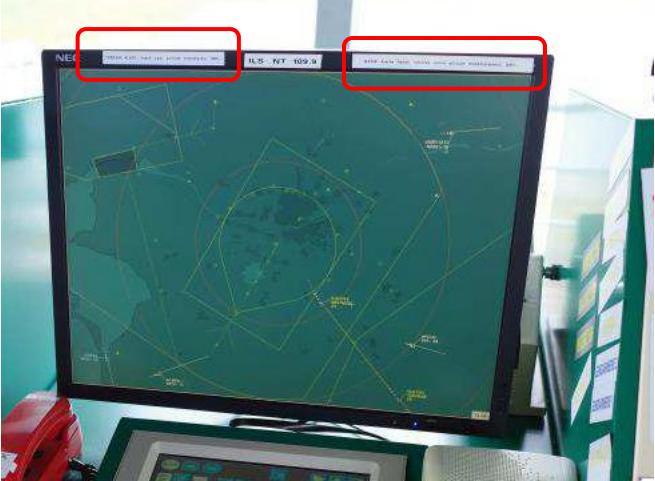
Figure 4: position of stickers on radar screen at LOC position (source: SNA-O¹⁶)

In the Nantes control tower, stickers have been affixed to the upper frame of the radar screen at the LOC position, reminding the controller of the phraseology to be used in the event of a MSAW, both in French and in English. This phraseology is for aircraft that are not being radar vectored. The exact wording on these stickers is as follows:

Alerte Relief, Vérifiez votre altitude immédiatement, QNH... (label on the right side) TERRAIN ALERT, check your altitude immediately, QNH... (label on the left side)
