Flight Crew Computer Errors (FMS, EFB) Case Studies

1st Edition Oct 2011

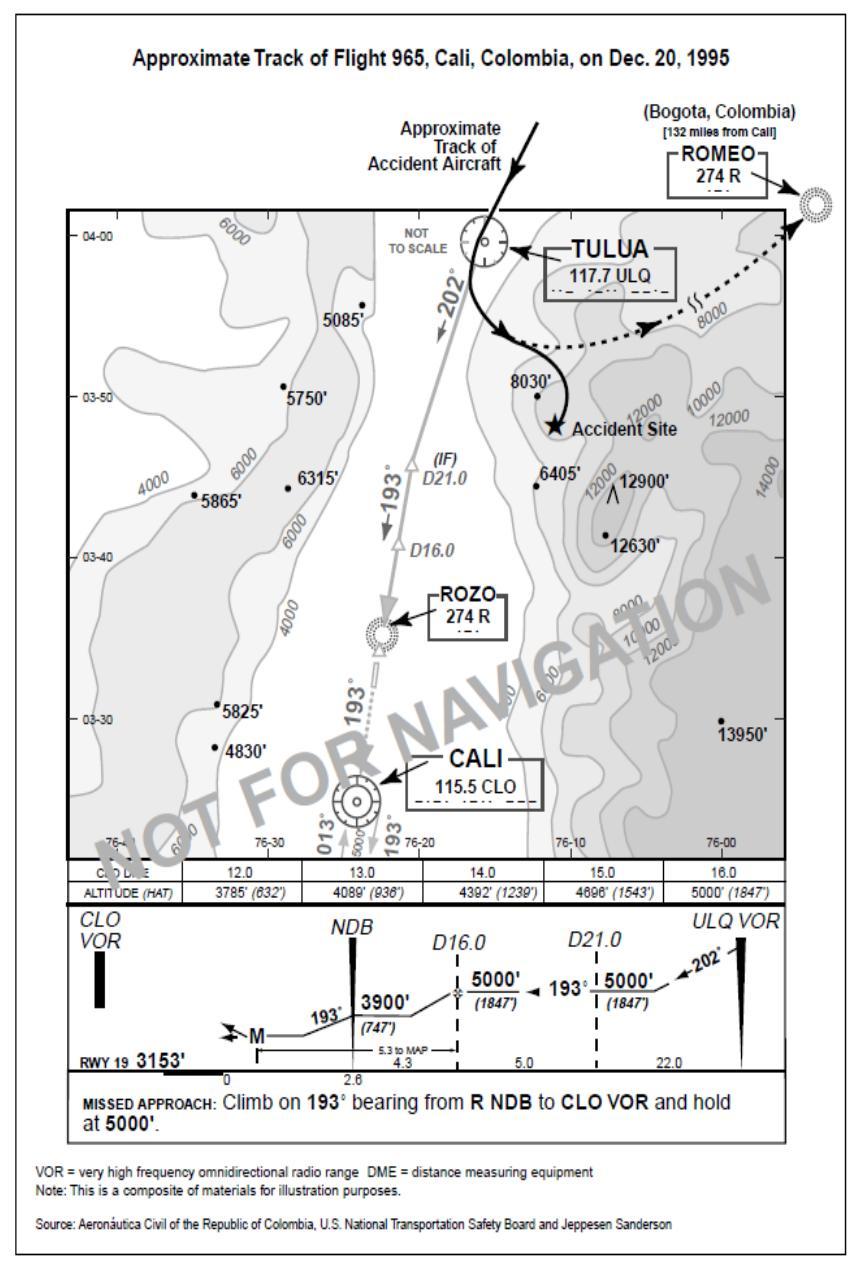
Tests on the FMC indicated that it had been programmed to track direct to Romeo NDB and this is supported by the recorded turn to the East. After approximately one minute the pilots recognized that the aircraft navigation was incorrect and they turned back to the right towards Cali but continued to descend, apparently unaware of high terrain now between them and the Runway 19 approach course. The descent was expedited by use of the speedbrakes.

When the GWS 'terrain' warning activated the autopilot was disconnected and a large nose up input made on the controls but it was insufficient to avoid impact. The speedbrakes remained extended and it was not possible to determine whether the accident would have happened had they been retracted in the 'escape' maneuver.

The Captain's failure to recognize that the FMC was not offering Rozo NDB in response to the selection of the 'R' identifier may be attributed to workload or to unfamiliarity with the system's operation. Inconsistent FMC programming characteristics (driven by technical limitations and/or the geographical distribution of navigational aids) have potential to confuse the user. The delay in recognizing the plainly anomalous aircraft navigation to the east was almost certainly a function of workload and lost situational awareness.

Individual – time pressure, whether perceived or actual, can lead to poor decision making and pilots must develop Threat Error Management strategies that promote safe operations – accepting track shortening and/or runway changes may not be an appropriate decision, based on situational awareness and flight conditions. Pilots must also be able to recognize when the cockpit workload is reaching a level that threatens to erode their ability to safely and correctly manage the flight. When operating in a procedural ATC environment it is essential that all instructions are clearly understood, and queried if they are not. Acceptance of direct routing when close to high terrain should only be with careful consideration for the implications. Finally, whenever there is any doubt with regard to aircraft position it is vital that a safe altitude is achieved and maintained until situational awareness is regained and questions about the state of the aircraft are resolved.

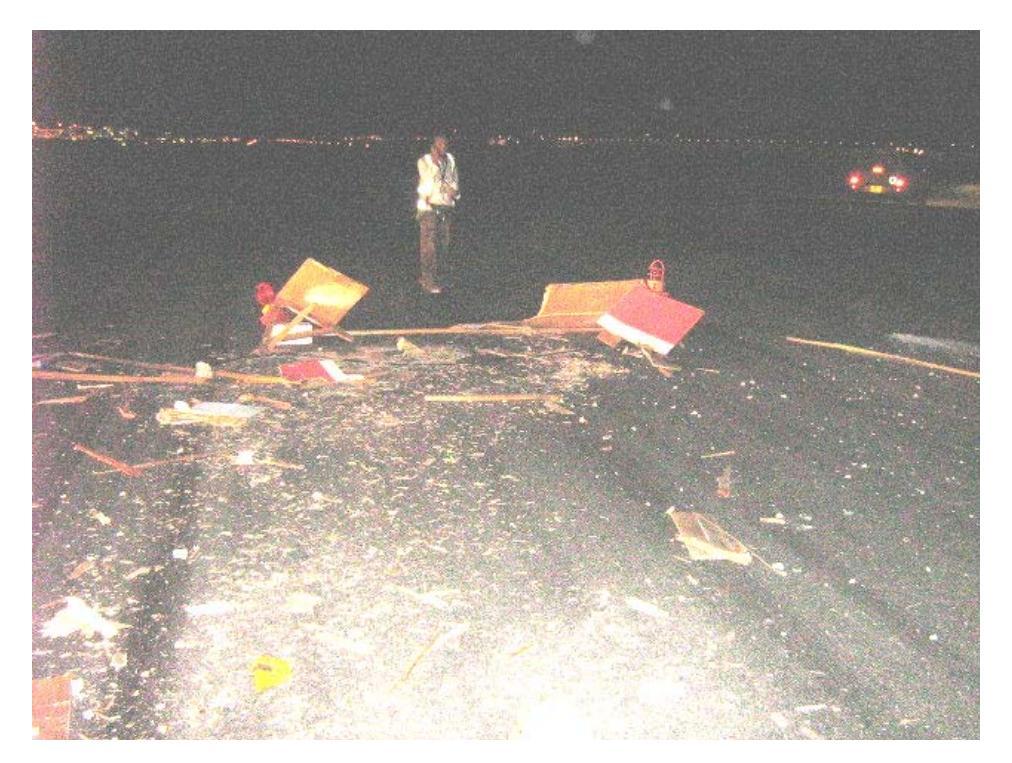
During the take-off roll all three cockpit crew members observed red runway lights approaching, indicating that the aircraft was nearing the runway end. However, the Captain, as Pilot Flying (PF) apparently made no changes to the thrust and rotated the aircraft normally.

The controller on duty observed that the lighting of some marker boards at the runway end had been extinguished as the aircraft passed them on take-off and inspection found damage commensurate with aircraft tire impact.

The NOTAM regarding reduced TORA on 20C was not included in the pack of papers provided to the crew but the condition was highlighted to them by the dispatcher, and the flight engineer reported this as confirmed by the automated terminal information service (ATIS) prior to departure. The investigation concluded that the crew were aware that they would be taking off from a shortened runway.

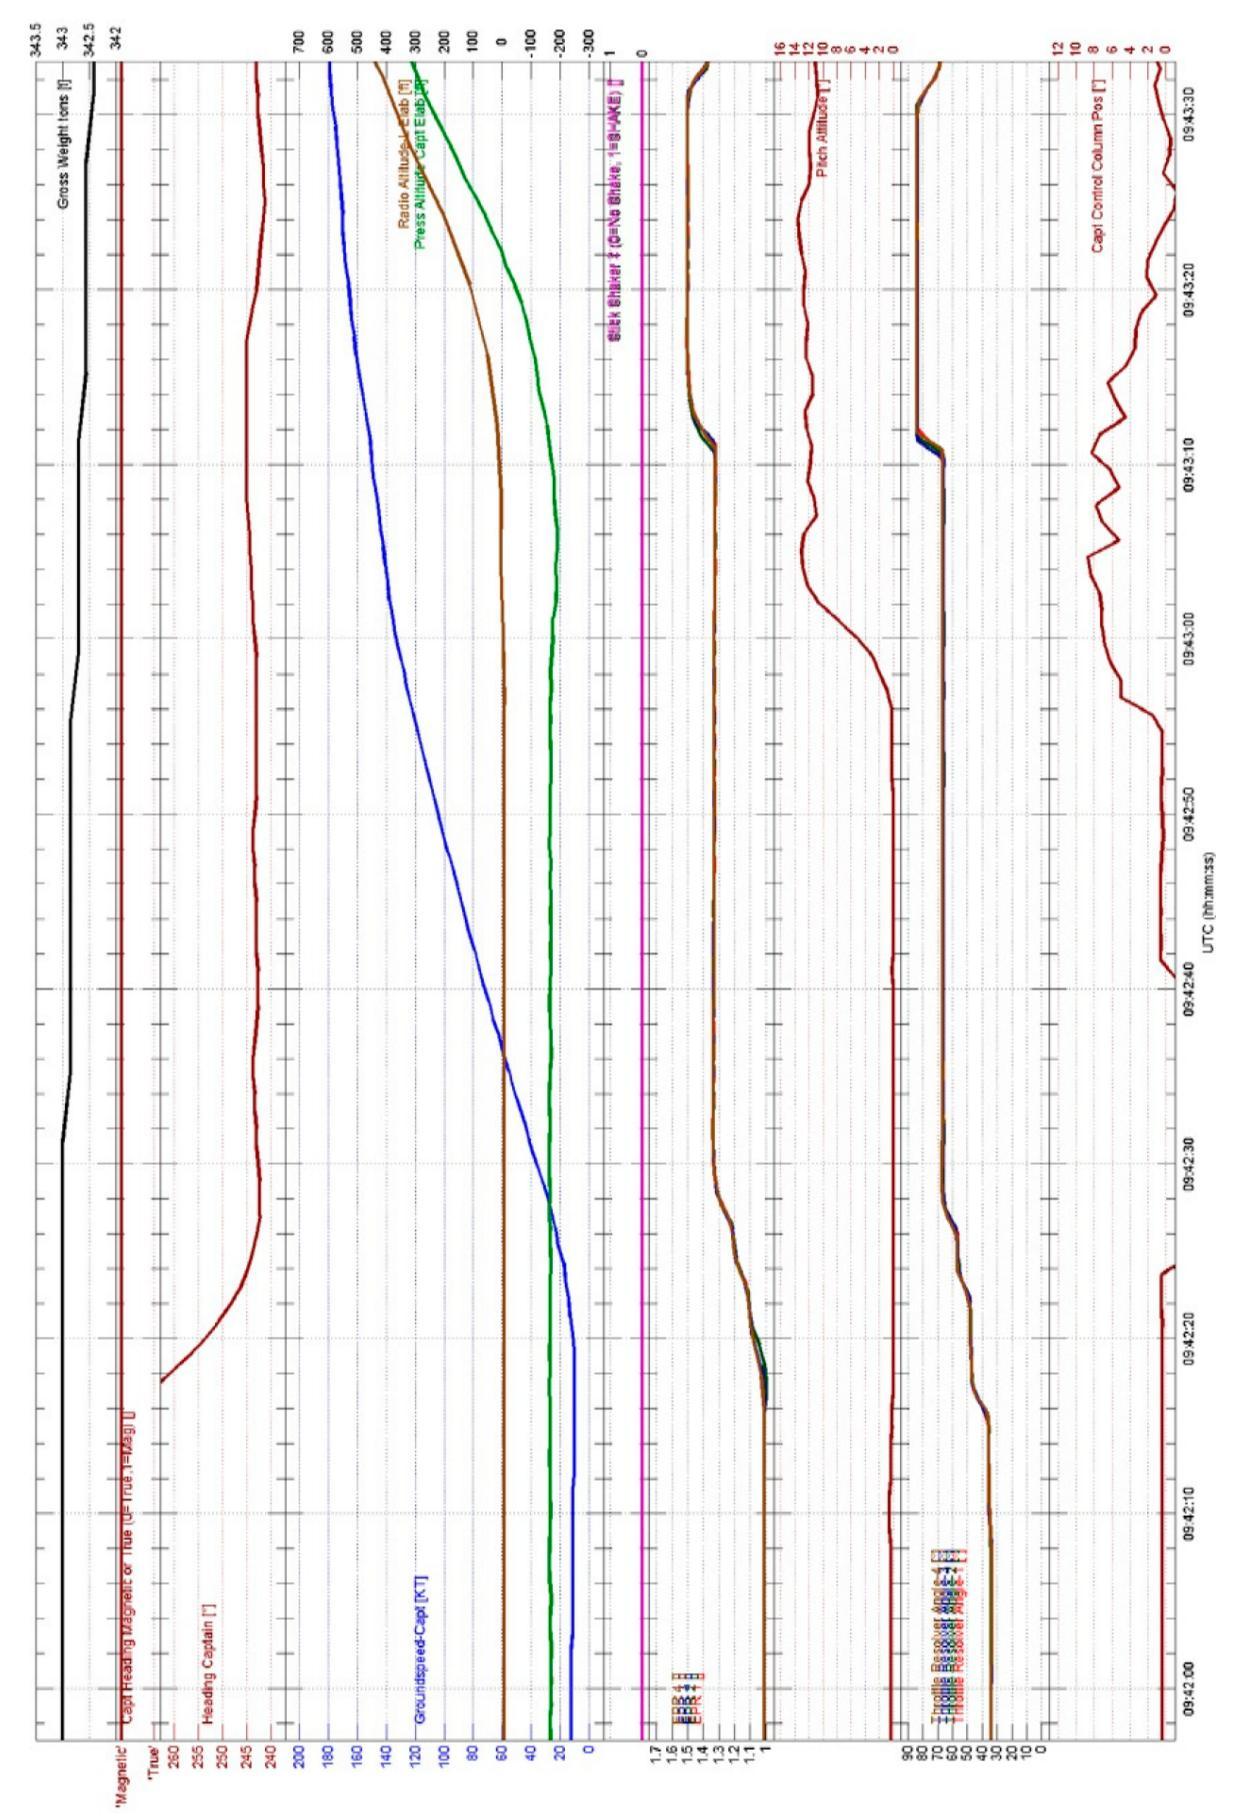
The recorded flight data (below) showed that full take-off thrust was applied several seconds after rotation commenced and as the aircraft lifted off. This was simultaneous with activation of the stick shaker. Evidence of tailstrike was found on the aircraft aft fuselage after landing.

The recommendations of the report indicate that distraction may have been a factor during the critical phases of take-off performance calculation.

The opportunity for a valuable gross error check using data from different sources appears to have been missed when overwriting the FMS speeds with those from the BLT. A substantial discrepancy between the two calculations, as in this case, should have been cause for investigation by the crew. A second innate gross error identification opportunity was missed when the first officer was able (incorrectly) to explain the high assumed temperature following the captain's query. Pilots should be reminded that any question over critical data should be properly resolved.

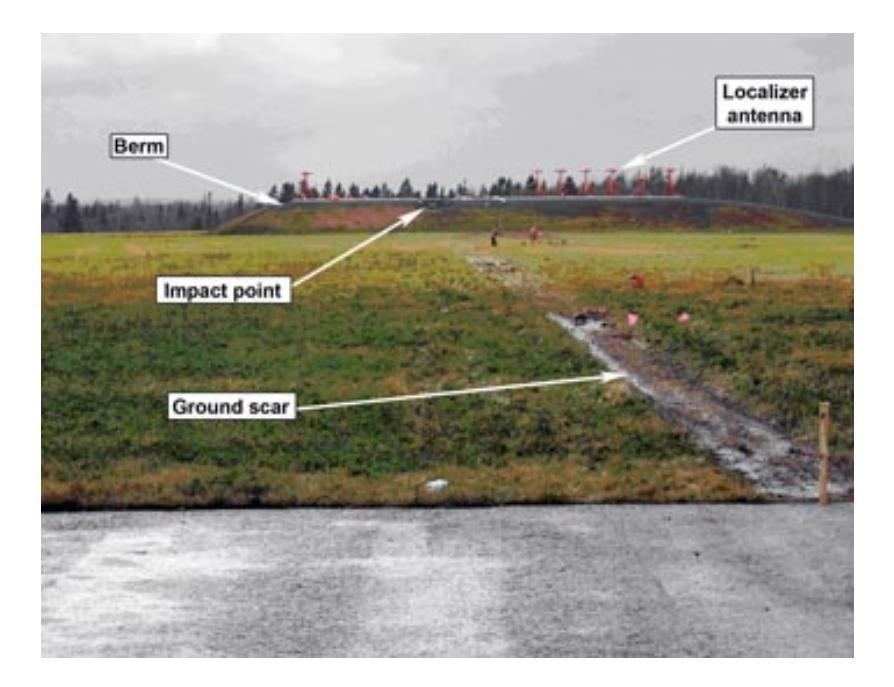
Incorrect Take-off Weight - Runway Excursion Boeing 747-200, Halifax, Canada, 14 October 2004

The investigation determined that the crew had probably used a take-off weight of 240,000 kgs (529,109 lbs), which was equal to the take-off weight for the preceding sector, to calculate the take-off thrust and V speeds they inserted into the flight management computer (FMC). This was more than 100 tons less than the load sheet take-off weight of 350,698 kgs (773,156 lbs), which in itself was less than the actual weight due to some organizational and procedural deficiencies at the operator and at the ground handling service provider. The laptop application (BLT) used for the take-off data calculation defaulted to the take-off weight value inserted for the previous calculation until such time as it was updated by the crew. The investigation suggested that crew members had not undergone any formal training in the use of the laptop application.

The crew failed to observe that actual aircraft performance during the take-off roll was inadequate to permit it to get airborne within the runway length, until it was too late to prevent a runway excursion. The aircraft did actually get airborne beyond the end of the runway, and was probably capable of returning to a safe landing in the absence of the impact with the berm. However, the berm was not considered an obstacle for take-off performance as it did not penetrate the surface of the obstacle free zone.

In this case there was a significant functional deficiency in the laptop application, in that the take-off weight field defaulted to the last entered value, rather than a blank or 'void' field to remind users to enter the correct value.

Operator – with safety critical activities like take-off data calculation it is vital that pilots are adequately trained and tested in the use of the associated equipment. As important is to provide them with error tolerant procedures and robust gross error checks to validate the data they use. Automated systems such as the laptop BLT application should be rigorously examined for potential deficiencies like the take-off weight default, before they are brought into service. Fatigue management strategies are required to ensure that pilots are fit for the duties expected of them and less prone to simple errors.
