**OPERATIONAL EVALUATION
OF PROTOTYPE TAXIWAY
RUMBLE FEATURES**

Edition Number	:	1.0
Edition Date	:	20 October 2009
Status	:	Released Issue
Intended for	:	General Public

In response to Stakeholder requests, Eurocontrol conducted an operational evaluation to assess the potential of a 'Taxiway Rumble Feature' as an additional runway incursion prevention measure.

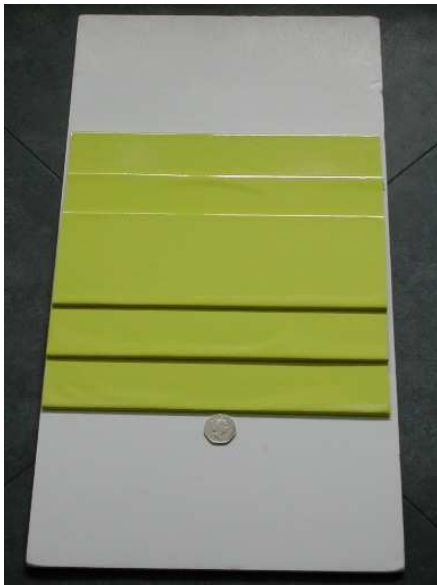
Prototype Rumble Features
 Layout of Features for Trial and
 Operational Evaluation

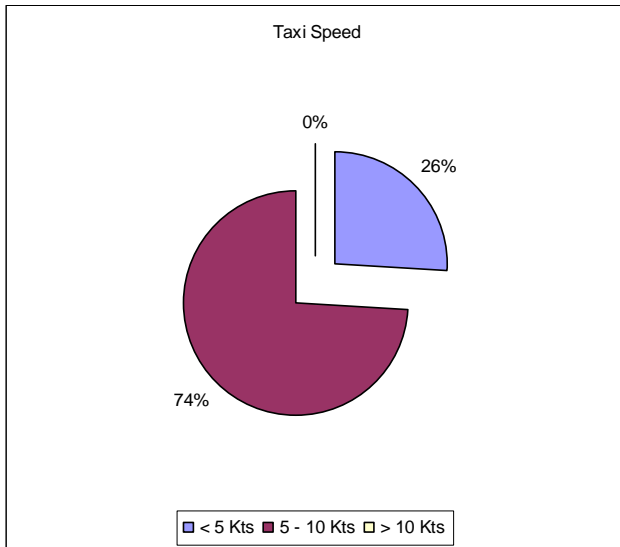
Taxi speed:

The majority of respondents reported crossing the rumble features at a taxi speed in the range 5 – 10 knots. None reported a taxi speed greater than 10 knots.

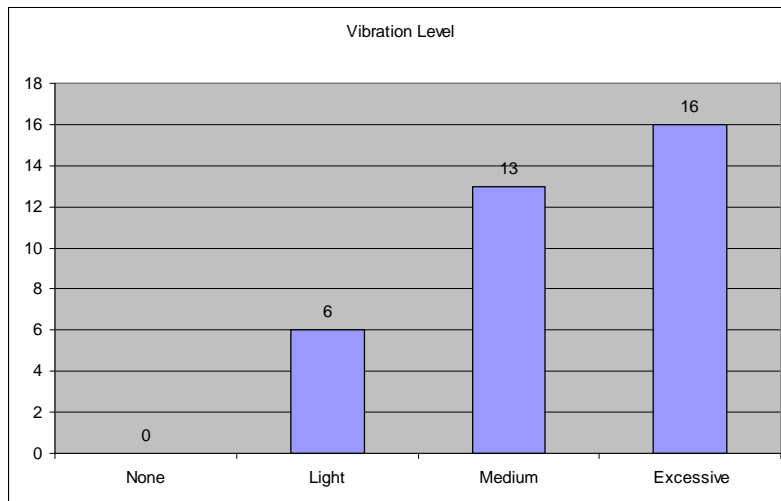
Did you feel the Rumble Feature?

All respondents reported that they could feel the vibration from the rumble features. Perception of the vibration varied as illustrated below.

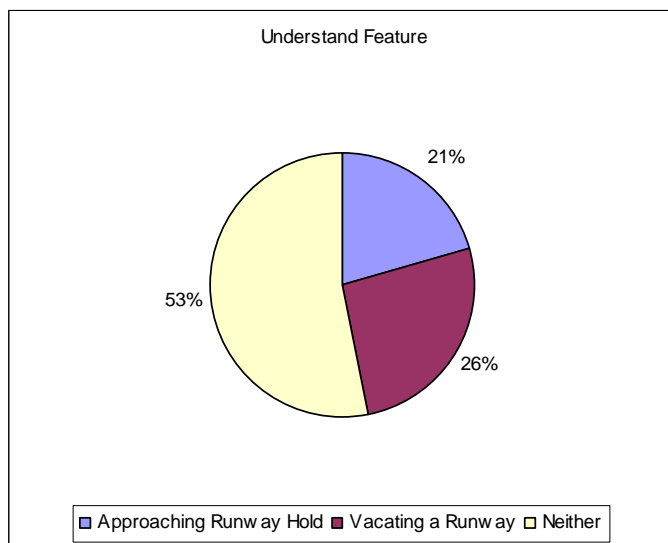
Understanding of the Rumble Feature:

Over half the respondents did not understand that the presence of the rumble feature was intended to indicate a location at the Runway Holding Position, so that it indicated that the aircraft was approaching a RHP (or, in the opposite direction, that it was in the process of vacating the runway). This may indicate a deficiency in the briefing process or materials prior to the evaluation period.
