# REPORT

SL 2011/10

## WINTER OPERATIONS, FRICTION MEASUREMENTS AND CONDITIONS FOR FRICTION PREDICTIONS

### VOLUME II - MAIN REPORT

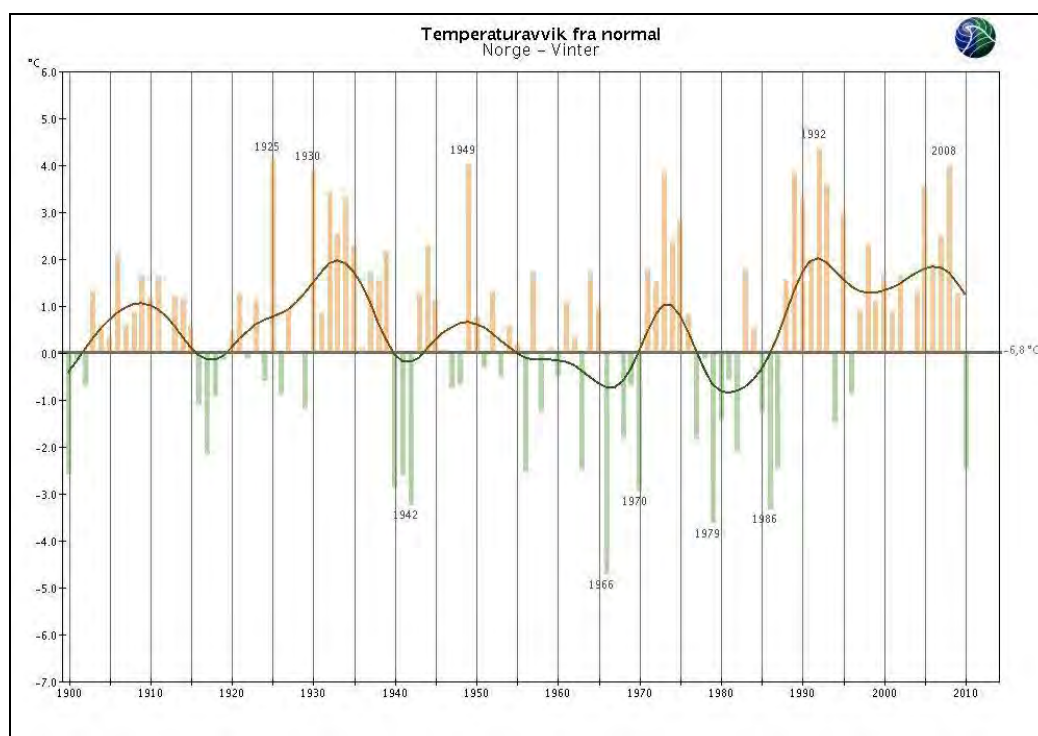
Figure 1: Annual deviation from mean winter (November-April) temperature in Norway. Normal period 1961-1990 (met.no). [Met.no/Winter temperature last 150 years/Norway](http://Met.no/Winter%20temperature%20last%20150%20years/Norway)

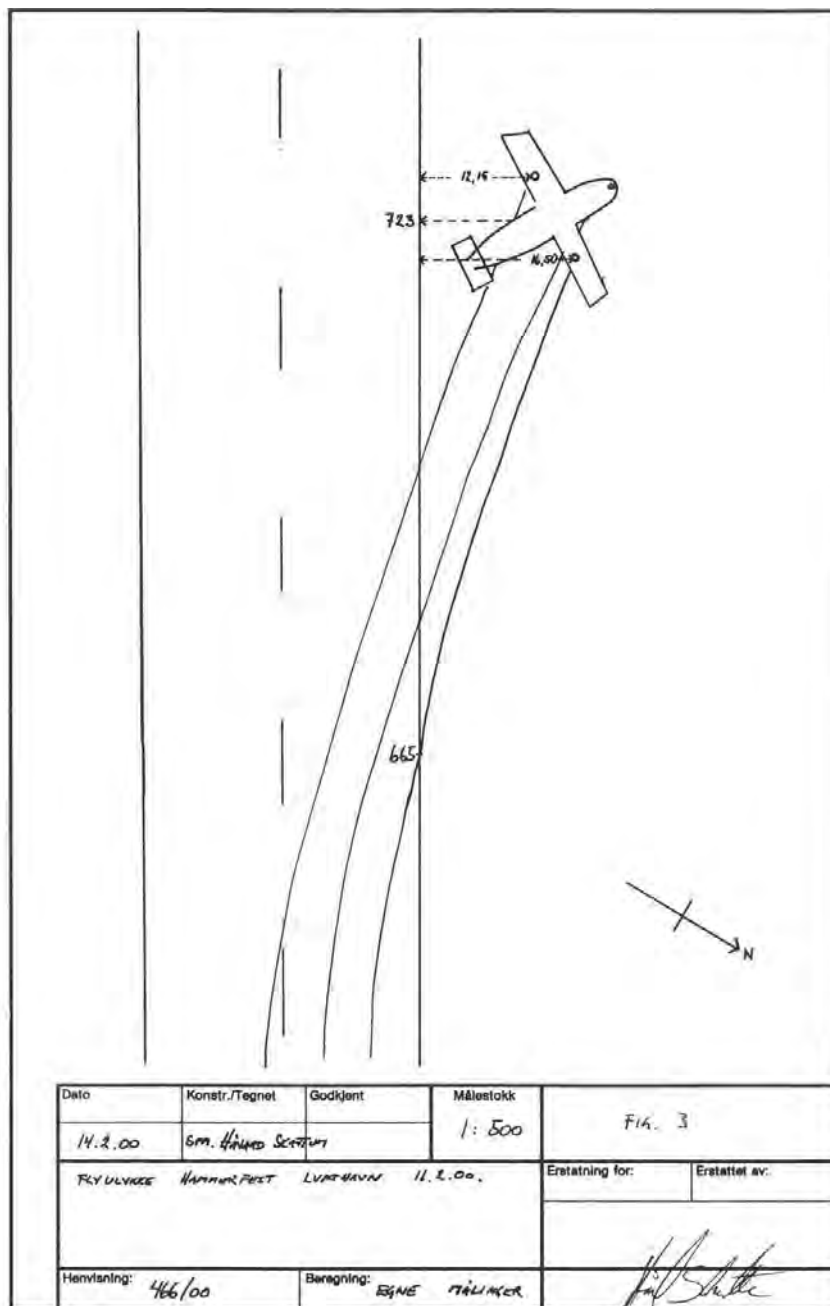
Wideroe DHC-8-103 skidded off the side of runway 23 while landing on a slippery runway in crosswind conditions.

Figure 3: Serious aviation incident with LN-WIL at ENHF on 11 February 2000.

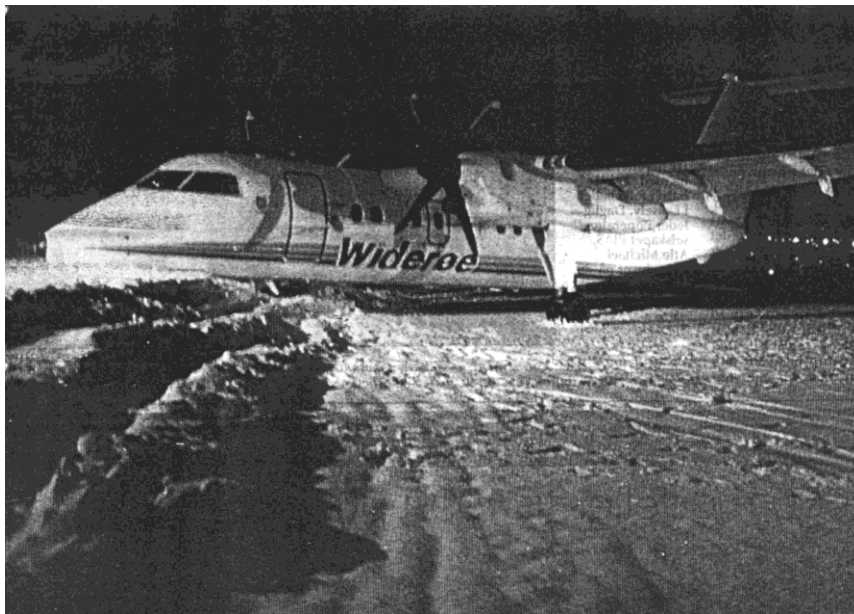
The runway was covered with compact snow and ice with 3-4 mm of slush on top. The runway had been sanded. Measured FC was 32-34-33 (Griptester/GRT)<sup>18</sup>. Actual ABC as deducted from FDR data was in the order of 0.05 (POOR).

Figure 4: Aviation incident with LN-WIL at ENHF on 11 February 2000.

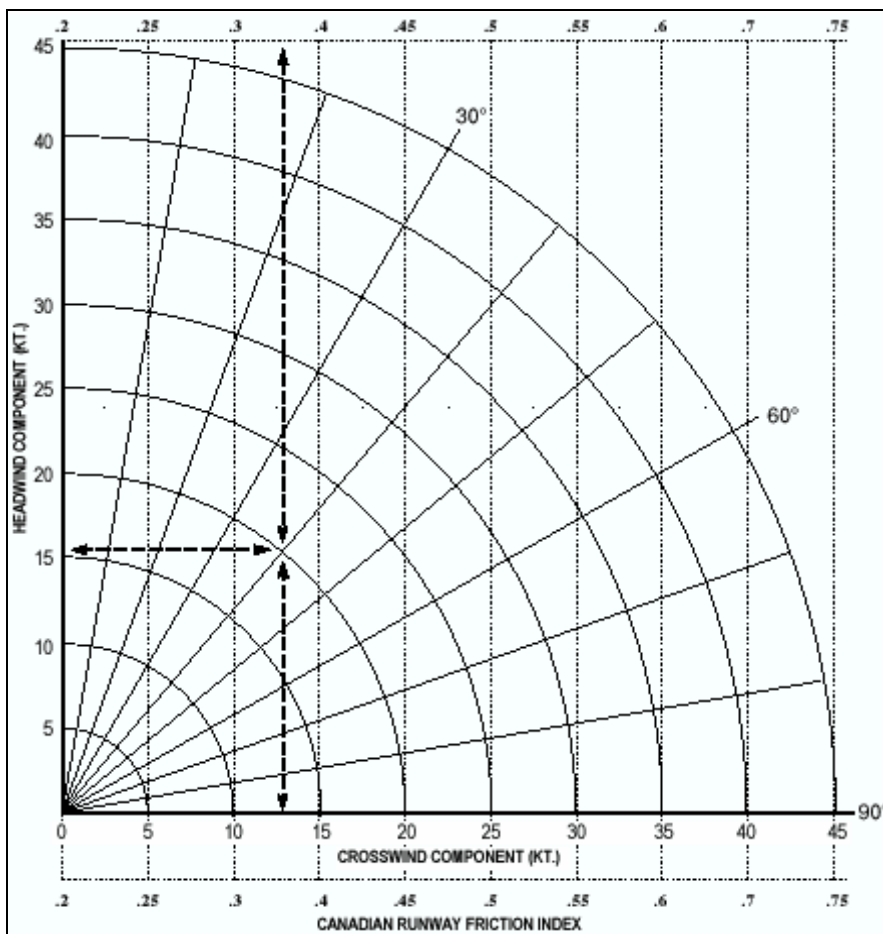
Figure 5: Crosswind Limits for Canadian Runway Friction Index (CRFI).

The intention behind this recommendation was that Widerøe's crosswind limits on slippery runways with measured FCs of less than 0.40 (GOOD), ought to be reduced to increase the safety margins on short runways. The AIBN judged that, since ICAO had already recommended a crosswind limit of max 10 kt on dry runways less than 1,200 m in length, an assessment should be carried out as to whether Widerøe should set the same crosswind limit on a shorter (800 m) runway with reduced friction of less than 0.40 (GOOD).

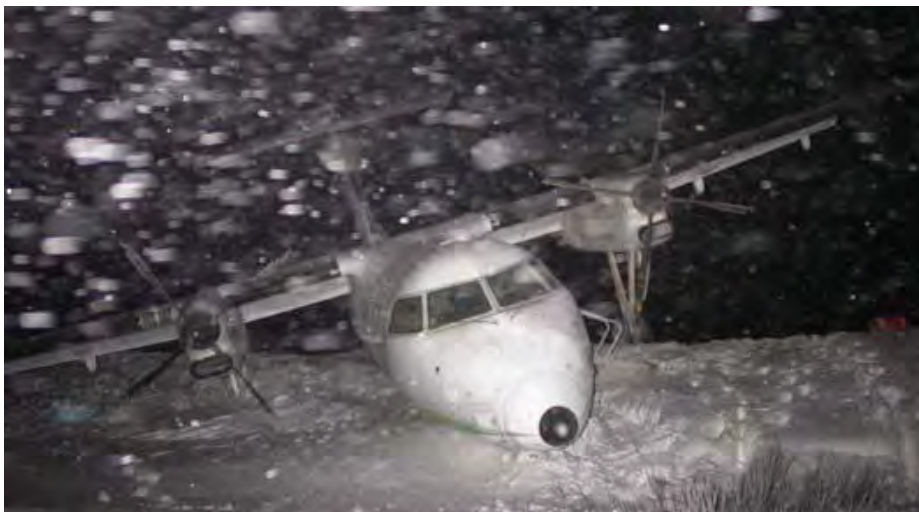
Wideroe DHC-8-103 skidded off runway 08 after landing on a slippery runway in crosswind conditions.

Figure 6: Aviation accident with LN-WIN at ENVD on 6 January 2003.

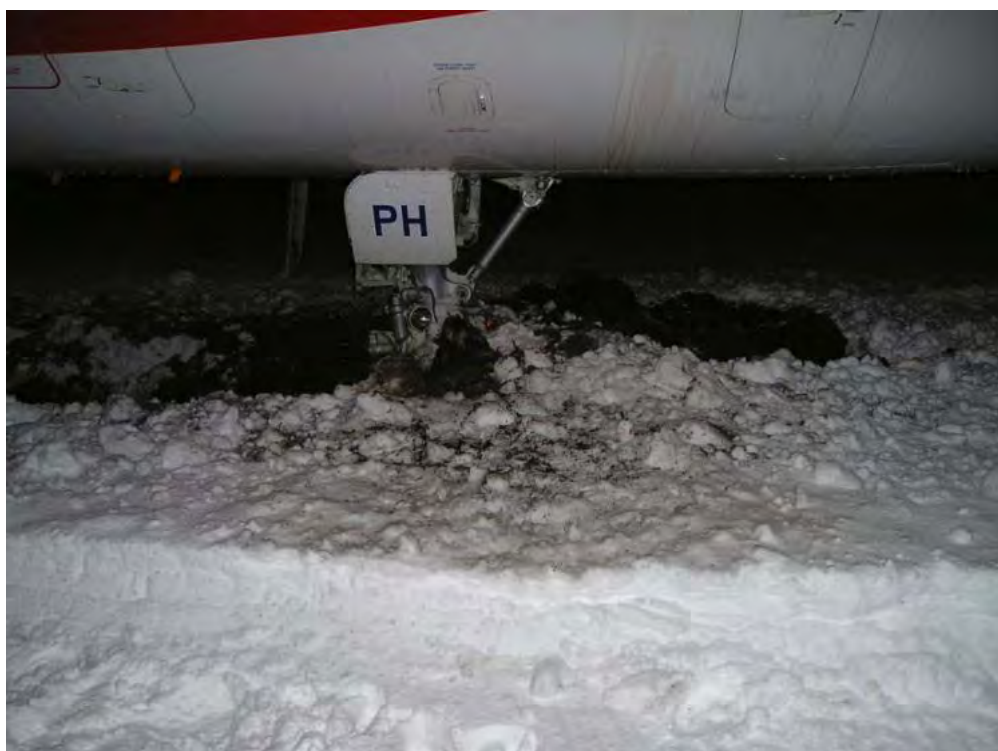
The runway was covered in sanded ice with 8 mm dry snow on top. Measured FC was 34-32-32 (Skiddometer/SKH). Actual „effective  $\mu$ “ was perceived by the crew as POOR.

Figure 7: Serious aviation incident with G-CRPH at ENEV on 25 November 2004.

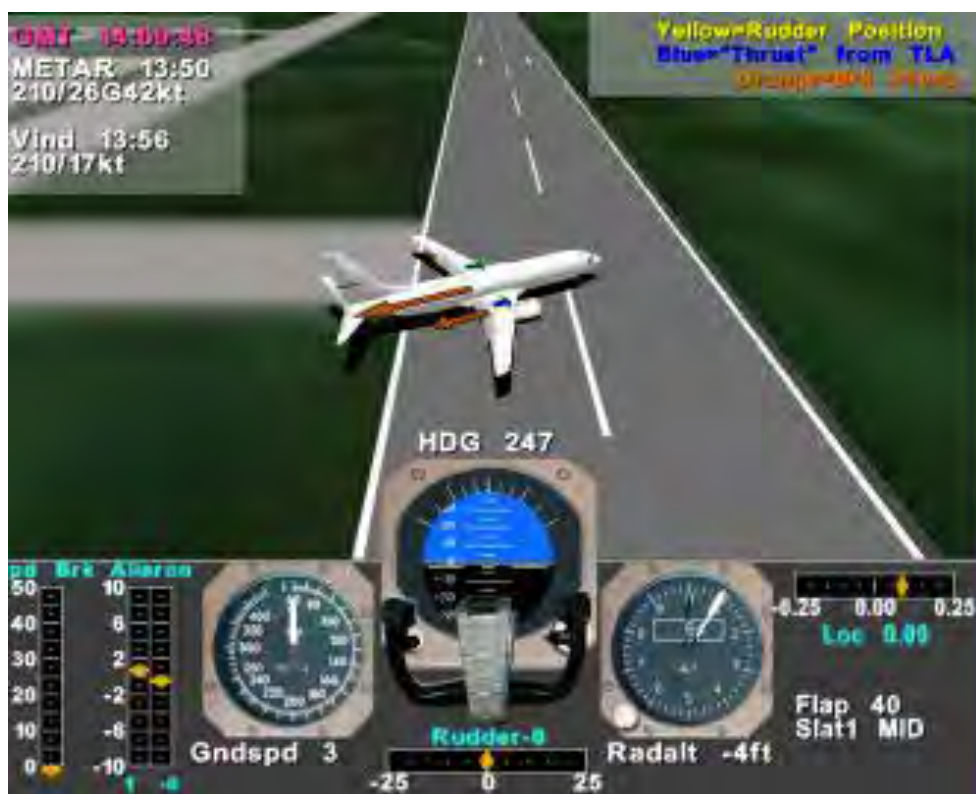
Figure 8: Serious aviation incident with LN-BRV at ENEV on 30 January 2005. Animation available at [www.aibn.no/aviation/reports/2011-10](http://www.aibn.no/aviation/reports/2011-10)

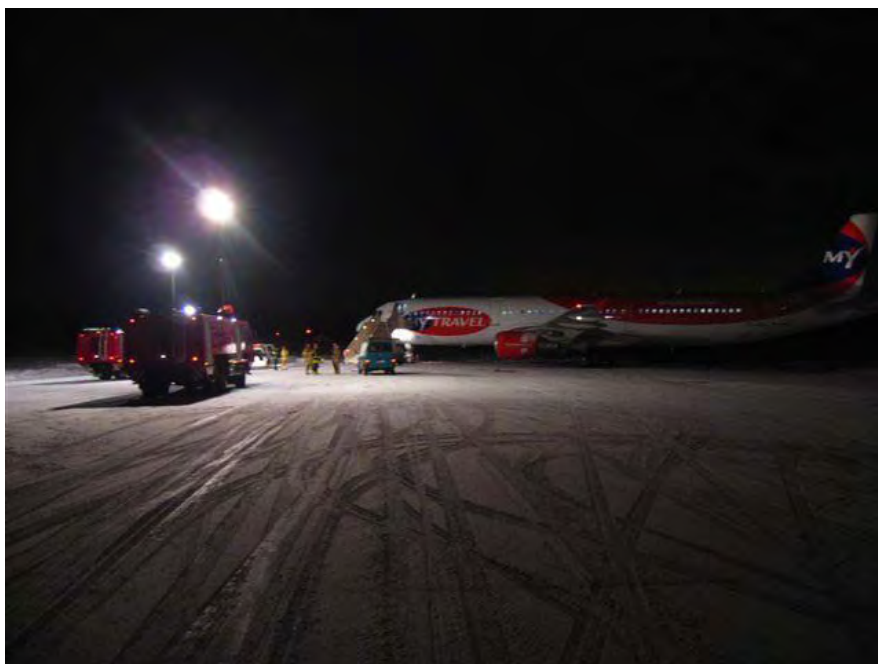
The runway was reported to be covered with 8 mm of wet snow. Measured FC was 32-33-31 (Skiddometer/SKH). Actual „effective  $\mu$ ” as deducted from FDR data was in the order of 0.05 (POOR).

Figure 9: Serious aviation incident with OY-VKA at ENTO on 26 March 2006 (AIBN). Animation available at [www.aibn.no/aviation/reports/2011-10](http://www.aibn.no/aviation/reports/2011-10)

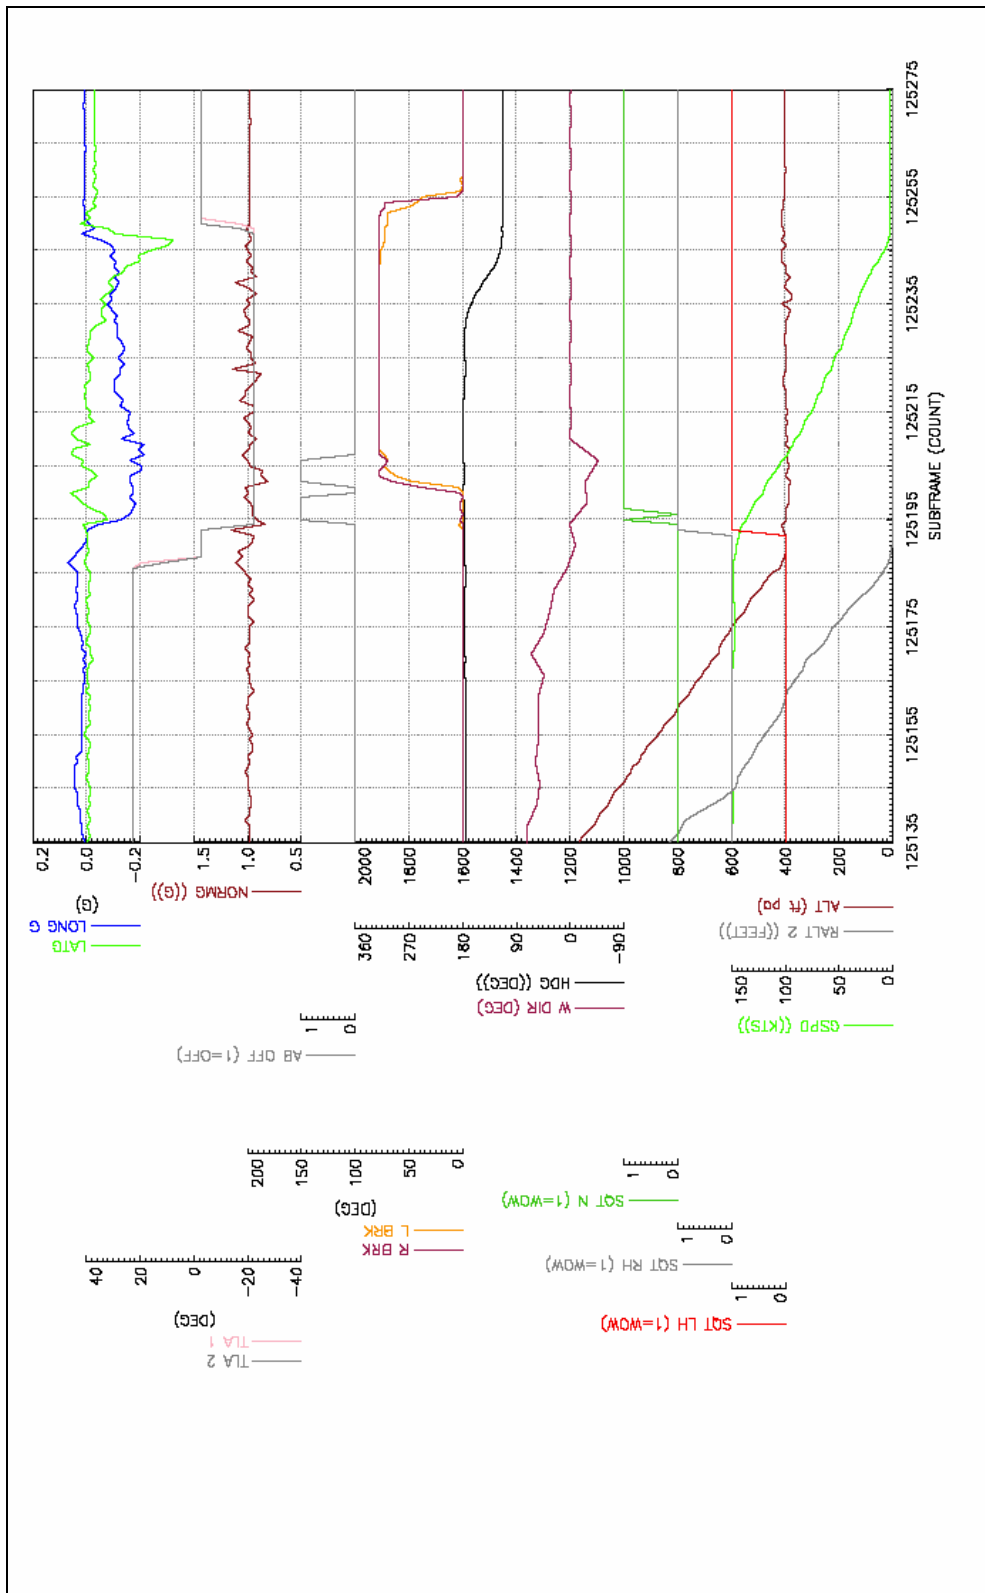
Figure 10: FDR data from OY-VKA (AIBN).

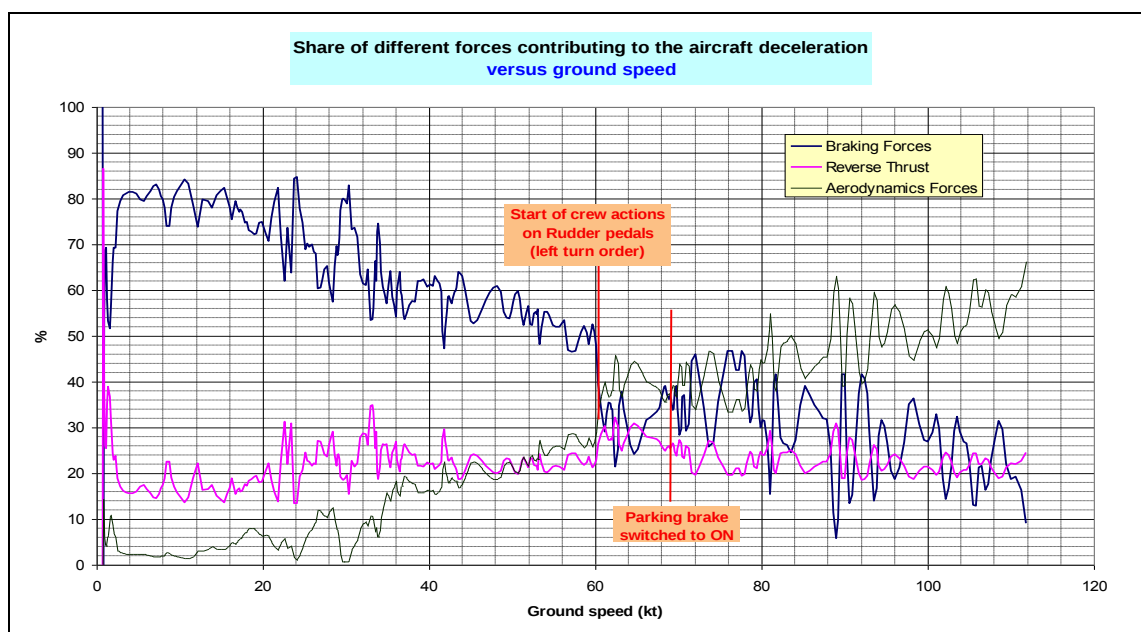
Figure 11: Graph showing the percentage distribution of braking forces from flaps/spoilers, from reversing and from wheel brakes for OY-VKA (AIBN).

Figure 11 shows the relative braking power that can be ascribed to the three braking forces air resistance, reverse thrust, and wheel braking, when braking on a contaminated runway with an „effective  $\mu$ “ in the order of 0.05. At this low friction level the „effective  $\mu$ “ and ABC are of the same order (Boeing POOR). The data concerns a relevant runway excursion in Norway (OY-VKA, RAP 2010/05, see 1.1.22). The graph shows that maximum reverse thrust accounts for approximately 20 % of the total braking power given the available POOR friction, and remains almost constant down to a ground speed of 20 kt. It also shows that the wheel brakes contribute 20-30 % during the first phase of the braking process. Although the FDR data is from an Airbus A321, it is considered relevant in general. The engine and reverser characteristics are similar if not identical, the anti-skid efficiency are of the same order and the aircraft aerodynamic layout are not much different.

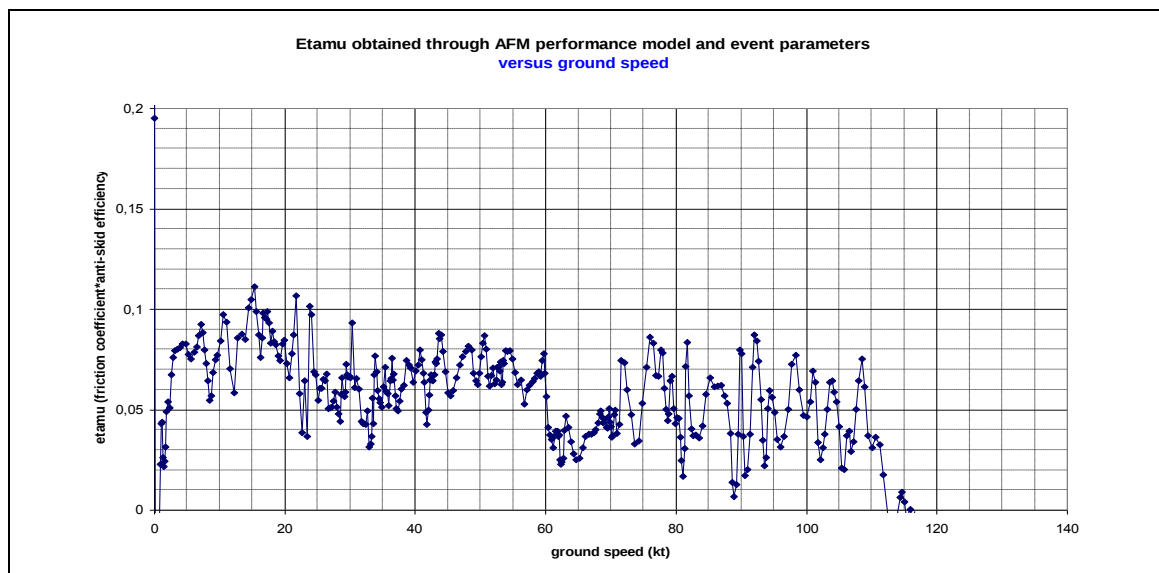
Figure 12: Graph showing the aircraft's effective braking coefficient for OY-VKA (AIBN).

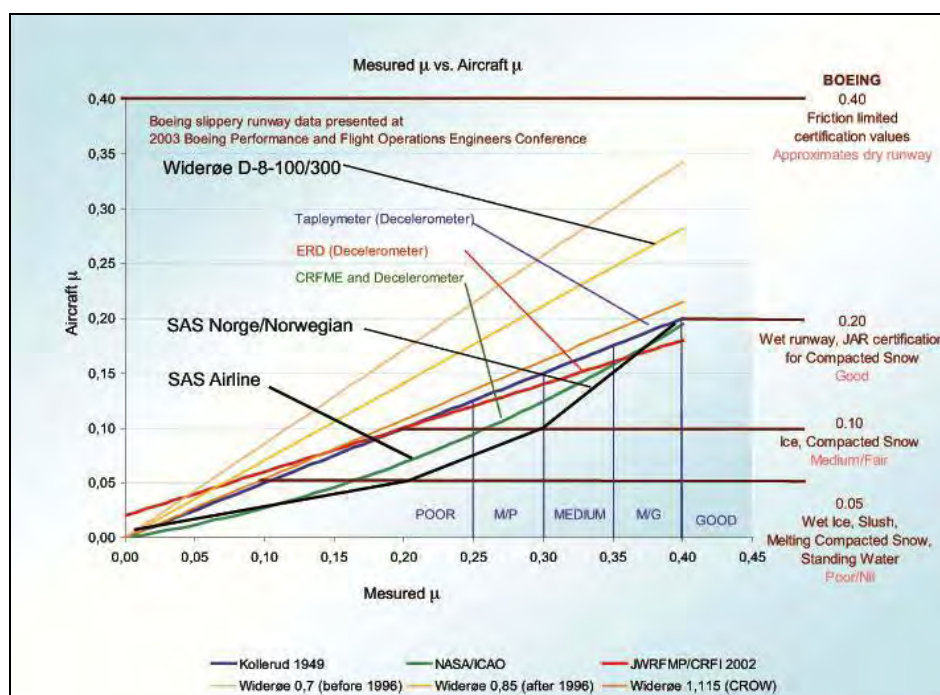
The first documented correlation curve based on comparative testing of friction measuring devices (decelerometer) and aircraft (DC-4, DC-6, DC-6B) were carried out by Kollerud (1949-54, see Figure 13).

Figure 13: Measured  $\mu$  (FC) vs. Aircraft  $\mu$ .

If the constant 1.115 is used as the denominator, Bombardier's correlation curves become almost identical to „ $\text{aircraft } \mu = 0.6 \mu_{\text{measured contaminated}}$ ” for DHC-8-100/300 and „ $\text{aircraft } \mu = 0.5 \mu_{\text{measured contaminated}}$ ” for DHC-8-Q400, respectively. Figure 13 (and Figure 9 in Appendix G) shows that use of the corrected value for „ $\mu_{\text{measured dry}}$ ” in Wideroe's correlation formulas, results in „ $\text{aircraft } \mu$ ” values that correspond to Kollerud's and JWRFP's values. However, the AIBN's findings suggest that „ $\text{aircraft } \mu$ ” for propeller aircraft may be somewhat higher than for turbojet aircraft. This is also indicated by test data from JWRFP (see Figure 3 and Table 4 in Appendix G). This may be supported by earlier tests that indicated that lower landing weights resulted in a higher friction coefficient, but not to such an extent as indicated by the Wideroe correlation curve as shown in Figure 13. See Figure 14 and Appendix V.

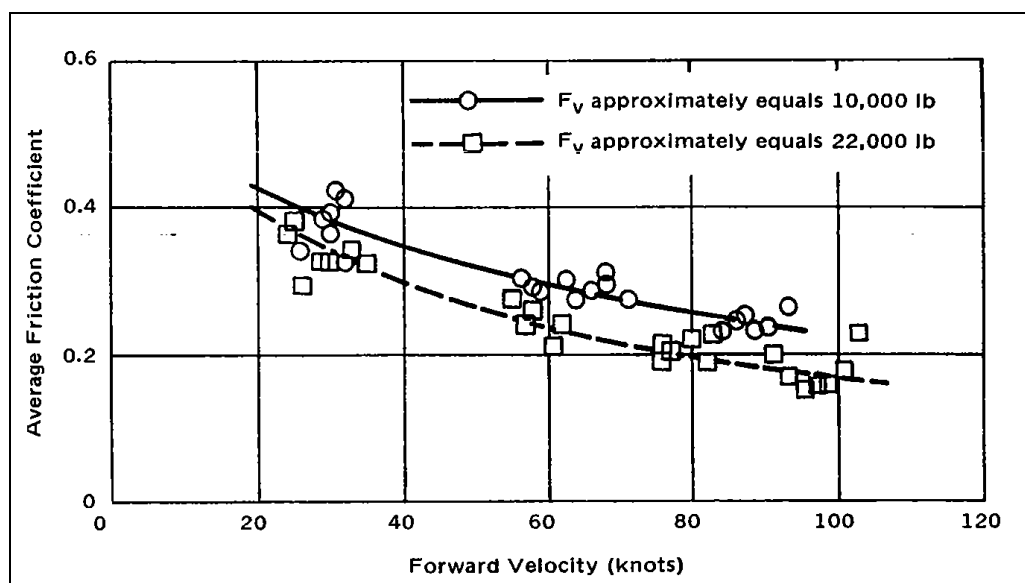
Figure 14: Average Friction Coefficient vs Velocity and Wheel Vertical Load (Horne and Leland, 1962. Appendix V).

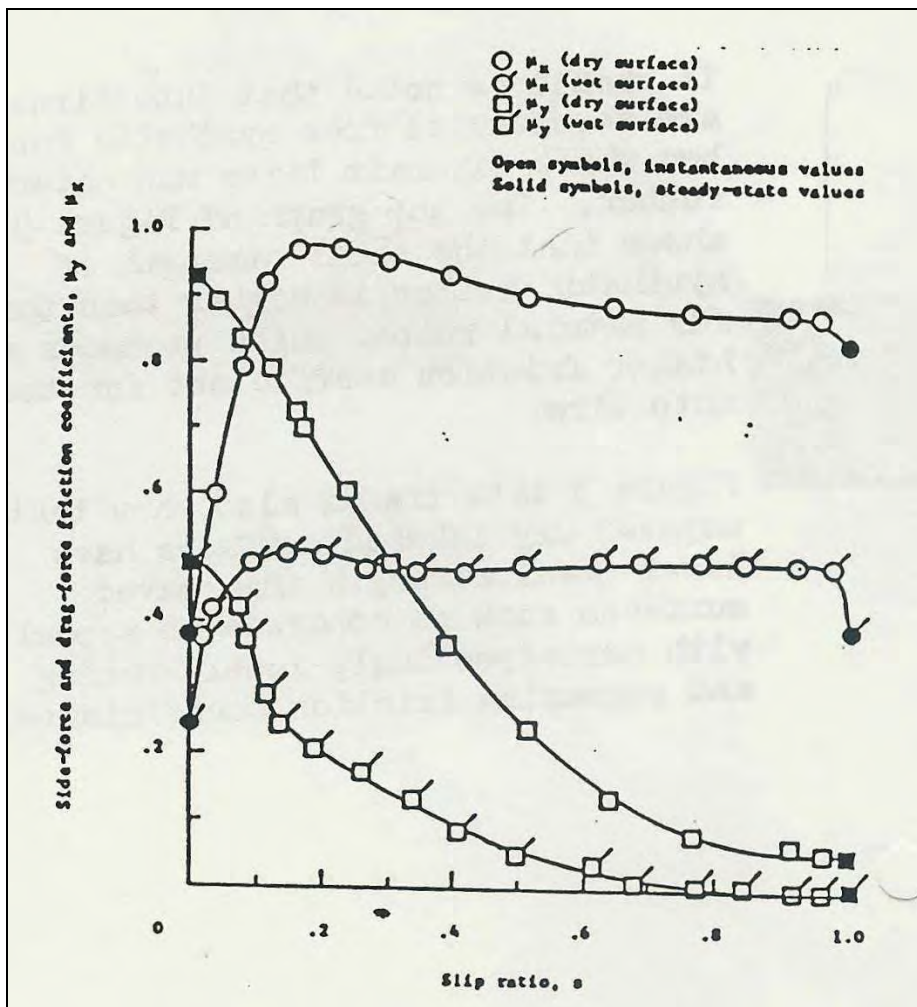
When braking and steering (cornering) at the same time, aircraft braking friction will be at the expense of aircraft cornering friction. The cornering friction is reduced by an increasing slip ratio. This is shown in Figure 15. It occurs when turning the aircraft and in connection with crosswind landings, when cornering friction is required in order to keep

Figure 15: Cornering friction (W. B. Horne, NASA 1990).

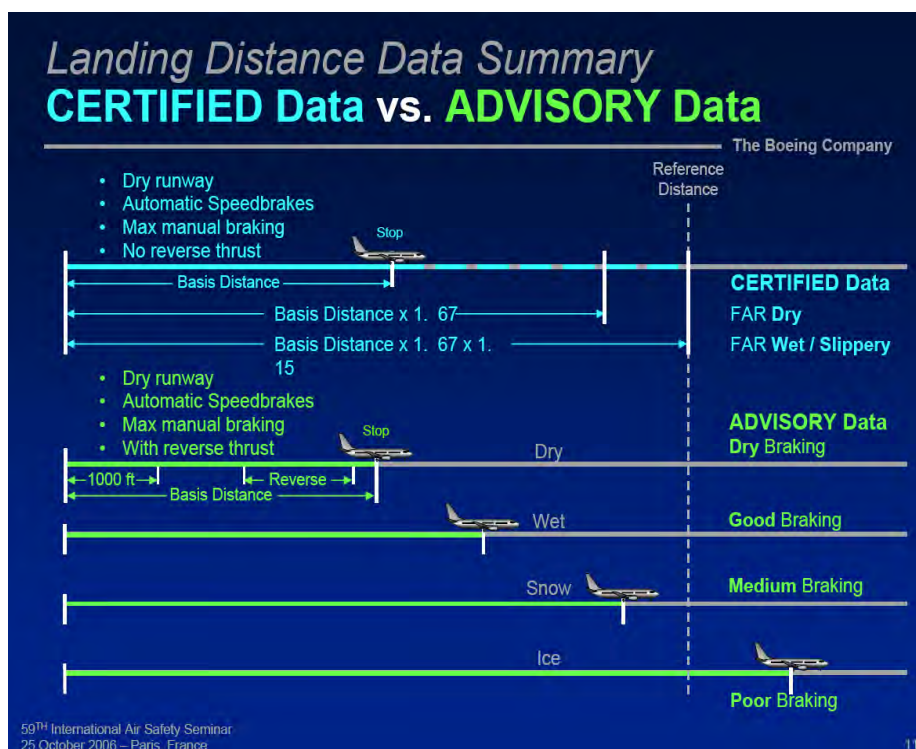
The JAA requirements at the time of certification of the B737NG called for a 7 seconds „flare“ distance and a 7 % speed bleed off from Vref@50 feet Threshold Height (THT) to touchdown on a contaminated runway. This is a much longer „flare“ distance than on a dry runway (4.5 sec / 1 % speed bleed off). Since the flight crews try to aim for the same touchdown point, there are some hidden theoretical margins in the landing calculations for a contaminated runway. These data are published in the AFM and all electronic performance databases, but in the printed Flight Crew Operator Manual (FCOM) Boeing calculates with a fixed flare distance of 1000 feet (300 m).

Figure 16: Boeing's Certified Data vs. Advisory Data (Boeing, 2006).

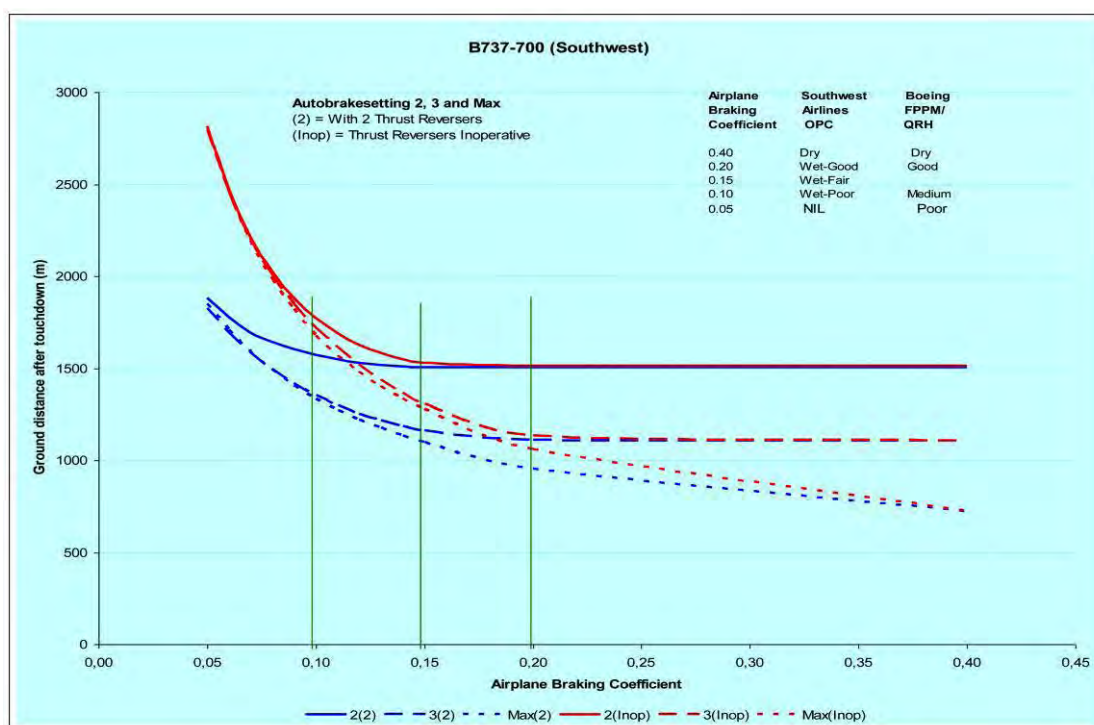
Figure 17 shows the effect of various autobrake settings combined with the use of both, or without thrust reversers. The data is from Southwest's runway excursion in the USA. The blue lines are for use of both thrust reversers, while the red lines are for use without thrust reversers. The figure shows that it was not possible to plan for landing with an ABC of 0.05 (Boeing POOR). However, it was possible to plan for landing without the use of thrust reversers with an ABC of 0.10 (Boeing MEDIUM). Landing with the use of one thrust reverser could be planned on a 2,400 m long runway. The figure also shows that, with an ABC of less than 0.10 (Boeing MEDIUM), it makes no difference to the braking distance whether autobrake setting 3 (7 ft/sec<sup>2</sup>) or Max (14 ft/sec<sup>2</sup>) is chosen. This is because the effective braking is friction limited.

Figure 17: The effect of thrust reversers versus Airplane Braking Coefficients (NTSB).

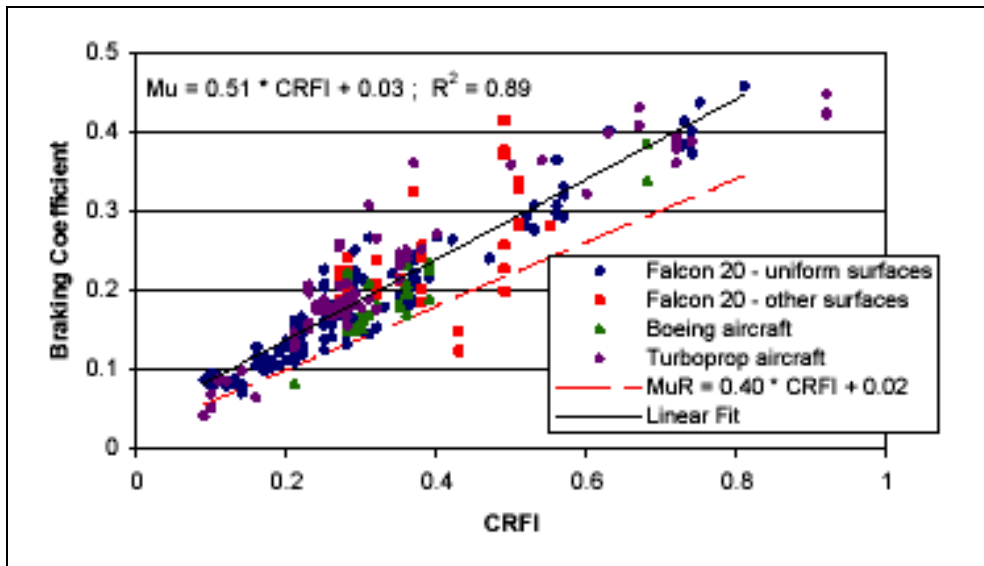
Figure 18: TC's correlation curve between CRFI and Braking Coefficient (aircraft  $\mu$ ).

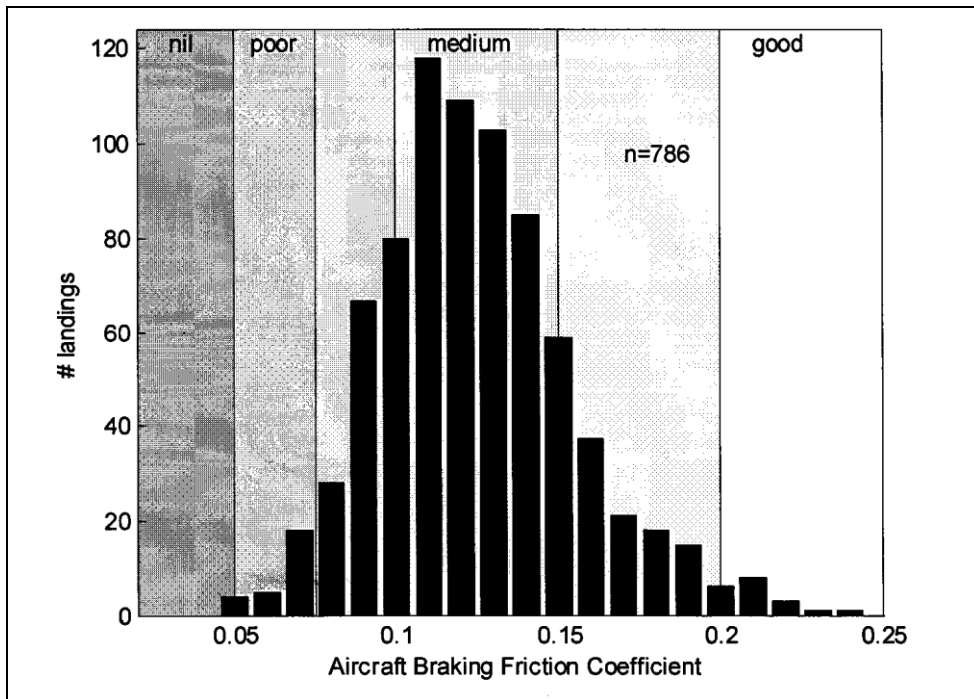
Figure 19 show measured ABCs from B737 during the IRIS program. It shows the spread in ABC in the ranges of GOOD ( $ABC \geq 0.20$ ), MEDIUM ( $ABC 0.10 - 0.19$ ) and POOR ( $ABC < 0.10$ ) under wet or moist conditions..

Figure 19: Aircraft Braking Coefficient measured under wet or moist conditions including Dew Point Spread  $\leq 3$  K.
