# focus

ON COMMERCIAL AVIATION SAFETY

WINTER 2016

# The Inflight Damaged Window Scenario

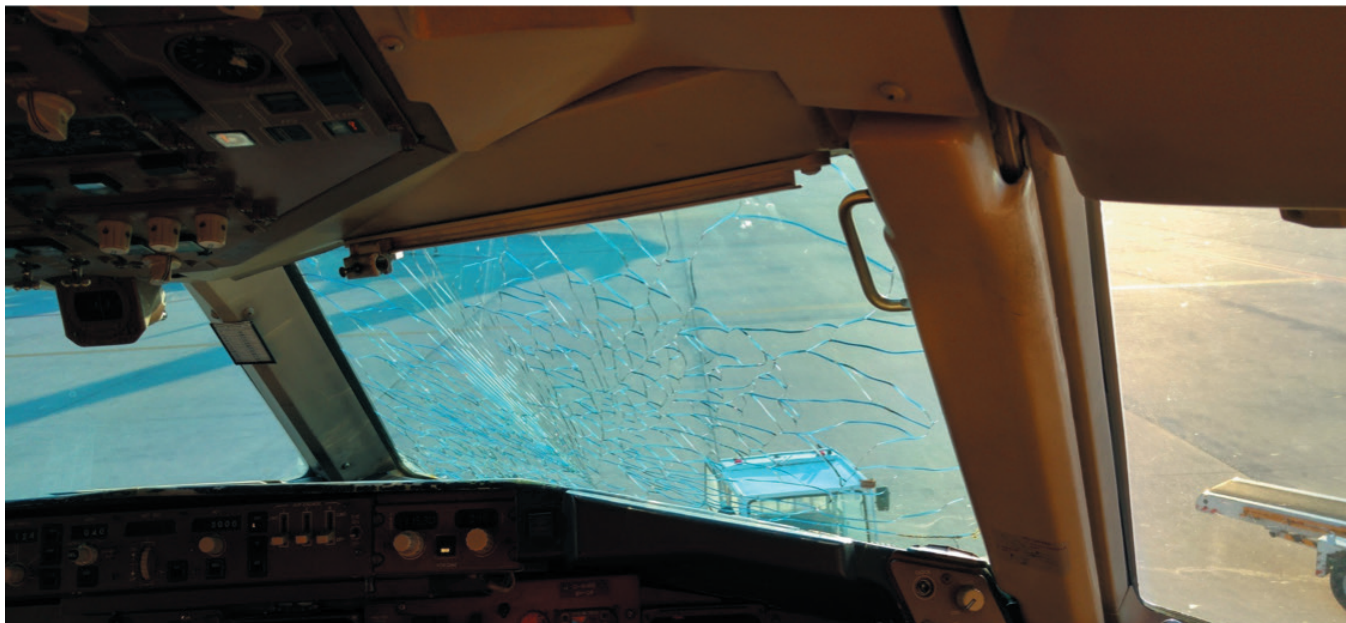
As you can note from the cross section above, the front windshield has 3 'Herculite II' glass panes. The thinner outer layer, is not load bearing and is heated on the inside surface for anti-icing and anti-fogging. This is the only pane to come into contact with electrical power and is separated by an interlayer from the middle full thickness load bearing pane. This is, in turn, separated from the inner load bearing pane, thus there are two load bearing panes in the window. Damage to any single pane does not affect the ability of the window to carry operational pressures. However in the majority of cases it is the outer pane that is the only one affected.

A common cause for windshield problems is the moisture seal, the external seal between the windshield and the aircraft structure. This seal acts as an 'aerodynamic smoother' and moisture bar to the laminate. This moisture seal degrades over time and can allow water ingress to the 'Z-bar' or windshield laminate. This can result in de-lamination and/or arcing of the heating system. See Figures at the top of next column.

The windshield system is as robust as it is dramatic, when it fails. However it is designed to fail in the outer, non-load bearing, section. This may be as a result of electrical arcing and if so sparks, smoke and

a burning smell can be expected. If the window heating system fails, or is turned off as directed by the QRH, then it's possible the outer pane may fail with a loud bang or crack and crazing of the windshield. However, whatever the event, unless pressure is escaping out of the window area or the glass is visibly and obviously deformed then there is no reason to doubt the integrity of the windshield.

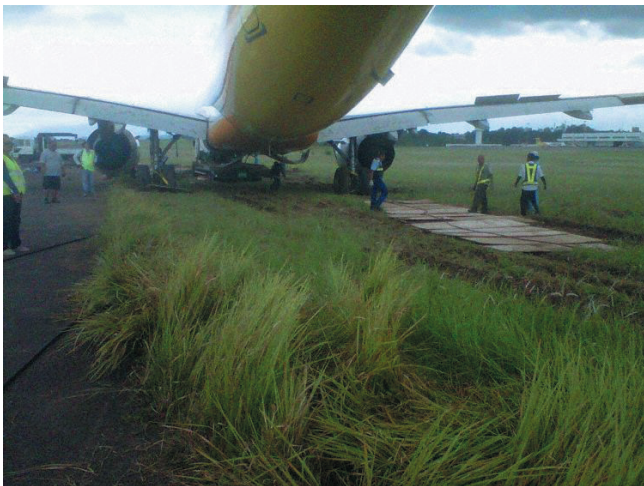
A Cebu Pacific A320-200 was operating from Manila to Davao in the Philippines on 2 June 2012. It ended its flight with a collapsed nose gear and substantial damage to the engines and fuselage from ground contact.

The captain as pilot flying (PF) failed to maintain a stabilized approach in heavy rain that seriously reduced forward visibility; shortly before touchdown the aircraft was still left of the runway centreline. The first officer called him to go right (to align) but the correction was too large and the aircraft drifted towards the edge of the runway. The first officer by this time was calling for the captain to correct left for the centreline, but the captain aligned the aircraft on the right-hand edge lighting on the mistaken assumption that it was centreline lighting. Unfortunately, Davao was not equipped with centreline lighting.

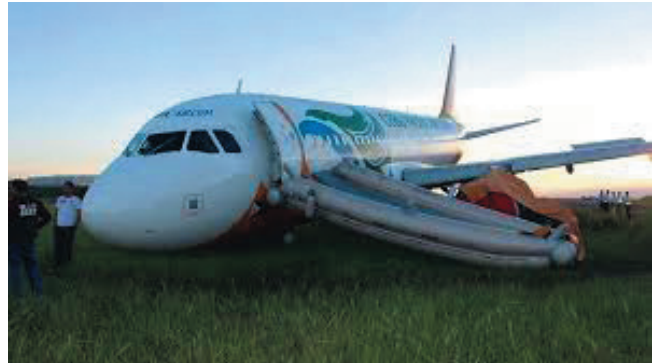
In the subsequent investigation it became clear that not all the damaged runway edge lights could be attributed to the A320. At least two of them were believed to have been broken by another aircraft, a turboprop from the same operator that had landed 5 minutes before the accident aircraft and which was found to have damaged wheels. A timely report from the crew of that aircraft may have given the A320 captain, who had only made one approach to Davao in the previous 3 months, a better understanding of the conditions he was facing. The investigators also noted that the crew had not complied with their company SOPs, which (not surprisingly) required a go-around in such circumstances. There were also several non-standard calls and "lapses, omissions and contradictory words employed during the landing approach".

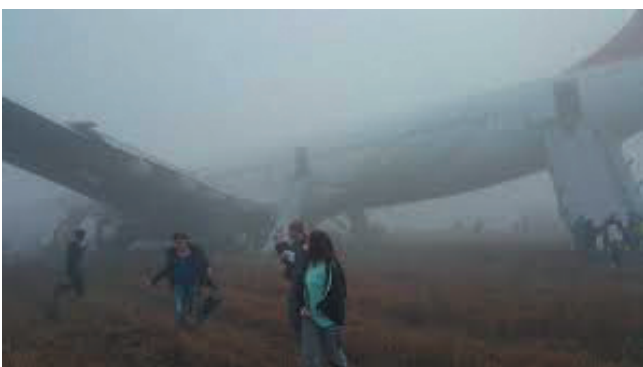
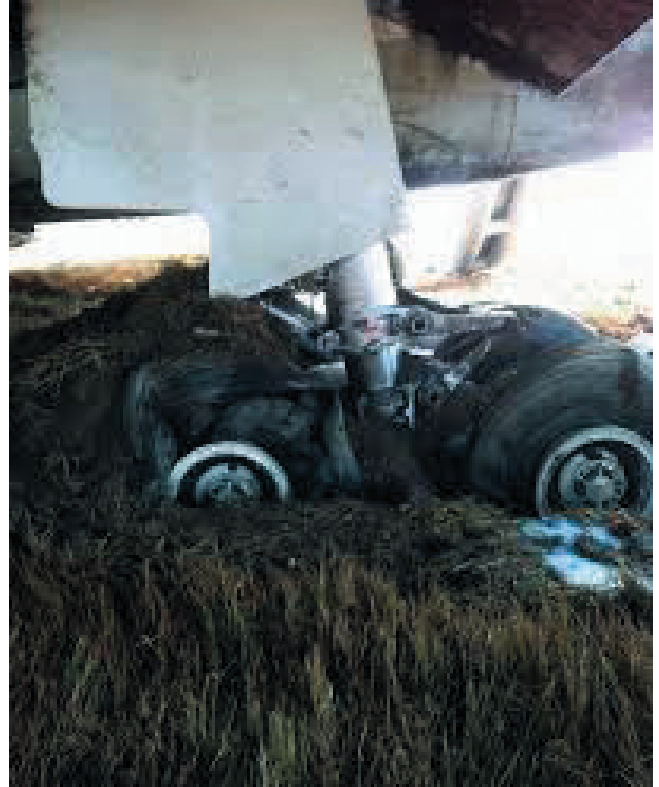
A Turkish Airlines Airbus A330-300, registration TC-JOC flying from Istanbul to Kathmandu (Nepal) with 227 passengers and 11 crew, had gone around from its first approach to Kathmandu's runway 02 due to fog. The crew positioned for a second approach to runway 02, from which they landed, but the left main gear touched down off the paved surface and the nose gear was also outside the runway markings although still on the pavement. The aircraft veered further left off the runway and came to a stop with all gear on soft ground; the nose gear collapsed during the runway excursion and 4 people received minor injuries in the subsequent evacuation. The aircraft was damaged beyond economic repair.

FDR data showed the auto-pilot remained coupled until 14 ft AGL, when it was disconnected for the flare. Pitch at touchdown was lower than normal at 1.8 degrees nose-up, and the peak vertical acceleration was 2.7g. It was apparent from CCTV evidence that the visibility had been steadily decreasing and was well below minima at the time of landing; the reduction in visibility had not been passed to the crew.

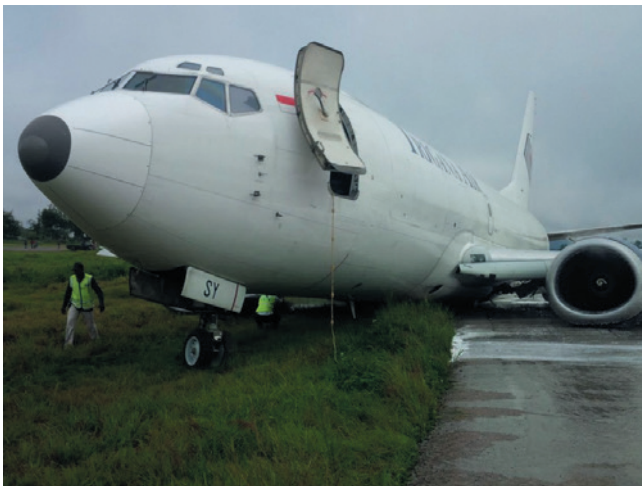
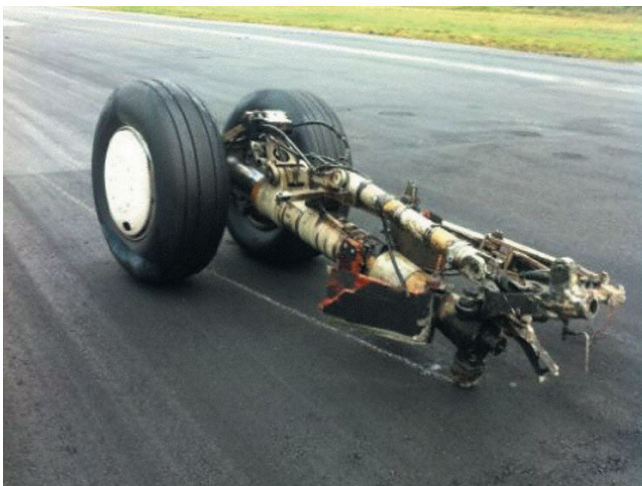
PK-YSY was seen to break cloud, correcting to the right and pitching down rapidly towards the runway. The initial runway contact was very hard and in a high nose attitude. The left main landing gear failed and separated, the right main gear also collapsed, and the aircraft slid along the runway on its nose gear, belly and engines before coming to a halt just off the right edge of the runway. The crew members were uninjured. The accident is still being investigated and no interim report has yet been issued.

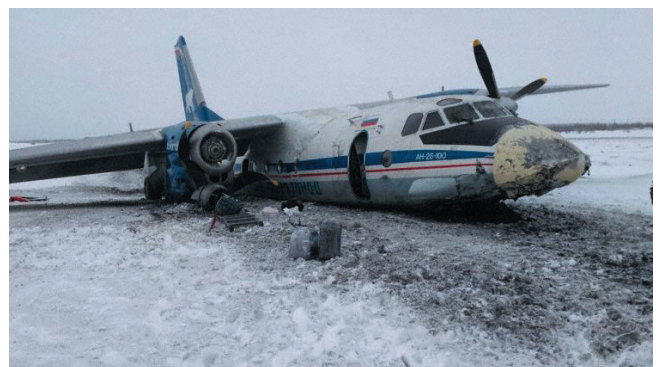
A Polar Airlines AN-26-100 was seriously damaged in a landing accident at Belaya Gora on 13 October 2016. The aircraft touched down on the banks of an ice-covered river approximately 1200 ft short and 900 ft left of the runway in poor weather; all the landing gear collapsed and one propeller was torn from its engine during the initial ground contact.
