Dick van Eck  
Hans Houtman

ATC The Netherlands  
EASS March 17th 2009 Nicosia

# Up Hill and Down Dale Continued Preventing Runway Incursions at Schiphol Amsterdam Airport

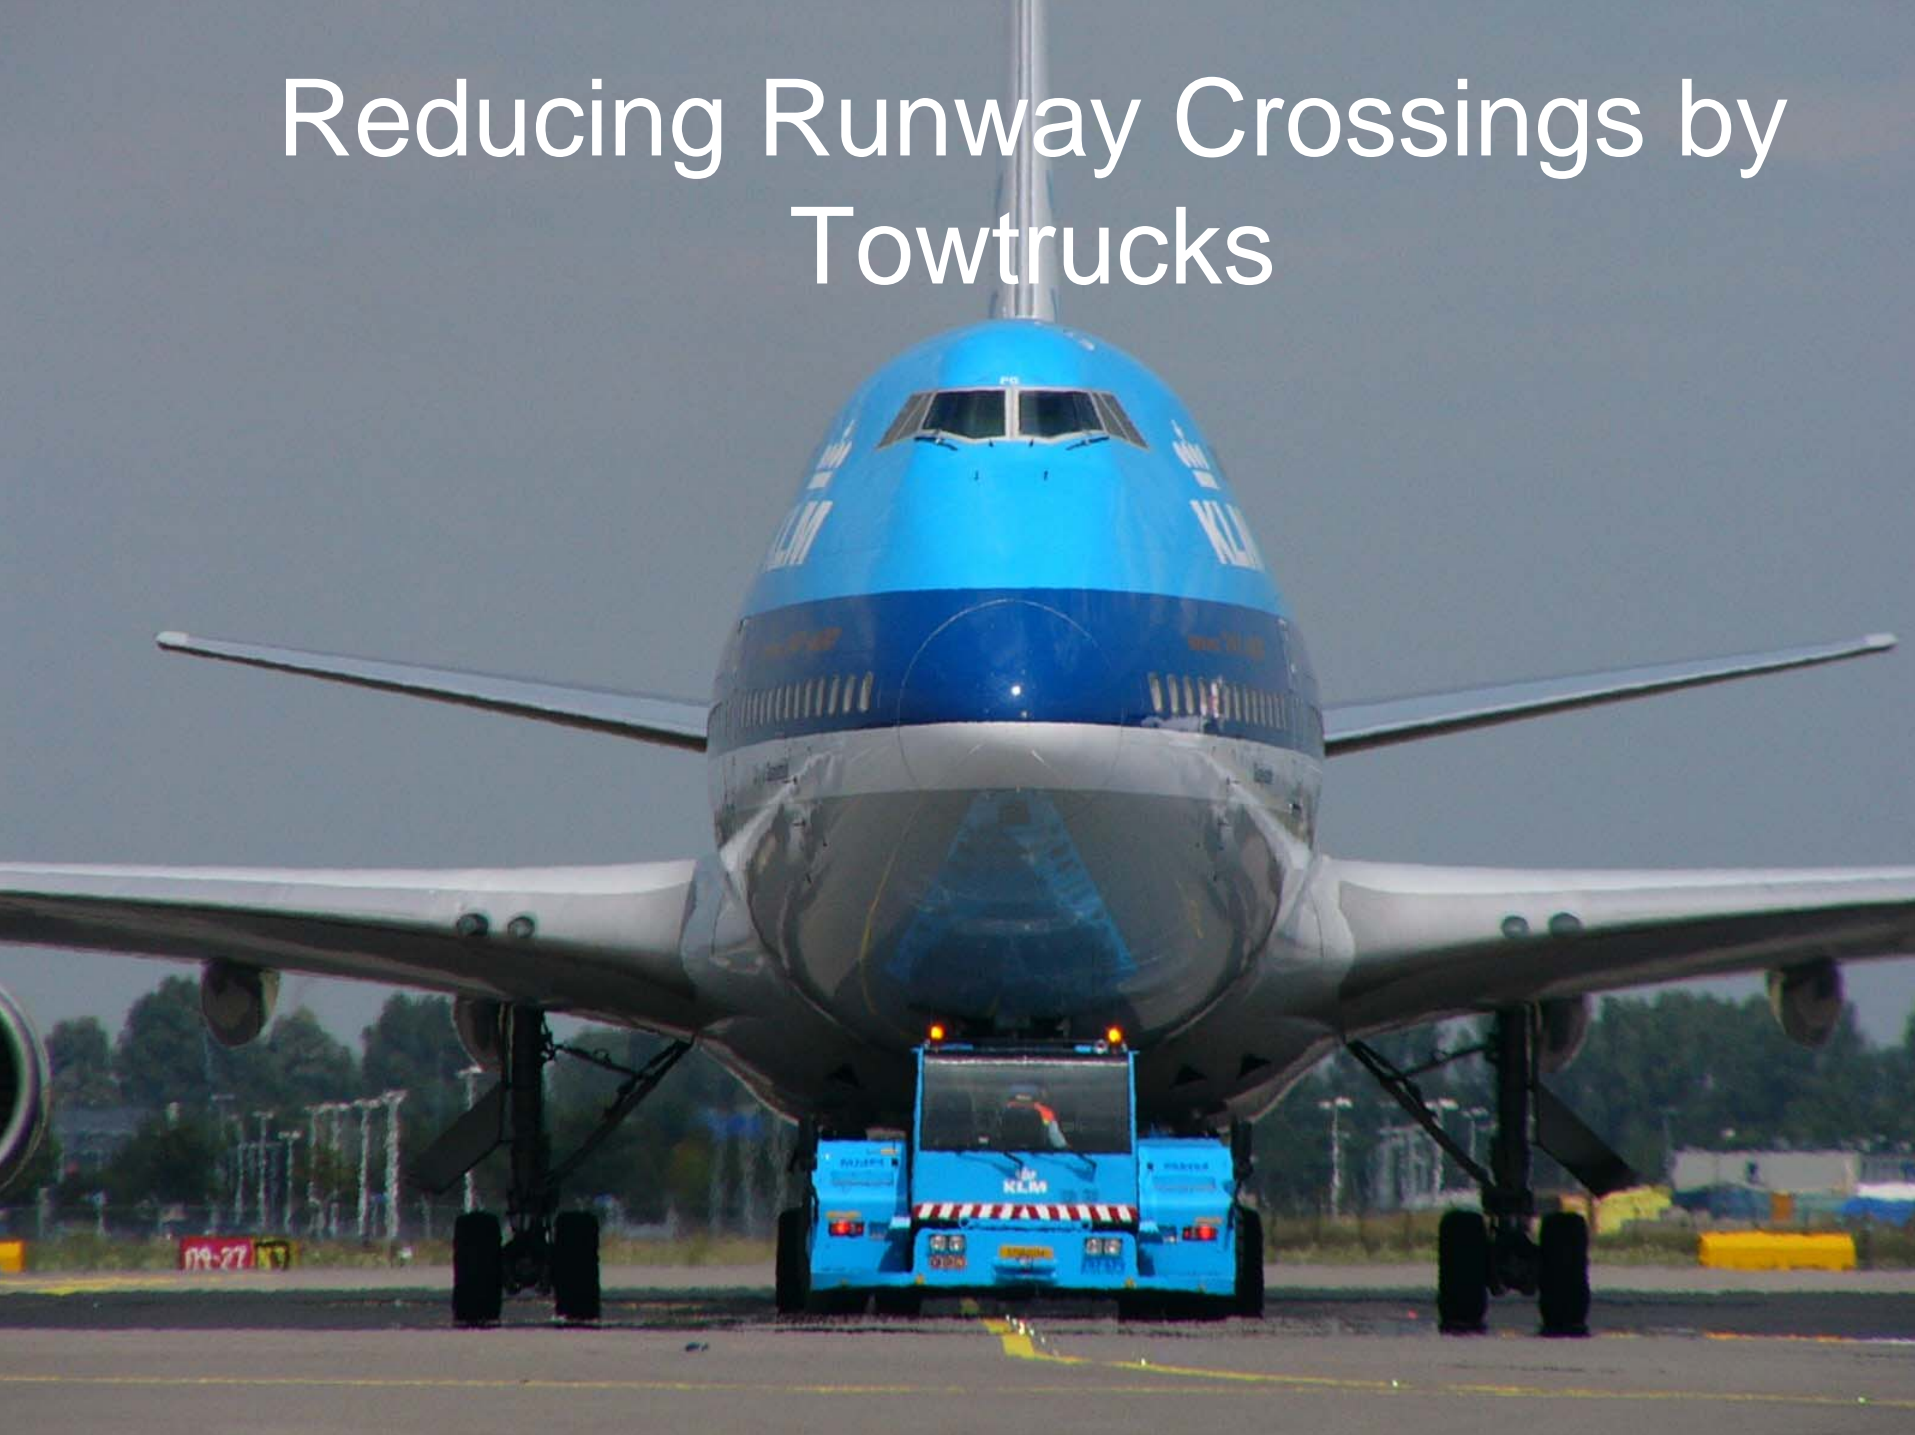
# Reducing Runway Crossings by Towtrucks

- Per day: 140 aircraft tow movements
- Per day: 60–80 towtruck movements
  - Per day: 50 towtruck movements crossing live runways
