Safety First

The Airbus Safety Magazine

03 | December 2006

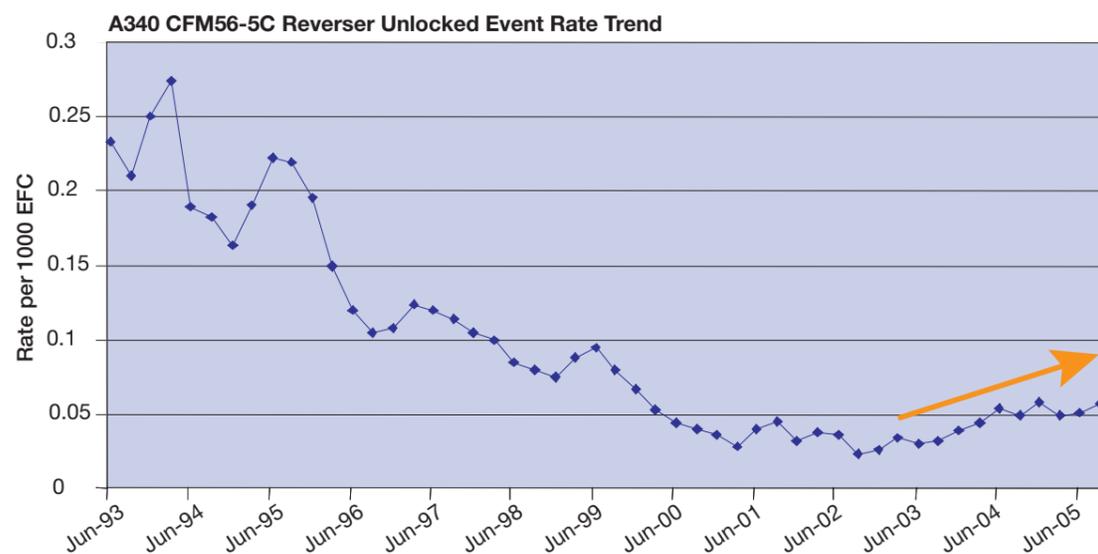
Fig 1: Trend of the "Rev Unlock" event rate since Entry Into Service

However, this rate has been rising again in the last 2 years, as highlighted on Figure 1.

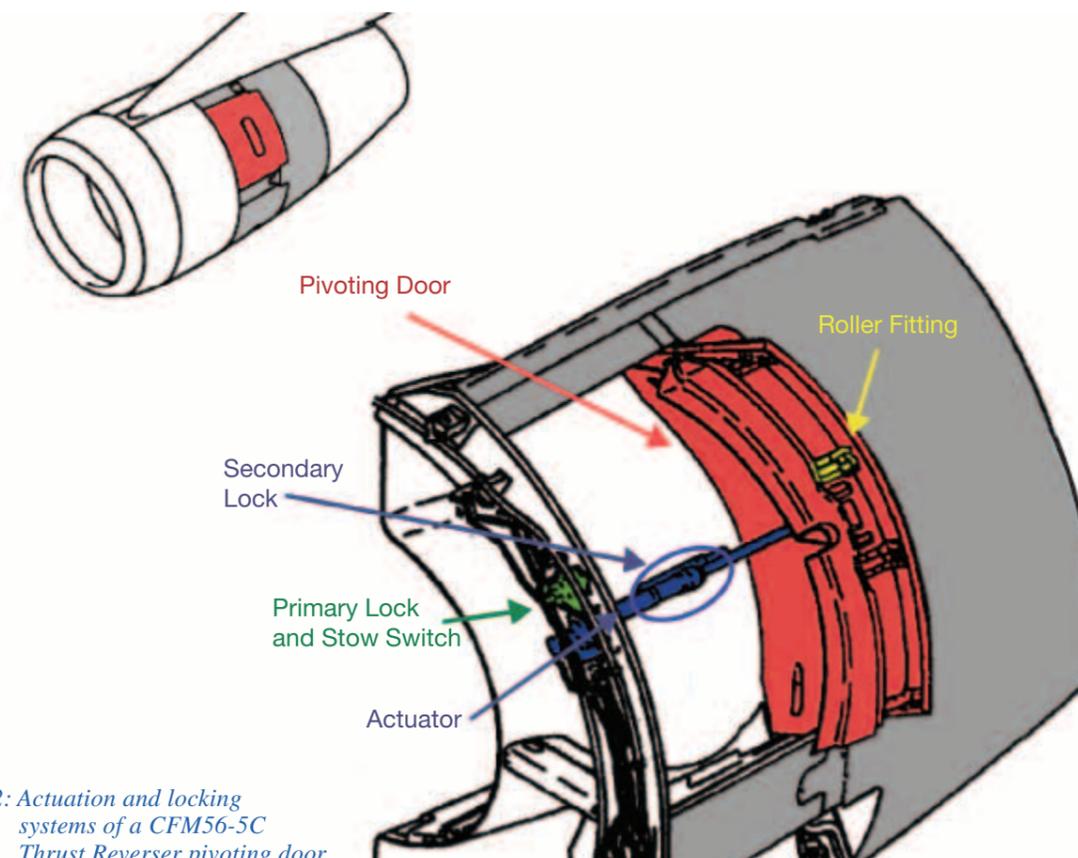
Fig 2: Actuation and locking systems of a CFM56-5C Thrust Reverser pivoting door

When the locking system is not pressurized, the secondary lock is engaged, ready to retain the actuator in its almost full-retracted position. If the primary lock fails, the door will extend slightly above the flush position before the secondary lock engages. In that case, the stow switch sensor is released (Fig 3), which leads to the generation of an “**ENG X REV UNLOCKED**” warning on the ECAM.

The continuous feedback from the operators allowed identifying that the primary lock rotating cam can fail to hook the roller-fitting due to:

The above-described root causes usually lead to an unstable position of the primary lock between open and closed position. This unstable position switches to the open position (secondary lock activated) during the following flight due to engine acceleration/vibration. In most cases this happens during the takeoff run. An “**ENG X REV UNLOCKED**” warning is triggered and the crew performs a Rejected Take Off.

Maintenance will find a pivoting door ajar on the affected engine. Pushing the door back in its closed position will engage the primary lock and clear the issue for the next takeoff. But as the root cause has not been addressed it is likely that an “**ENG X REV UNLOCKED**” will appear after some thrust reverser actuations.

This is why troubleshooting has to be done in accordance with Ref. D or E in order to find the root cause and to apply the appropriate corrective action.

In addition to those practices, a final solution will introduce a set of improvements to the locking system by addressing the above root causes. See also ref. G for further information.
