The Airbus Safety Magazine

Edition July 2012

- ▶ Thrust Reverser Selection Means Full-Stop
- ▶ Transient Loss of Communication due to Jammed Push-To-Talk A320 and A330/A340 Families
- ▶ A380: Development of the Flight Controls - Part 2
- ▶ Preventing Fan Cowl Door Loss
- ▶ Do not forget that you are not alone in Maintenance

Issue **14**

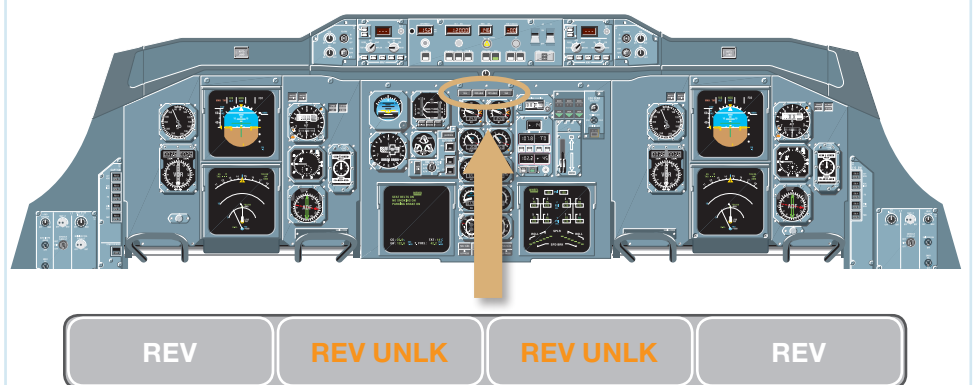
note 4

The thrust reverser lights indicate the operational status of the thrust reverser systems. When all lights are OFF, the translating sleeves are in the stowed position, the systems are latched.

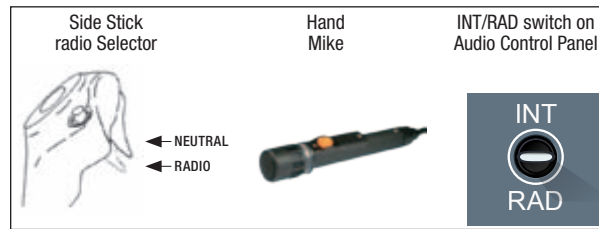
Figure 2
Push-To-Talk devices

On the A320 and A330/A340 families, when a transient loss of VHF communication is experienced in association with the triggering of the alert COM VHF EMITTING, the root cause can almost always be attributed to a jammed PTT device.

1. If any Push To Talk (PTT) transmission selector (sidestick radio selector, hand mike selector, or PTT switch) is jammed in the transmit position, try to release it in order to remove the caution.
2. If unsuccessful, deselect the identified failed VHF/HF transmission keys on the associated Audio Control Panel (ACP) to remove the caution. This ACP should only be used in reception mode. The associated PTT transmission selectors must not be used.

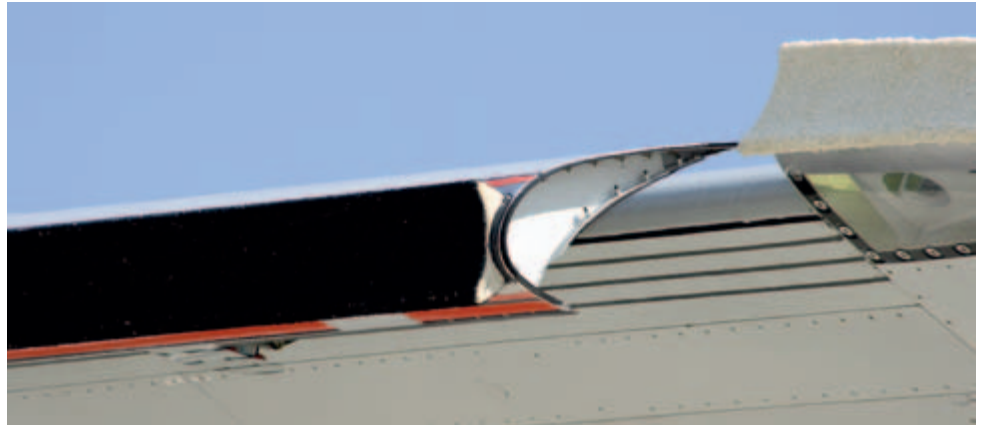
Figure 1
*Polystyrene shapes
simulating ice
accretion*

The ice shapes are then manufactured. They are made of polystyrene with some additional particles glued on in order to simulate the granularity of the ice. These shapes have a thickness of three inches, which is considered to be the maximum that an aircraft will keep on a leading edge. The regulations also consider that the de-icing system may fail. In this failure case, the relevant part of the wing is equipped with a smaller ice shape, as the crew will follow the procedures to leave the icing area, and therefore will accumulate a smaller

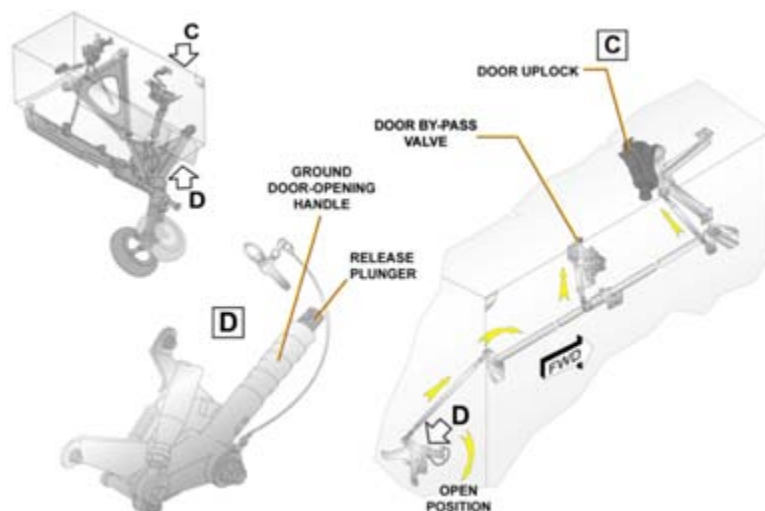
Figure 1
A320 Nose Landing Gear operation mechanism

A mechanic was working alone within the landing gear bay on an A320 Family aircraft. For an undetermined reason, the ground door opening handle was in the “closed” position, i.e. not corresponding to the actual position of the nose landing doors (fig. 1).

- ▶ MAKE SURE THAT THE CONTROLS AGREE WITH THE POSITION OF THE ITEMS THEY OPERATE BEFORE YOU PRESSURIZE A HYDRAULIC SYSTEM. UNWANTED MOVEMENT OF HYDRAULICALLY OPERATED ITEMS CAN LEAD TO SERIOUS INJURY AND / OR CAUSE DAMAGE.

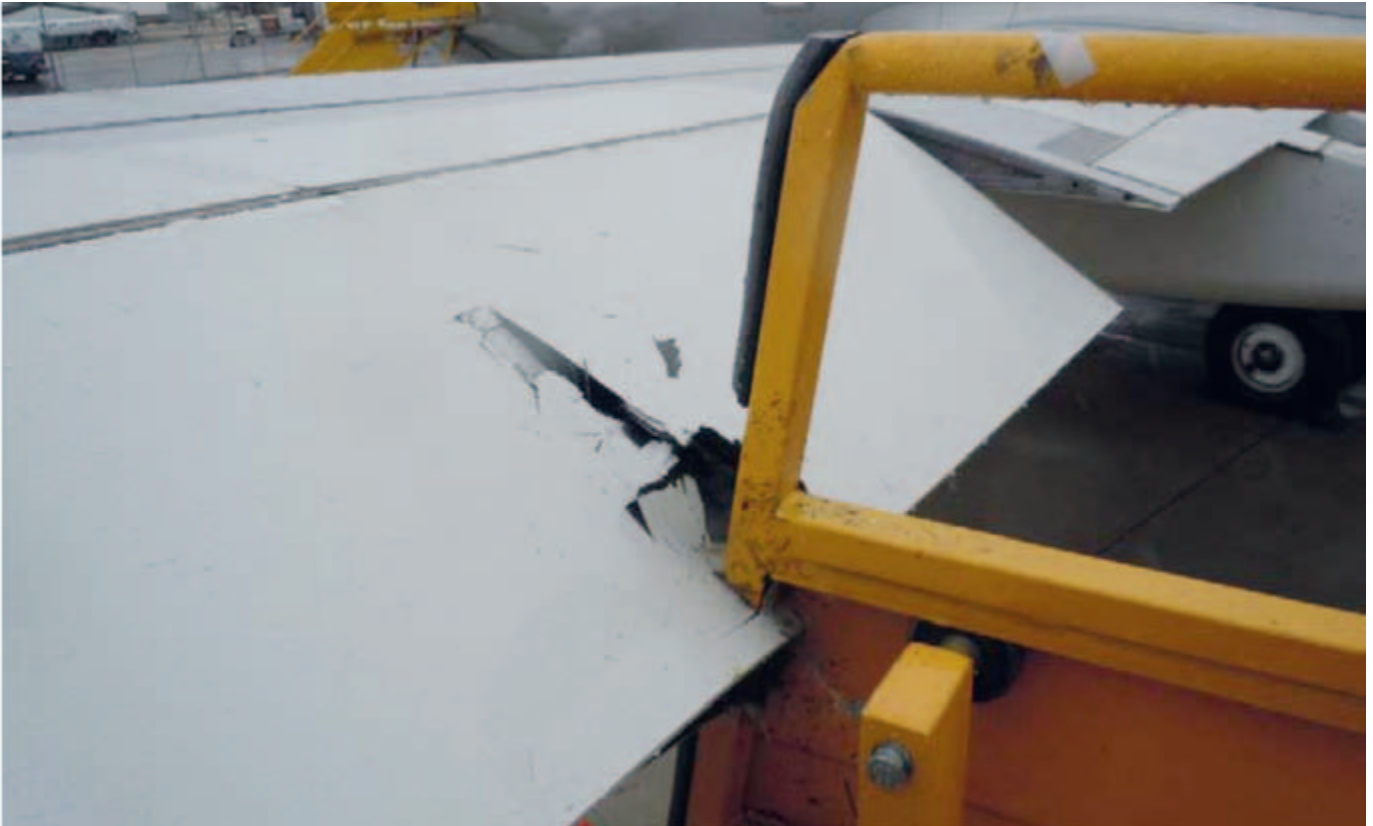
Figure 2
A possible consequence of the lack of awareness in the hangar

lost the “big picture”, also commonly known as “tunnel tasking”. Often technicians are given only their piece of the puzzle, for example, being assigned tasks with deadlines without explanation or direction – a “just do it” assignment.
