Issue 169

British Airways Corporate Safety & Quality

Flywise

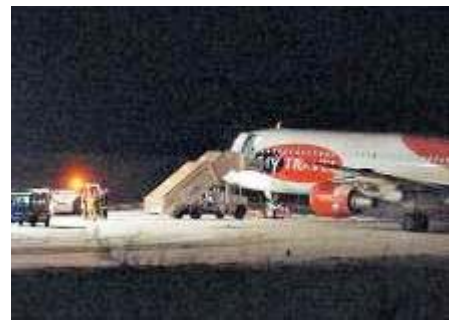
A321-211
Torp, Norway
26 March 2006

On landing in slippery conditions, the aircraft skidded beyond the end of the runway coming to rest 150 metres past the end of the paved surface. No one on board the aircraft was injured, but traffic was disrupted for hours. A localiser antenna was also reported as damaged.

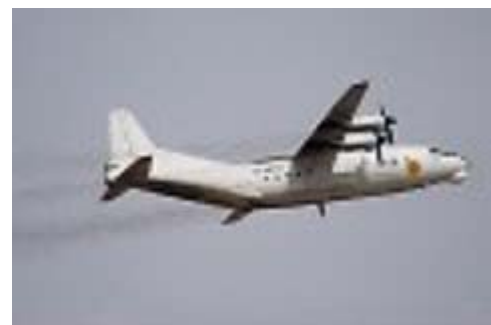
Antonov 12N
Teheran, Iran
28 March 2006

Shortly after take-off from Payam Airport, the crew radioed and reported their intention to return immediately due to a technical problem. The pilots were unable to reach the runway and made a forced landing in farmland about 3 miles from the airport where the aircraft broke into pieces and was destroyed. At the time, the local weather consisted of rainfall with strong winds. According to reports a bird strike may have been a contributory factor.

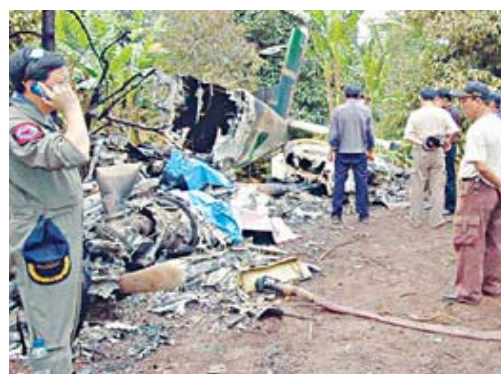
Pilatus PC-6
Chantaburi, Thailand
29 March 2006

The crew was performing an artificial rain operation when the aircraft crashed in the eastern province of Chantaburi. All four occupants were killed. The flight was being carried out for the Ministry of Agriculture.

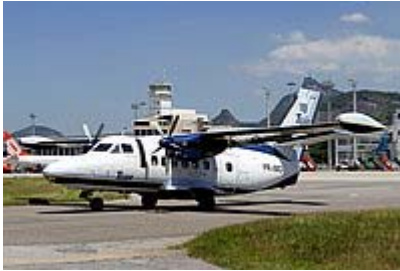
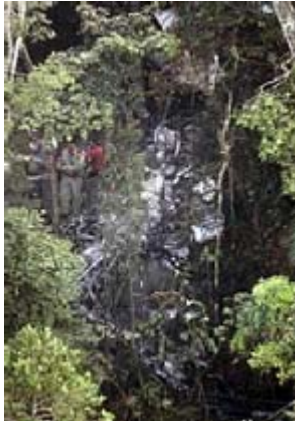
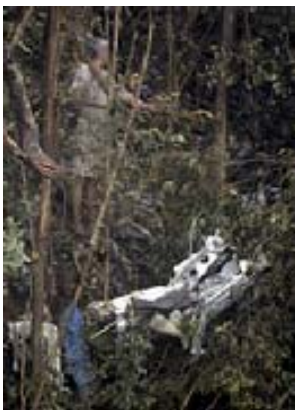
**Let 410
Saquarema, Brazil
31 March 2006**

The aircraft left Macae Regional Airport at 1719LT and crashed near Saquarema at 16 minutes later. The ETA was scheduled at Rio at 1802LT. The rescue teams did not find any survivors among the 19 occupants. It is the first accident involving a Let 410 in Brazil.

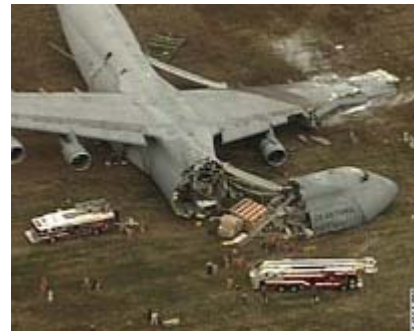
**Lockheed C5 Galaxy
Dover, Delaware
03 April 2006**

The crew encountered technical problems during take-off and the aircraft crashed in an open field after the runway end. The aircraft broke into three pieces: the empennage, the cockpit and also No.1 engine separated. All 17 occupants were injured.

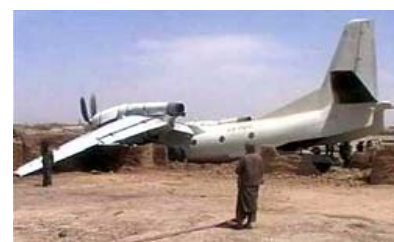
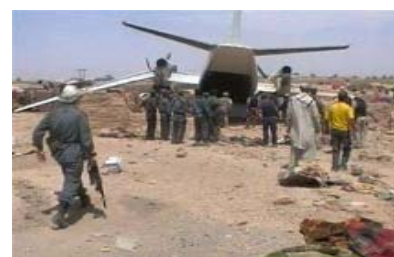
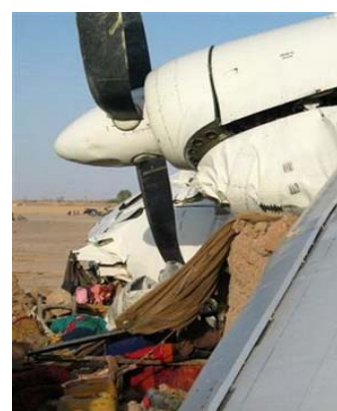
**Antonov AN32
Lashkar Gar, Afghanistan
24 April 2006**

A cargo aircraft carrying U.S. anti-narcotics officials crashed while attempting to land at Bost Airport in Lashkar Gah. The aircraft overran the runway and crashed into a residential area after trying to avoid a truck that pulled onto the runway. The pilot pulled up to avoid hitting the truck but was unable to gain sufficient speed to remain airborne. The AN32 crashed into a nomad settlement destroying two mud-brick houses before it came to a halt with a broken fuselage and demolished left wing. Both pilots, as well as two children in the houses, suffered fatal injuries.

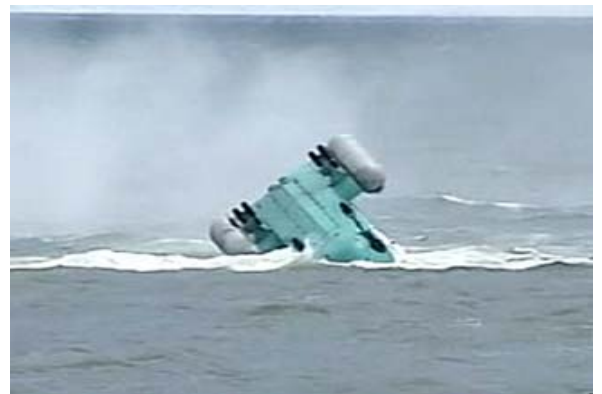
Mil Mi-14 Haze
Sea of Okhotsk
11 May 2006

The amphibious helicopter crashed into the sea during a Russian-Japanese exercise. One person was killed. Specialists were trying out measure to deal with an imaginary oil spill. The accident happened as the Mi-14 was flying just above the surface of the water.

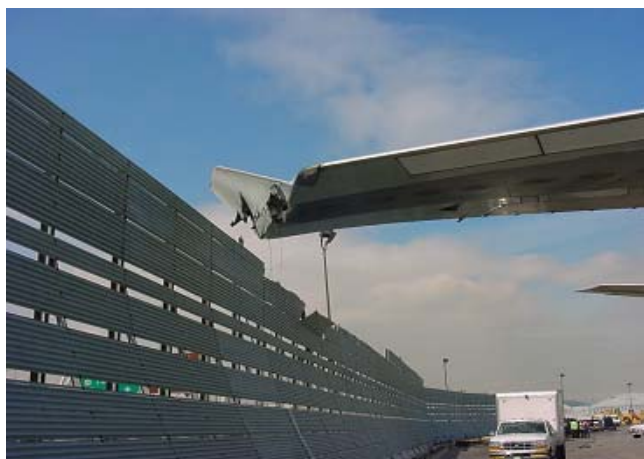
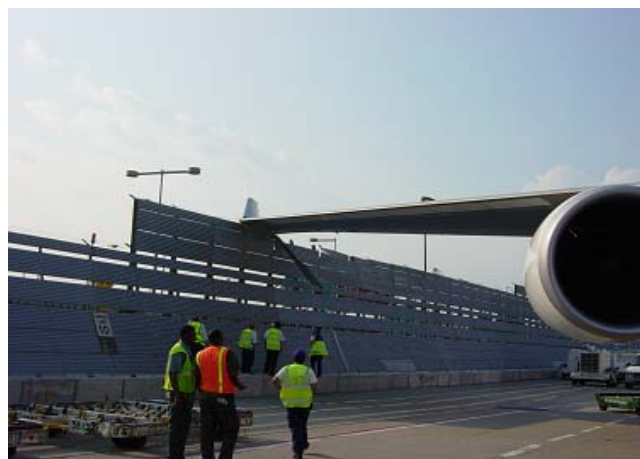
British Airways B747-400 at JFK - 2003

Another Operator's B747-400 at JFK - 2006

The only difference.....it was a cloudier day in 2006

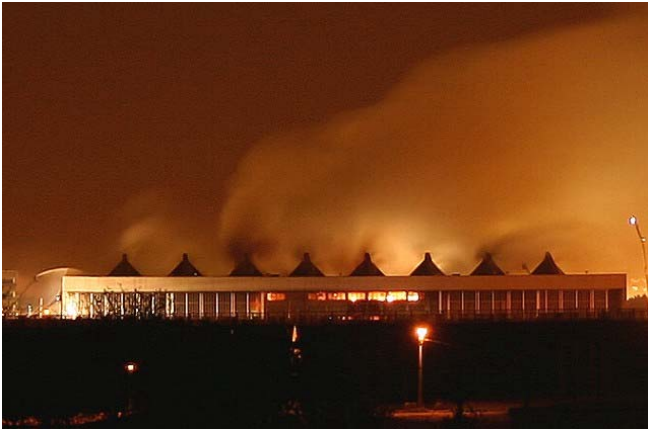
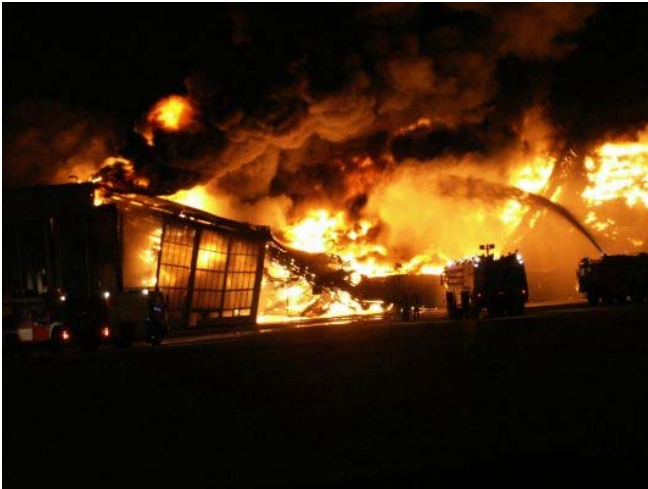
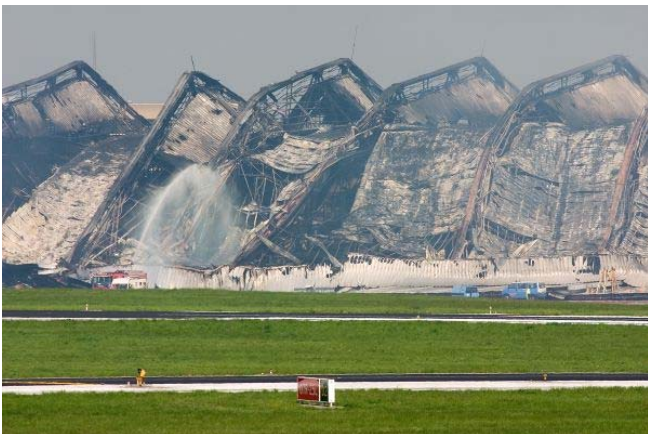
Three civil aircraft an Armavia A320, an Armenian International Airways A320 and a Hellas Jet A320 plus a Lockheed C-130 of the Belgian Air Force, are understood to have suffered damage in the blaze that broke out in a hangar at Brussels airport during the night. The ensuing fire caused the hangar roof to collapse increasing damage to the parked aircraft inside. One person was injured.
