# **Final Report**

**of AFRIQIYAH Airways Aircraft  
Airbus A330-202, 5A-ONG Crash  
Occurred at Tripoli (LIBYA)  
on 12/05/2010**

**Published February 2013**

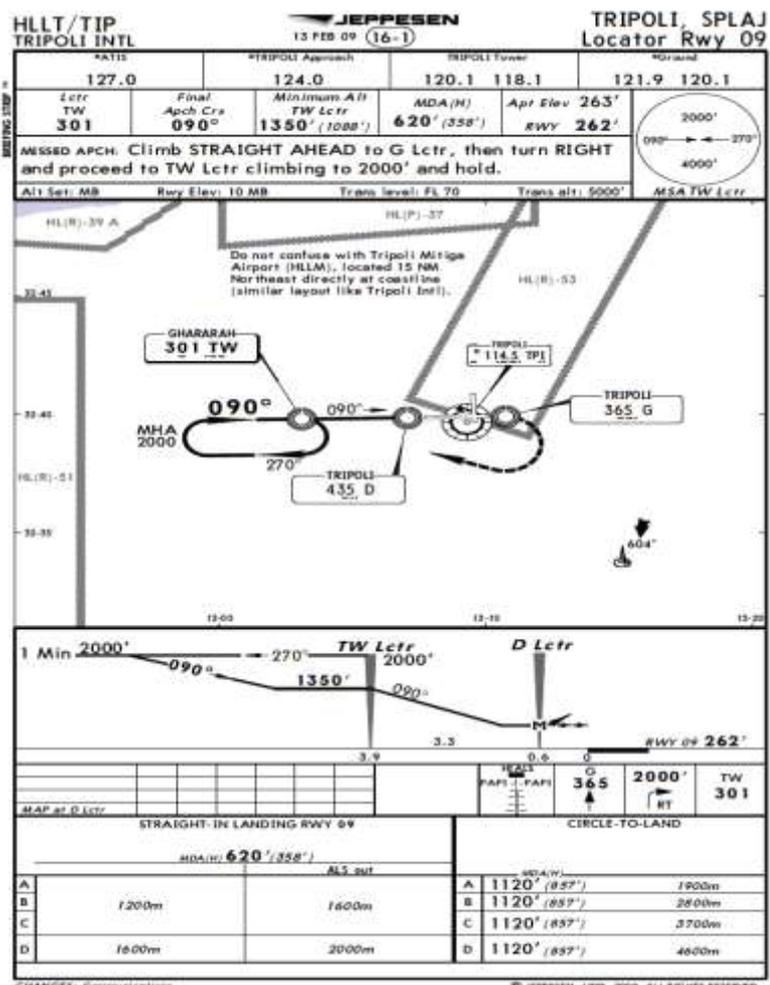
The Jeppesen chart did not provide any glide path after the FAF and did not include the table in the official map identifying crossing altitudes in relation the distance to the runway threshold 09 and rates of descent in relation the speed of the aircraft.

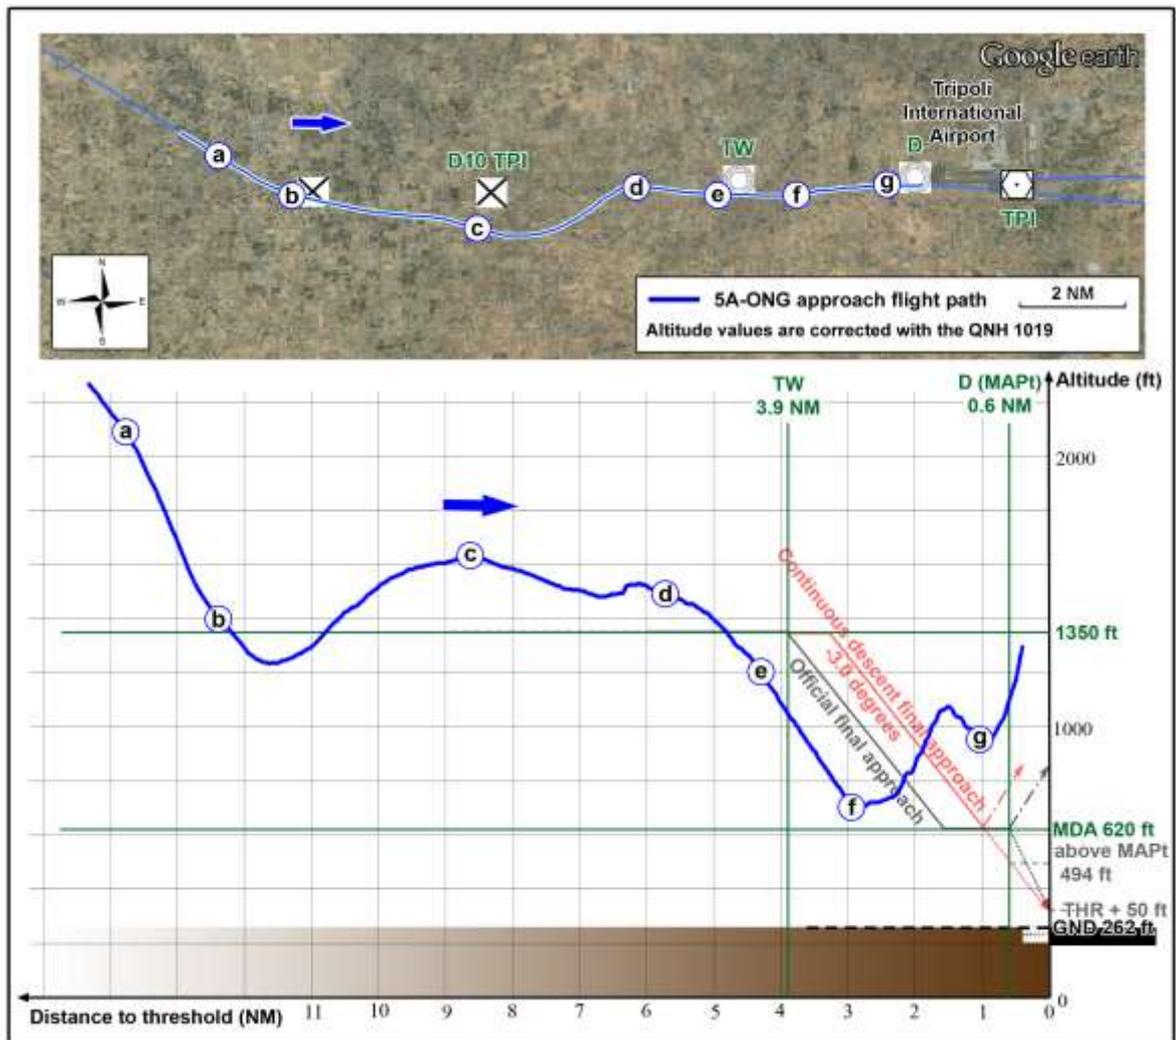
Overall, the approach was never stabilized, from the intermediate approach segment to the

missed approach. Parameters from the 28 April 2010 flight are presented in Appendix 12.

A comparison with the information on the accident flight highlights certain similarities:

- Final approach carried out in FPA vertical guidance mode before flying over TW;
- TW over flown at an altitude lower than specified in Locator approach procedure to runway 09;
- Lack of control and stabilization of pitch attitude during go around;
- Lack of adjustment of the thrust during go-around.
