**AIRCRAFT ACCIDENT REPORT 2/2013**

**ACCIDENT INVESTIGATION DIVISION**

**Report on the accident to Airbus A330-342  
B-HLL operated by Cathay Pacific Airways Limited  
at Hong Kong International Airport, Hong Kong  
on 13 April 2010**

**Hong Kong  
July 2013**

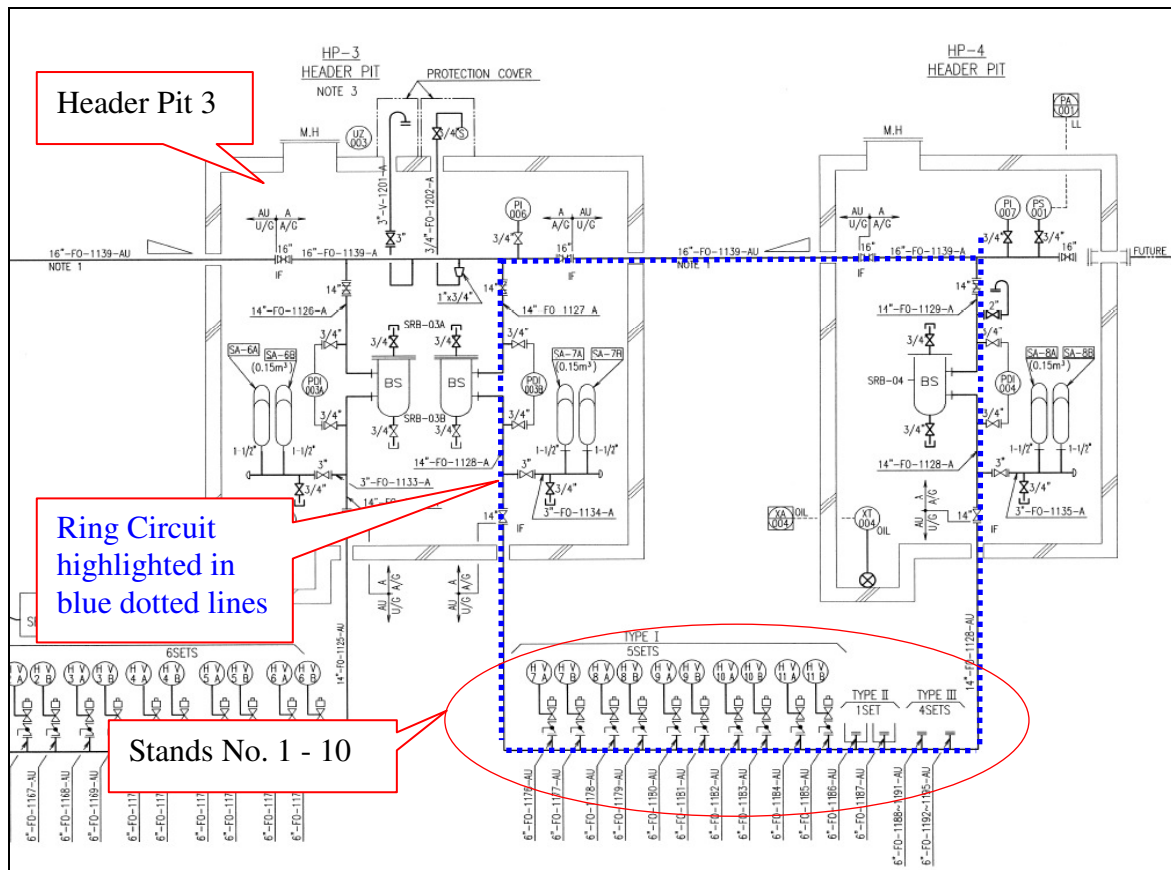
Fuel samples were collected from both the upstream and the downstream of the filter vessel on Dispenser JUA06, the ground refuelling hydrant at Stands No. 8 and 11, the fuel storage tank of WARR, and three low points of the WARR hydrant circuit. There was no sign of SAP spheres in the ground fuel samples. Water containing sodium chloride (NaCl) was found in the fuel sample collected from Header Pit 3 which was a low point in the hydrant circuit supplying Stands No. 1 to 10. Inspection of fuel storage facilities, which is located upstream of

the hydrant circuit, revealed no sign of NaCl corrosion. One SAP sphere was found trapped in the wire mesh of the gauze strainer which was fitted to the outlet hose of the dispenser (the hose end strainer).

**Figure 23: The WARR Ground hydrant refuelling circuit showing Header Pit 3 and the ring circuit that supplies fuel to Stands No. 1 to 10**

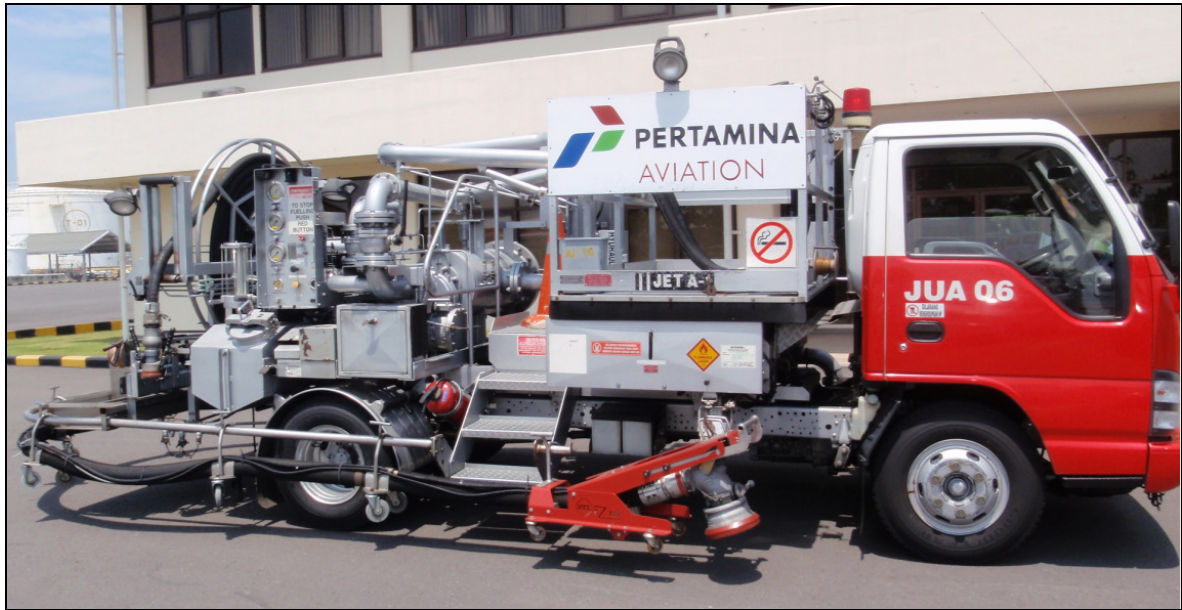
**Figure 28: Fuelling Dispenser JUA06**

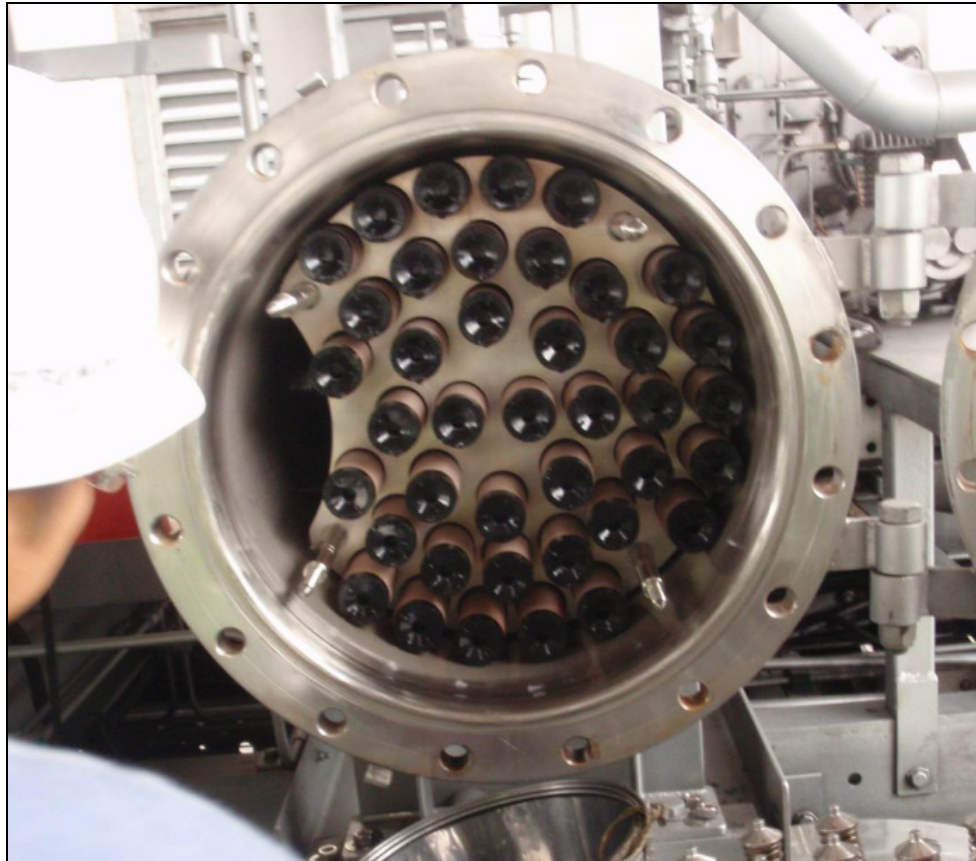
**b.** The 40 filter monitors (i.e. the accident filter monitors) installed in the dispenser JUA06 which had been used for the refuelling of CPA780 were removed six days after the accident. Twenty of them (Batch 1) were sent to UK for examination and analyses. Later, ten (Batch 2) of the remaining 20 filter monitors, which had been kept under quarantined in Indonesia were also sent to UK for examination and analyses. Another set of 40 filter monitors in JUA06 (Batch 3), which replaced the accident filter monitors and had been used for six weeks in WARR after the isolation of the disturbed Stands No. 1 to 10 hydrant circuit, were also removed and sent to UK for testing. These Batch 3 filter monitors which had been exposed to fuel but not to the contaminated hydrant fuel were used as reference standard to assist in the examination and analysis of the accident filter monitors.

**Figure 30: Filter monitors (Batch 3) installed in the filter vessel of JUA06**

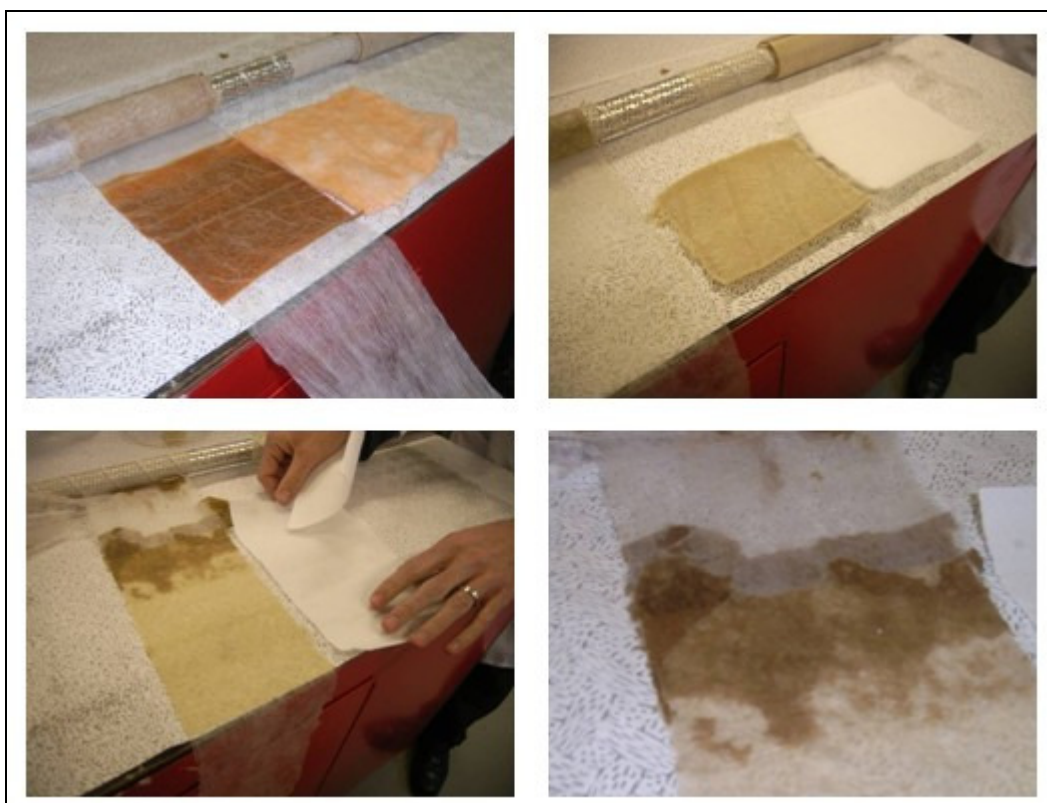
**Figure 32: Dissecting one of the event filter monitors**

d. Examination of the dissected filter monitors revealed that the construction of the accident filter monitors was identical in terms of media type to a recently manufactured element, and that the SAP layers had been exposed to water. There was very little evidence of dirt trapped in the media layers. Isolated SAP spheres were found in one filter monitor (see Figure 33). No SAP sphere was identified in the new pristine filter monitor when it was dissected and examined by using similar technique.

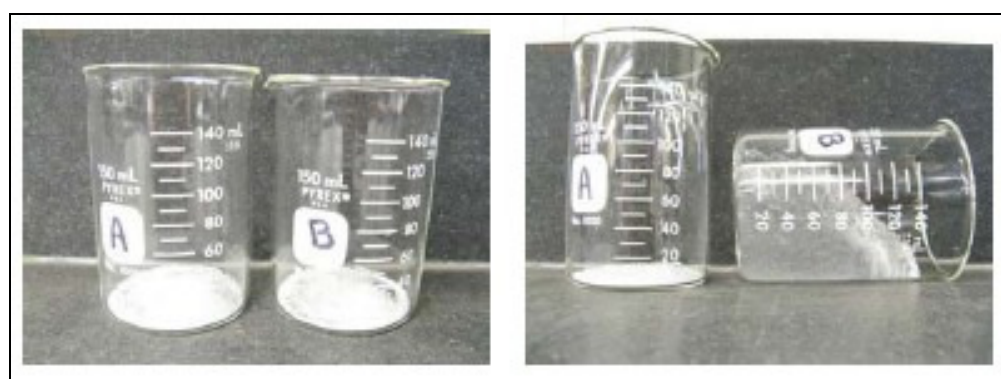
c. The composition of the SAP spheres was mainly sodium polyacrylate which was consistent with the material used in the first water absorption layer of the filter monitor. Sodium polyacrylate is a kind of SAP which when in contact with water, activated to absorb the water, and turns into a gel that swells to fill the filter monitor. As stated in EI 1550, *“In extreme situations, the gelling process may shut off the flow [across the filter monitor] completely.”*

**Figure 38: Beakers of SAP in powder form. After the addition of water to beaker B, the SAP powder swollen and turned to gel form**

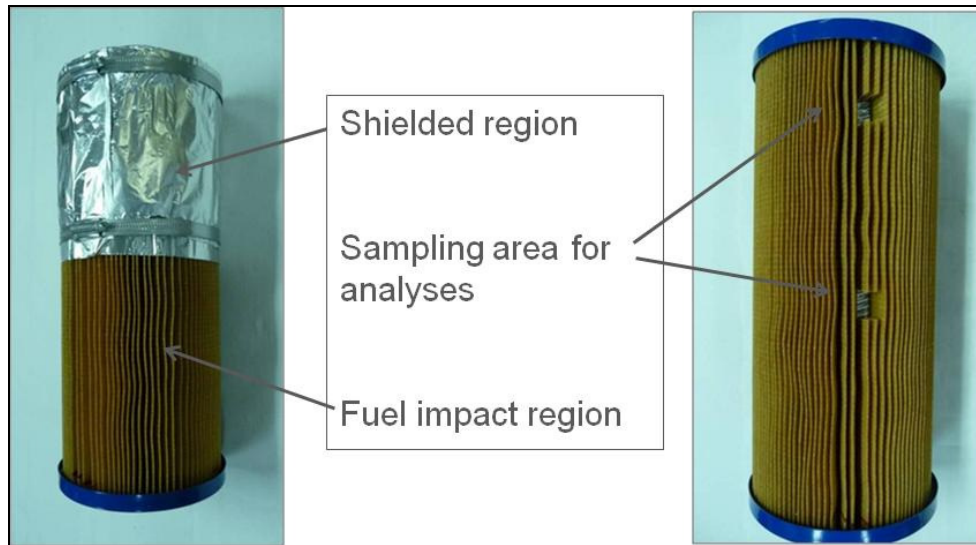
c. Examination of the microfilter media (Figure 42) after the flow tests of Batch 1 and 2 filter monitors revealed the presence of SAP spheres (Figure 43).

**Figure 42: Microfilter used in clean up vessel downstream of test vessel to capture any media released during filter monitor testing**

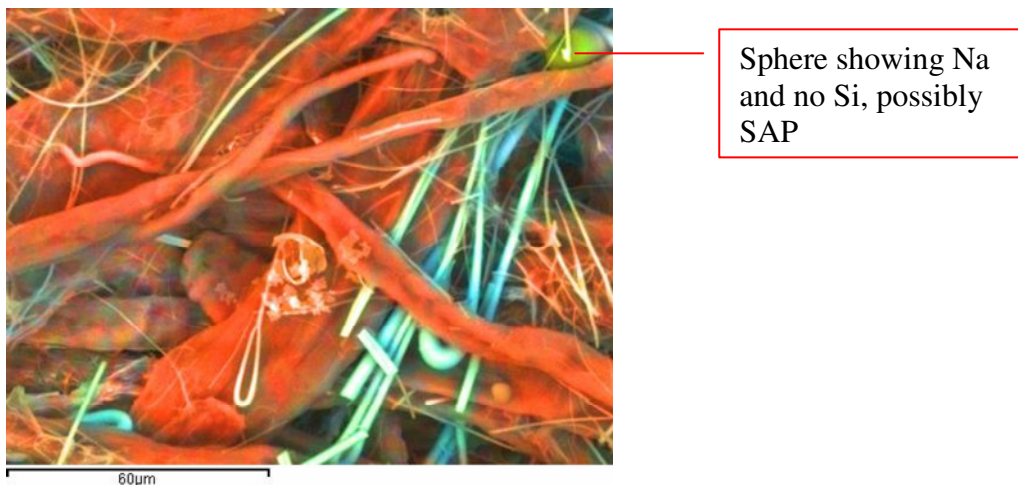
d. Similar to the water slug tests, the examination revealed that SAP extrusion was evident in the filter monitor layers, gauze strainer and the microfilter media. Moreover, several discrete SAP spheres were found embedded in the microfilter media (Figure 44). Although the simulation could not be conducted in identical operating environment and condition as that in WARR, the result indicated that SAP spheres could be generated under certain operating conditions.

**Figure 44: SEM-EDX chemical phase map of the area of the downstream micro-filter.**

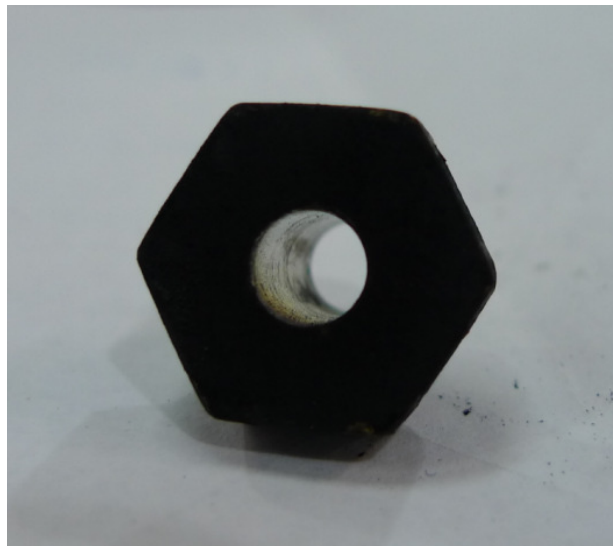
Wheel Nos. 1, 2, 3, 5 and 7 deflated after the aircraft came to rest due to the melting of the fusible plugs. Wheel Nos 4, 6 and 8 did not deflate and the fusible plugs were intact. Workshop inspection and testing confirmed that the fusible plugs fitted to Wheel Nos 4, 6 and 8 had not been exposed to the design melting temperature. There was no evidence of fire damage to the wheels and tyres.

**Figure 50: One event fusible plug showing the core had melted**

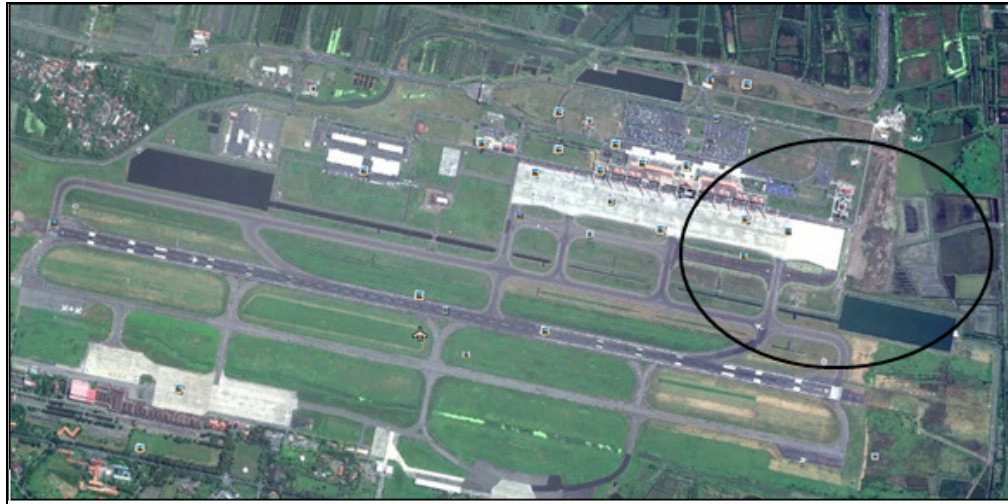
**Figure 52: WARR Stands and surrounding**

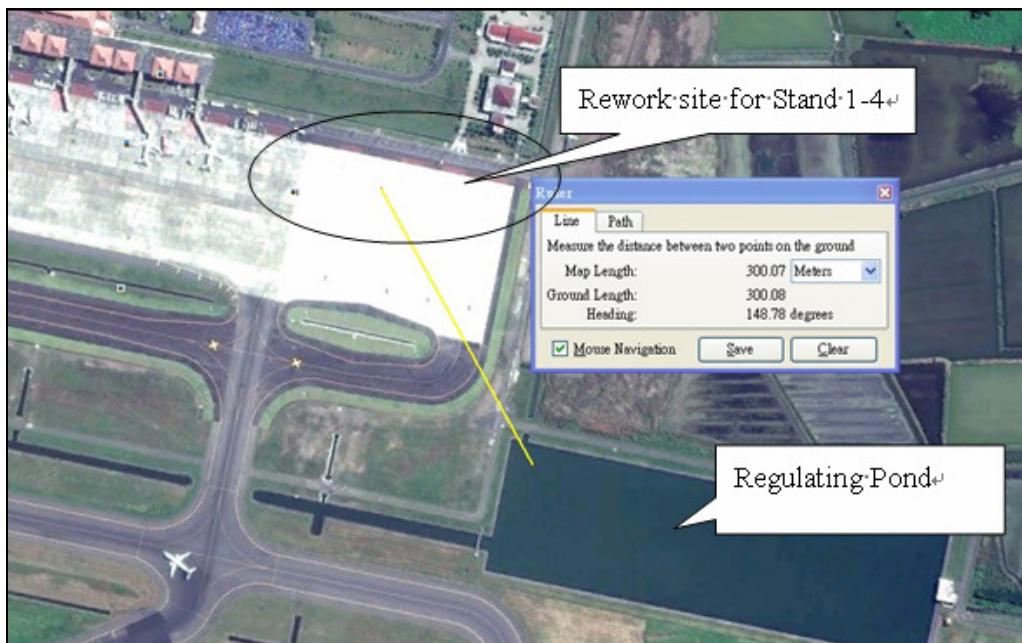
a. WARR is located close to the seashore and has three regulating ponds. As illustrated in Figures 52 & 53, the distance between the closest regulating pond and the work site was about 300 meters. After the accident, water samples were collected from the closest regulating pond and sent for analysis. The result indicated that the water in the regulating pond contained sodium chloride.

**Figure 53: The extension work site and the closest regulating pond was approx 300m apart**

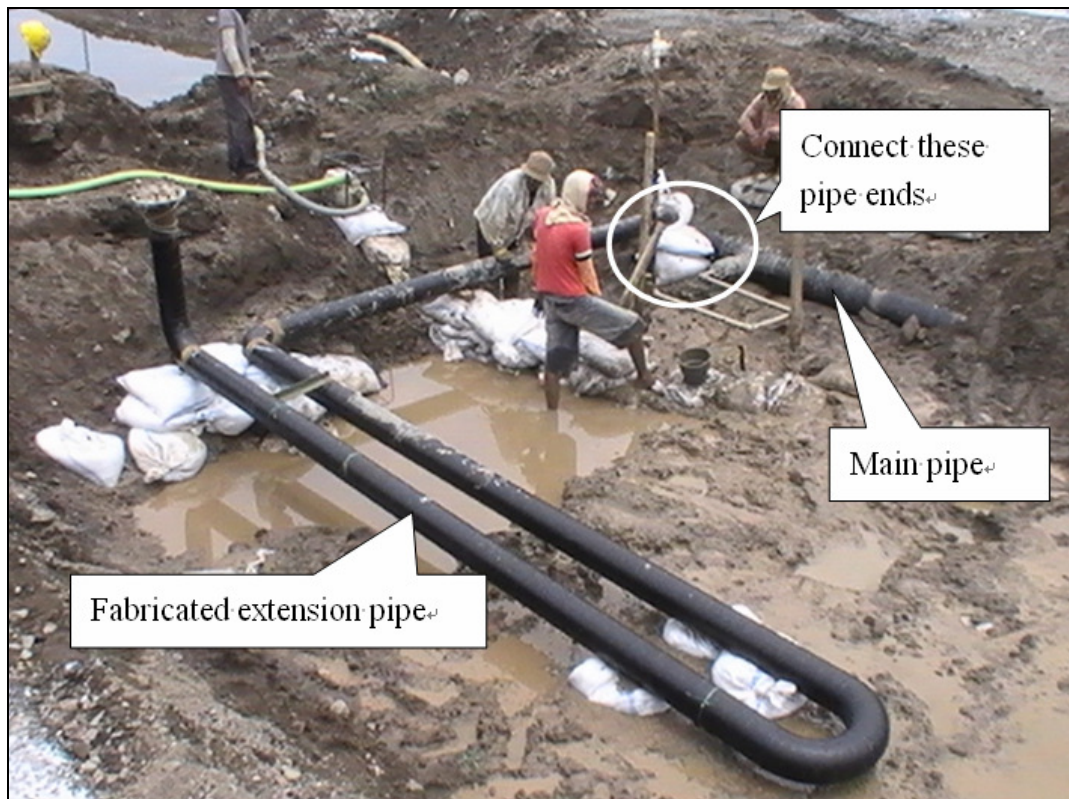
**b.** Before the "tie-in", the affected hydrant circuit was isolated and emptied to prepare for the connection of the extension pipe. During "tie-in" process, a fabricated 6" diameter extension pipe was transferred to the site on the day of connection. For each of the eight connections, the existing 6" diameter end pipe fitted onto the 14" diameter distribution pipe was cut open by hand sawing. The open end was blanked to be air tight with a "cap seal", and a "gas free" test of the open end was performed. The edge of the 6" pipe opening was grounded to create a bevel edge for subsequent joining by electric arc welding. The interior was swab cleaned by canvas or leather ball per specification. The fabricated extension pipe was then positioned and welded to the 6" diameter end pipe. According to the contractor, this "tie-in" process usually took 3 to 4 hours to complete. From the photos taken during the "tie-in" process (Figure 54), the work site was in a recess with water puddles, probably caused by recent rainfall, and with a drain pump to remove the water puddles in the work area.

**Figure 54: The tie-in process to connect the fabricated extension pipe to the main distribution pipe**

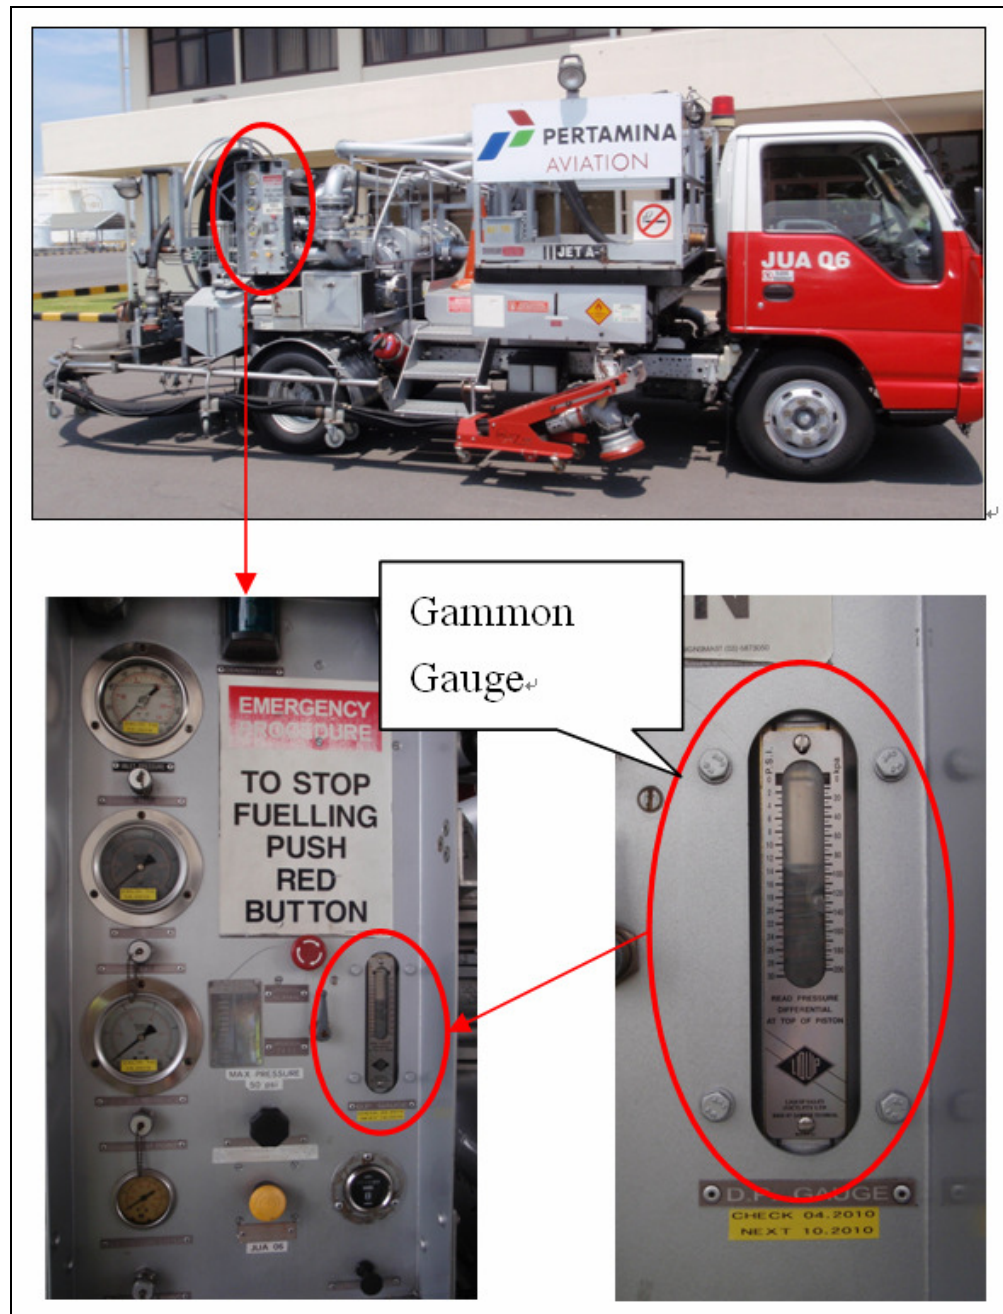
**a.** As discussed earlier under 1.16.6.1, a filter monitor system will restrict the flow of fuel before its capacity for particulate matter and/or water removal is exhausted. Such restriction is reflected by an increase of DP across the filter monitor system, indicating a drop in the supplied fuel cleanliness. On each fuelling dispenser operated by WARR, there is a Gammon gauge (mechanical piston type pressure gauge) with a range of zero to 30 psi to indicate the DP across the filter monitors. There is also an electronic device to measure and display the total fuel quantity uplifted, which also displays the current FR by pressing a button on the device.

**Figure 55: The differential pressure gauge (Gammon Gauge) of a fuelling dispenser**

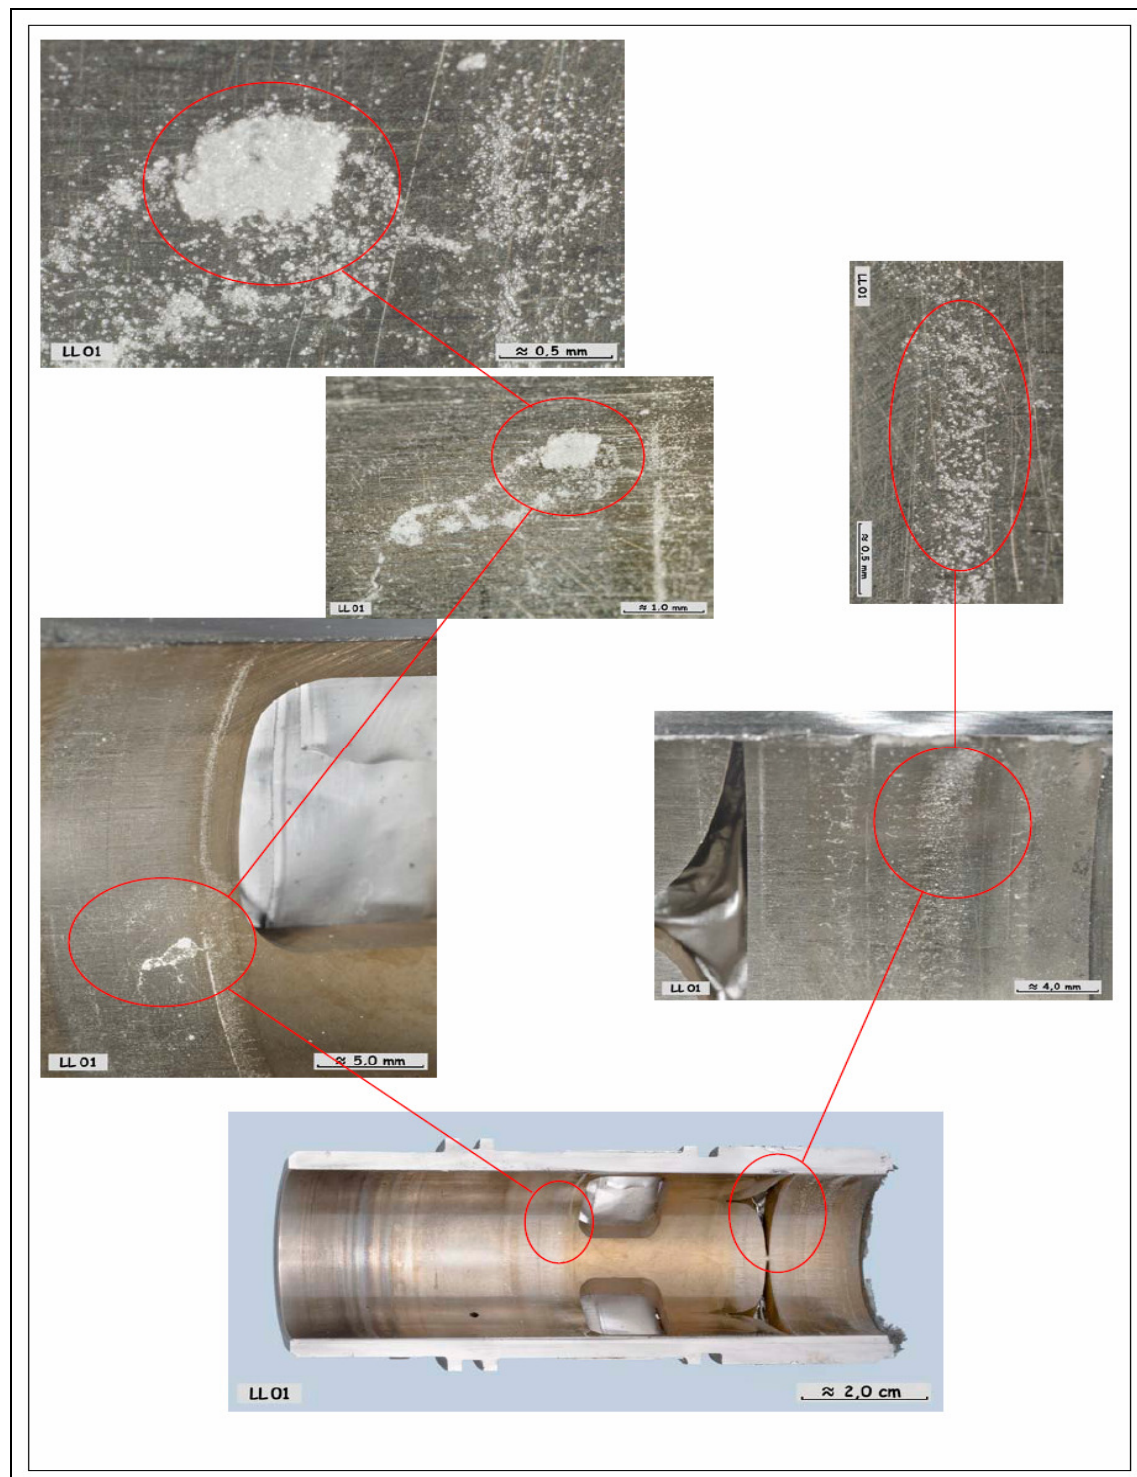
## Appendix 10: No. 1 Engine MMV SAP Spheres

### Engine No. 1 MMV cutaway view showing the presence of SAP spheres

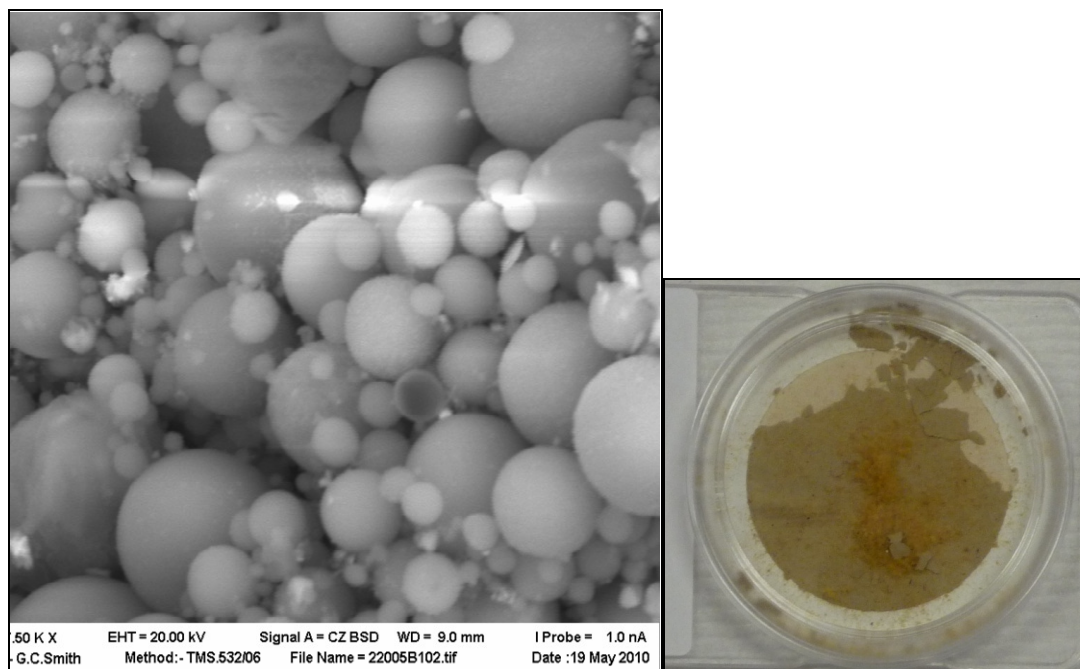
**A11.1 - The Millipore filter containing material extracted from the low pressure fuel filter by Rolls-Royce (right), and the corresponding higher magnification SEM image (left):**

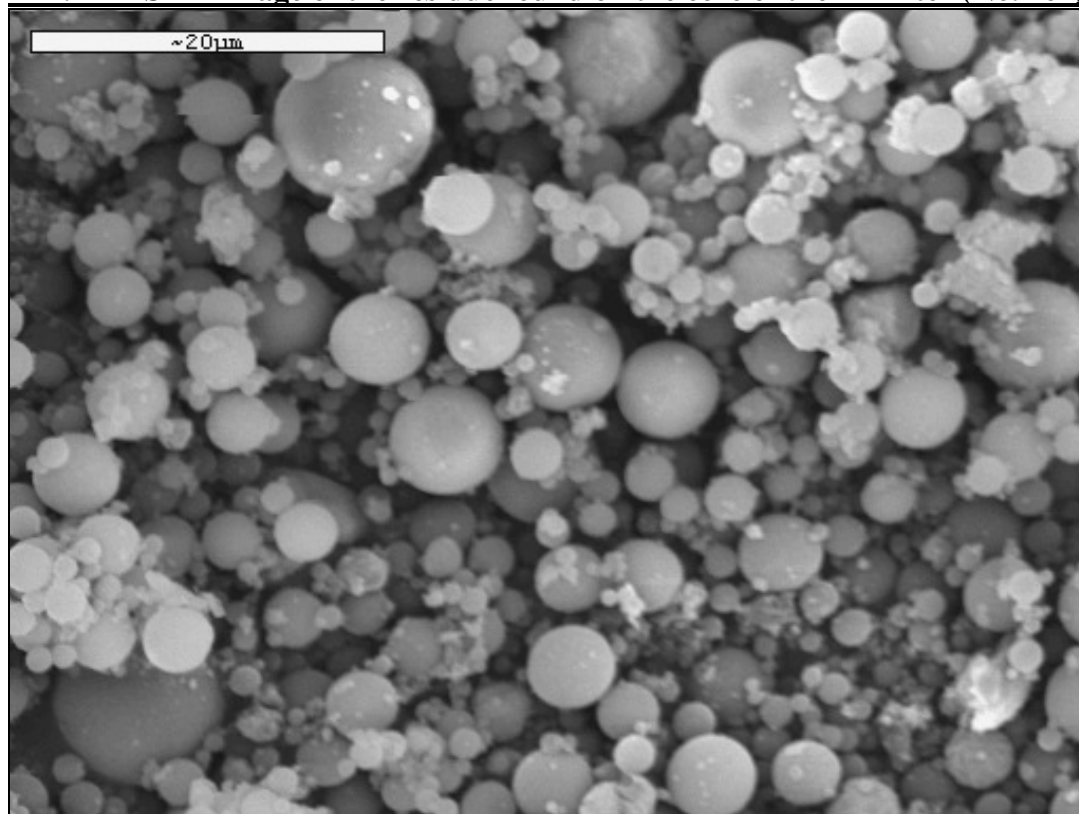
### A11.4 – SEM image of the residue found on the core of the LP filter (No.2 engine):

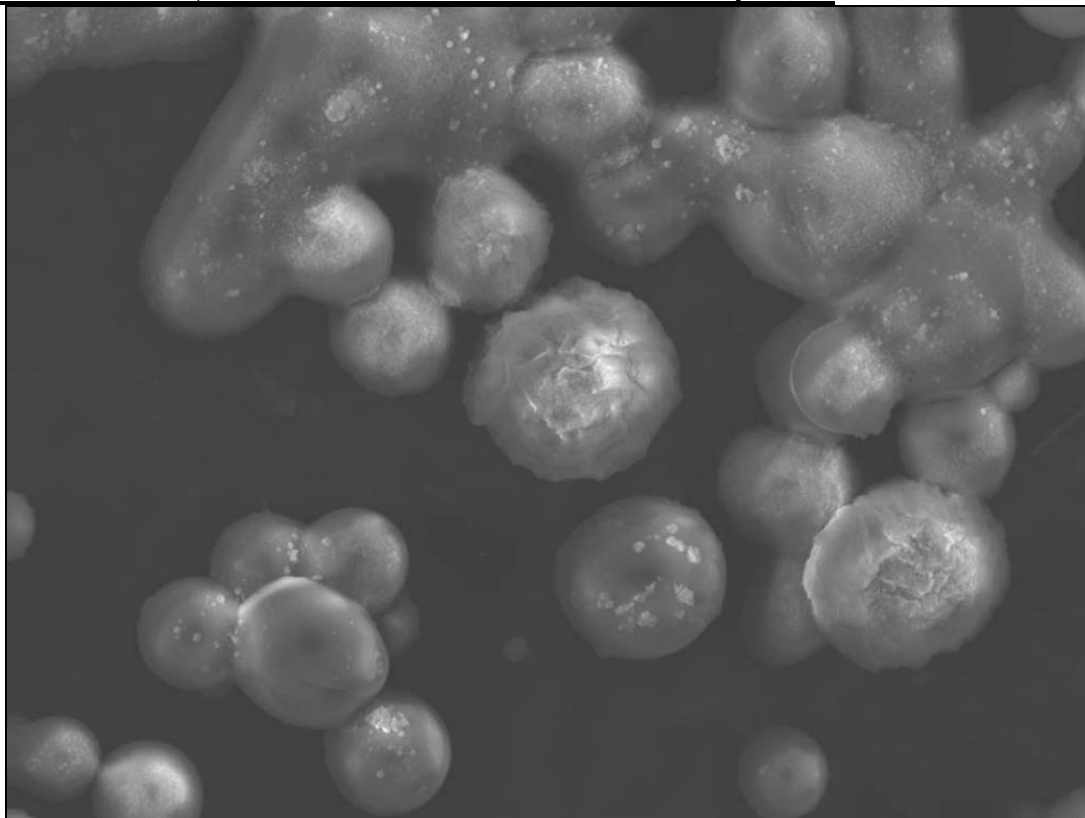
**A11.6 – SEM image of spheres with an apparent crystalline white deposit. EDX analysis would suggest that the white crystalline areas appear to be NaCl, but Na (not associated with Cl) is detected over all other areas of the spheres:**
