Investigation report

C11/2010L

A330 Jetliners' Engine Bleed Air System Failures: Serious Incidents on 11 and 22 December 2010

AIRBUS A330-302

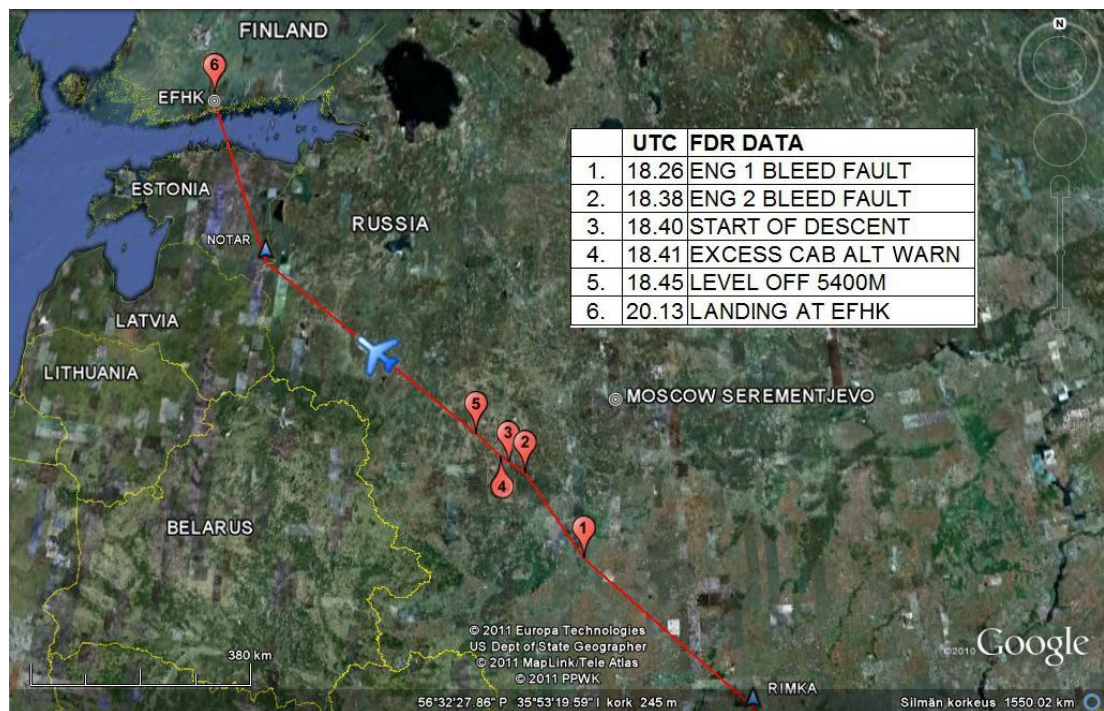
At 18:38 the bleed air system of the right engine failed as well (AIR ENG 2 BLEED FAULT). The flight crew requested that ACC Moscow clear them to a lower altitude because cabin altitude was on the rise. A moment later they received a clearance down to flight level 5400 m (17700 ft). The flight crew tried to reset the bleed air system of the left engine, which had malfunctioned earlier, to no avail. Following this, they continued to fly with both engines' bleed air systems being inoperative.

Figure 2. Key events associated with the serious incident of OH-LTS.

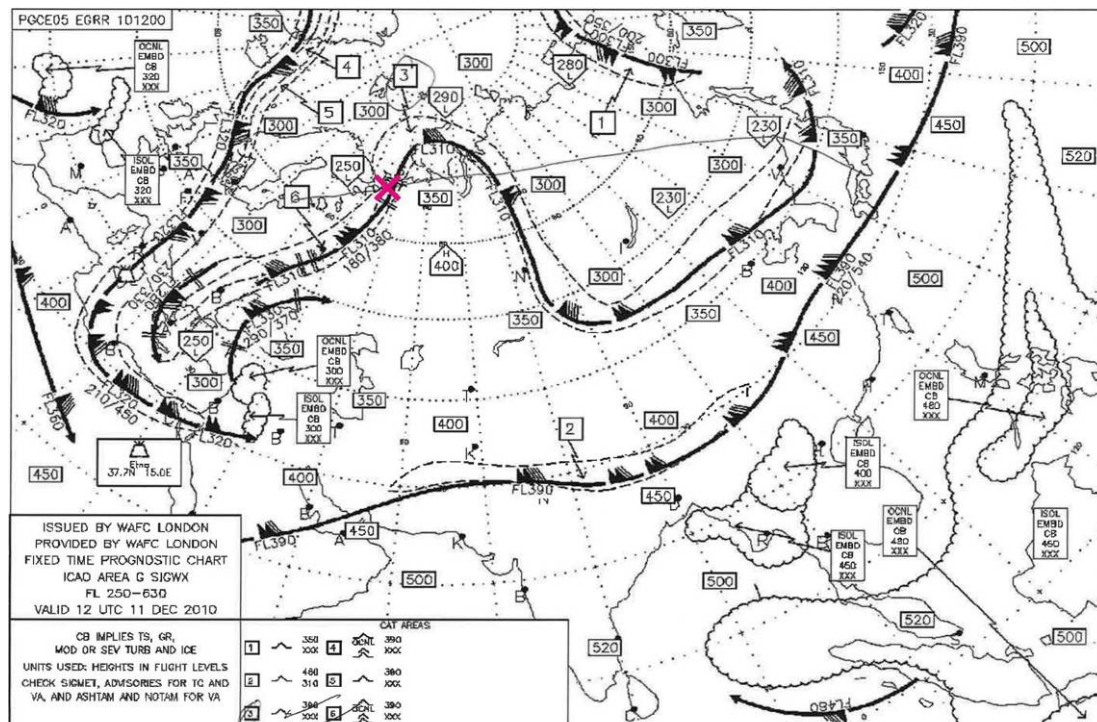
The Significant Weather Chart (SWC) valid 12 UTC 11 Dec 2010 (Figure 4) that was used in flight planning indicates a strong upper atmosphere jet stream at 9450 m (FL310), east of the Kola Peninsula and close to the location of the occurrence. The occurrence flight's route first crossed the jet stream approximately two hours before the incident and then momentarily before the incident.

Figure 4. The flight crew's SWC valid 12 UTC 11 Dec 2010. The location of the occurrence was later marked with a red X.

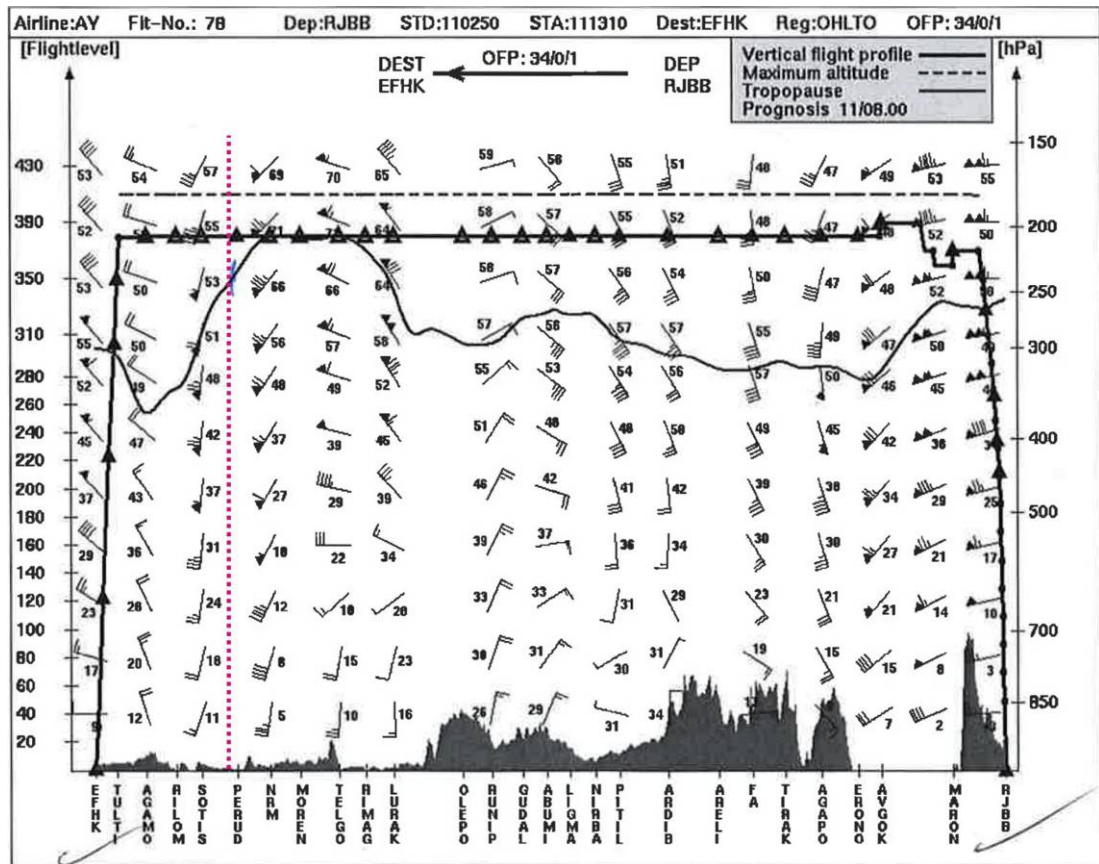
In addition, the flight crew had access to a vertical flight profile (Figure 5). The profile forecasted the tropopause¹ at their planned cruising altitude, close to the location of the occurrence. Moreover, the coldest ambient temperatures enroute, below -70 °C, are also forecasted for the same area where the incident occurred. The coldest FDR-recorded temperature in this area was -77 °C. The red-dotted line in Figure 5 represents the first malfunctioning of the bleed air system.

Figure 5. The flight crew's vertical flight profile for the flight on 11 Dec 2010. The red-dotted line was added later.

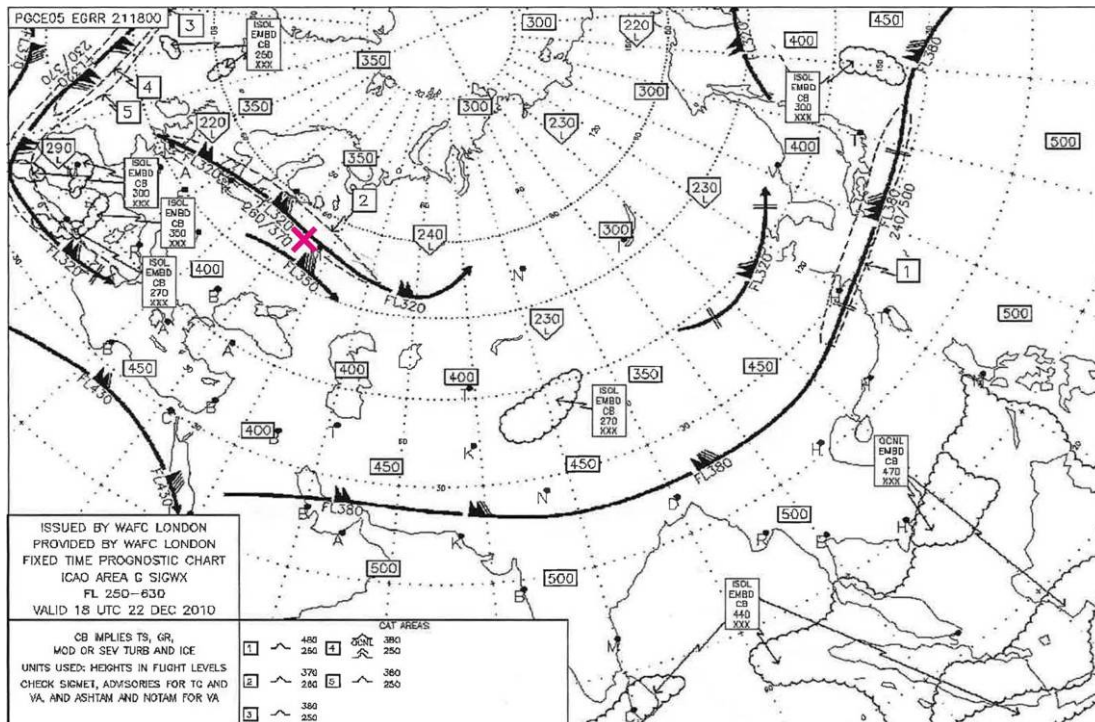
The Significant Weather Chart (SWC) valid 18 UTC 22 Dec 2010 (Figure 6) that was used in flight planning indicates one upper atmosphere jet stream at 10600 m (FL350) south of Moscow and another one at 9750 m (FL320) at the city of Moscow, close to the location of the occurrence. The occurrence flight's route crossed both jet streams momentarily before the incident.

Figure 6. The flight crew's SWC valid 18 UTC 22 Dec 2010. The location of the occurrence was later marked with a red X.

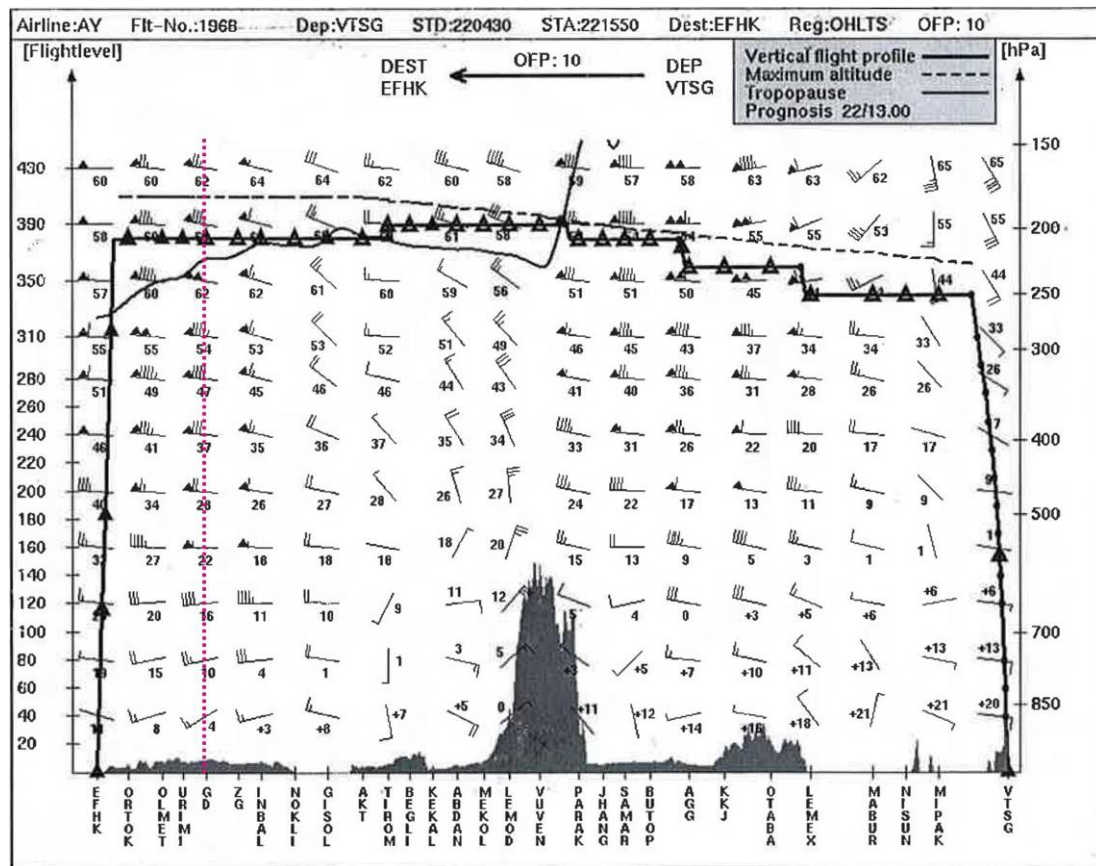
In addition, the flight crew had access to a vertical flight profile (Figure 7). The profile forecasts the tropopause at their planned cruising altitude before the location of the occurrence. Moreover, the coldest ambient temperatures enroute, below -60°C , are also forecasted to the same area where the incident occurred. The coldest FDR-recorded temperature in this area was -71°C . The red-dotted line in Figure 7 represents the first bleed air loss.

Figure 7. The flight crew's vertical flight profile for the flight on 22 Dec 2010. The red-dotted line was added later.

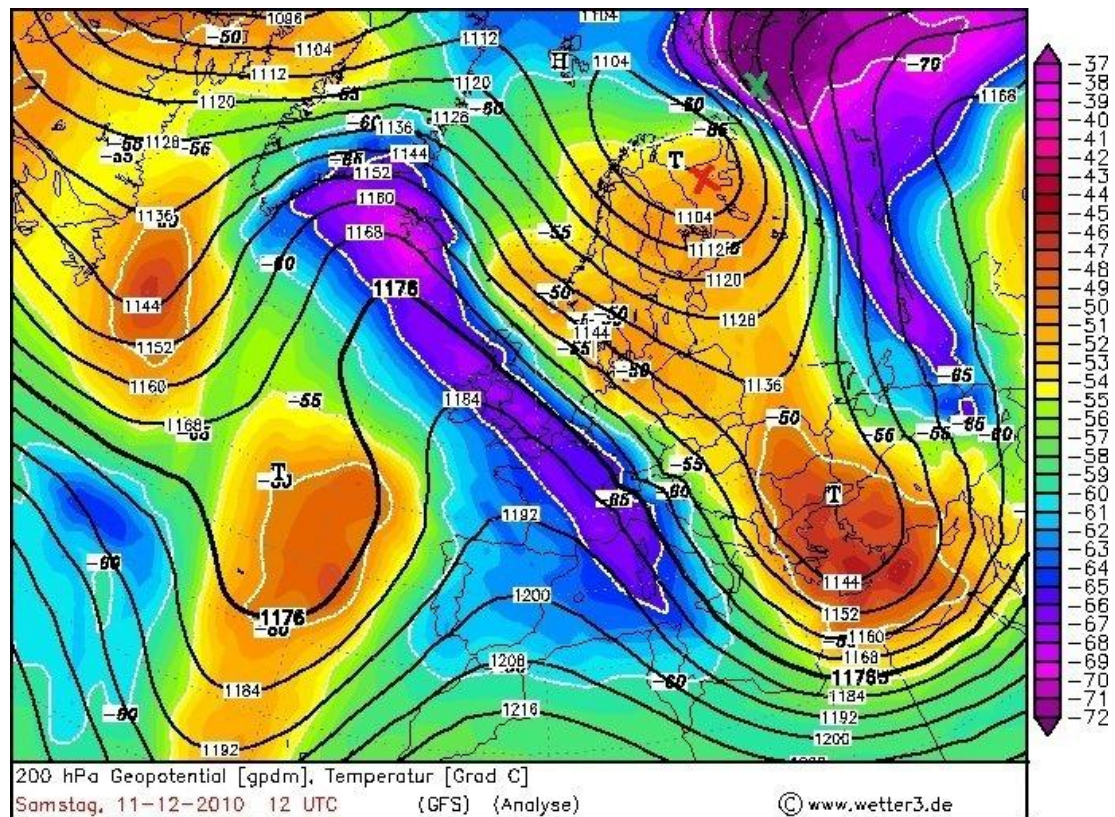
At the time of the occurrence flight a strong thermal gradient formed between the high-pressure ridge and the upper trough (from Novaya Zemlya over the Kola Peninsula towards the southeast). According to FDR data the ambient temperature rose from -77°C to -60°C in less than an hour of flying. The cruising altitude was at the height of the tropopause as well as within the range of the strongest thermal gradient.

Figure 8 depicts a reanalysis of 200 hPa streamlines (at approx FL390) at 12 UTC 11 Dec 2010, generated by the American Global Forecast System (GFS). It's different colours represent the large-scale low pressure system (amber) extending from Scandinavia to the Balkans as well as the Siberian High (violet). In addition, the green X and red X on the chart indicate Naryan-Mar and Kem weather stations, respectively, in northern Russia. Their actual radio-soundings are shown in figures 9 and 10.

Figure 8. GFS weather model reanalysis for 200 hPa streamlines at 12 UTC 11 Dec 2010. Source: www.wetter3.de.

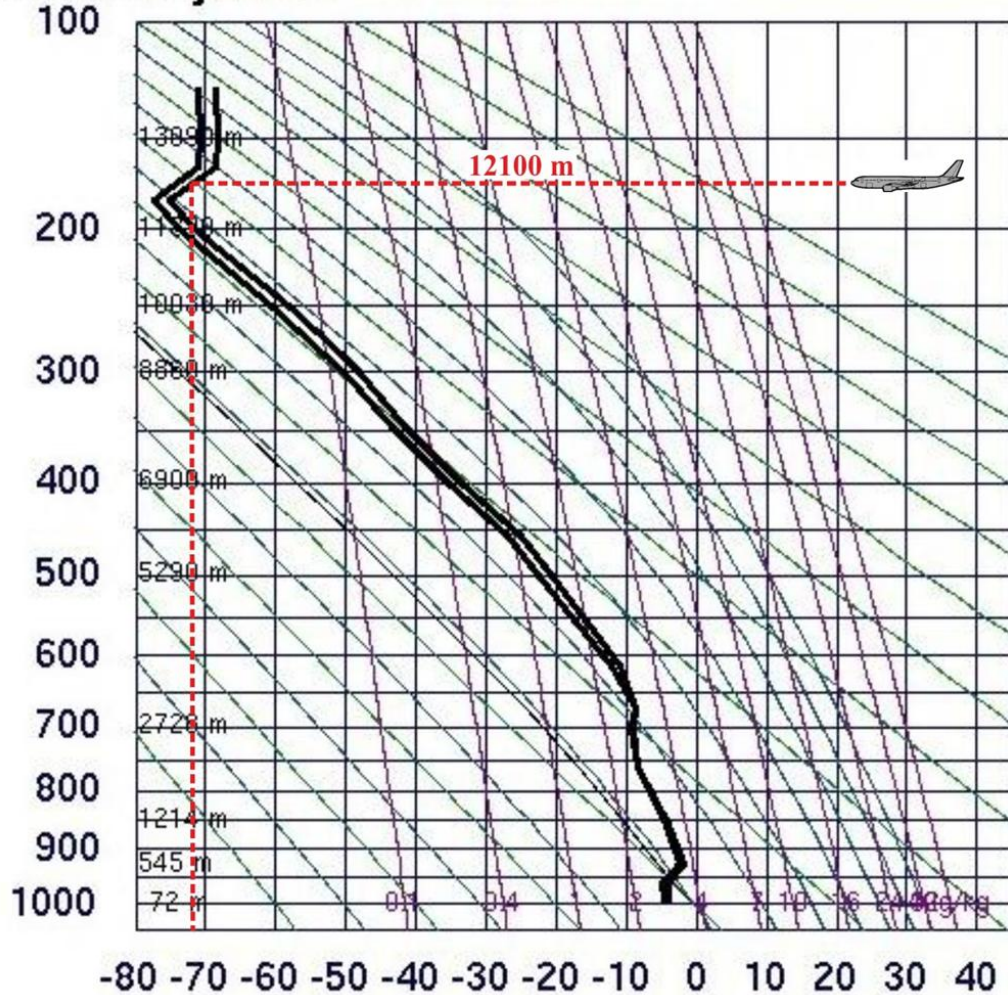
23205 Narjan-Mar

The Naryan-Mar radio-sounding (Figure 9) depicts the (mid-latitudes) air mass of the typically very high (ca. 11800 m) and cold (ca. -75°C) tropopause. The cruising altitude (12100 m, 39700 ft) of the occurrence flight was at the height of the extremely cold and well-defined tropopause.

Figure 9. Atmospheric temperature as a function of altitude in the Naryan-Mar sounding. The horizontal axis shows temperature [$^{\circ}\text{C}$] and the vertical axis pressure altitudes [hPa] and metres. The left plot is the dewpoint curve and the right one is the air temperature curve. Source: weather.uwyo.edu.

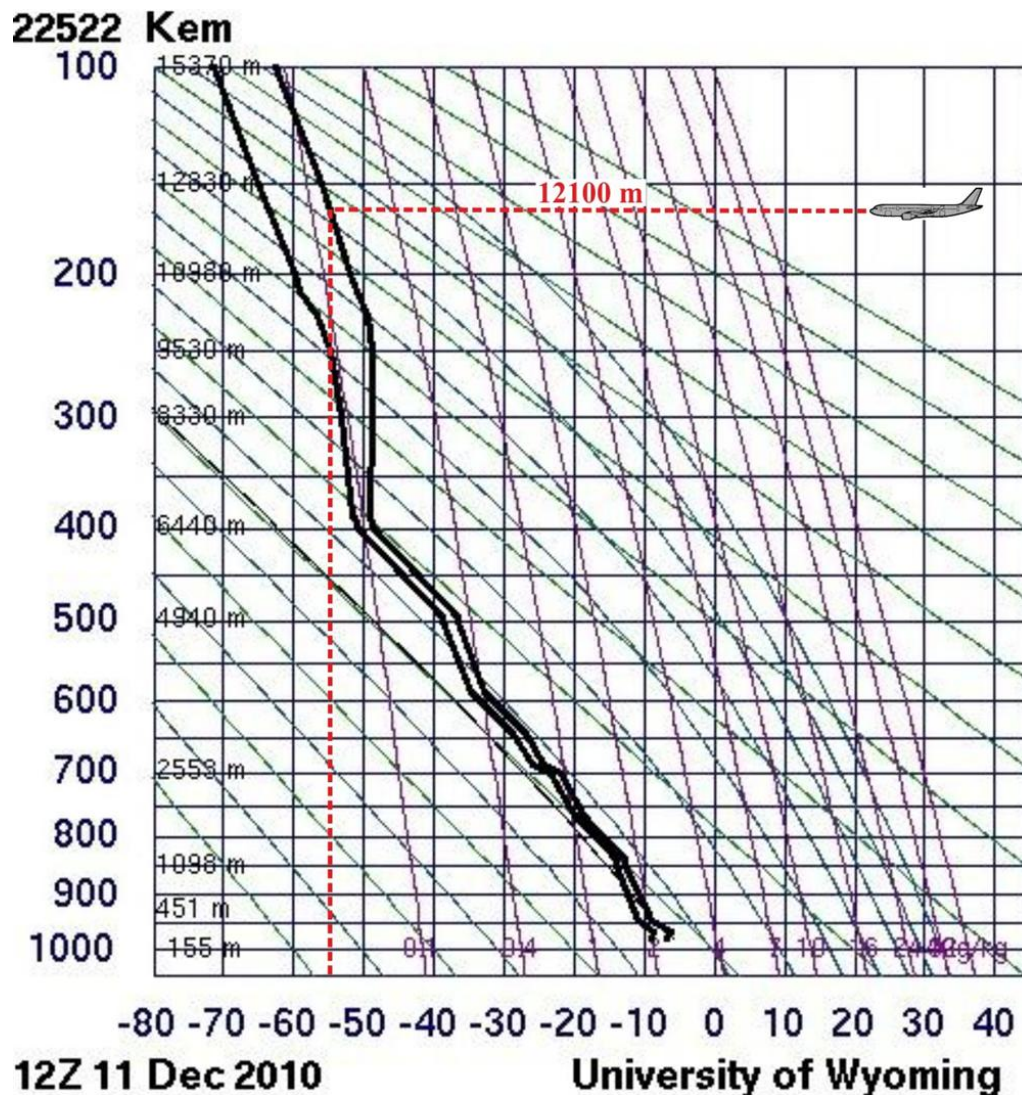
The Kem weather station sounding (Figure 10) depicts an air mass with a clearly lower (ca. 6500 m) and warmer (ca. -50°C) tropopause.

Figure 10. Atmospheric temperature as a function of altitude in the Kem sounding. The horizontal axis shows temperature [°C] and the vertical axis pressure altitudes [hPa] and metres. The left plot is the dewpoint curve and the right one is the air temperature curve. Source: weather.uwyo.edu.

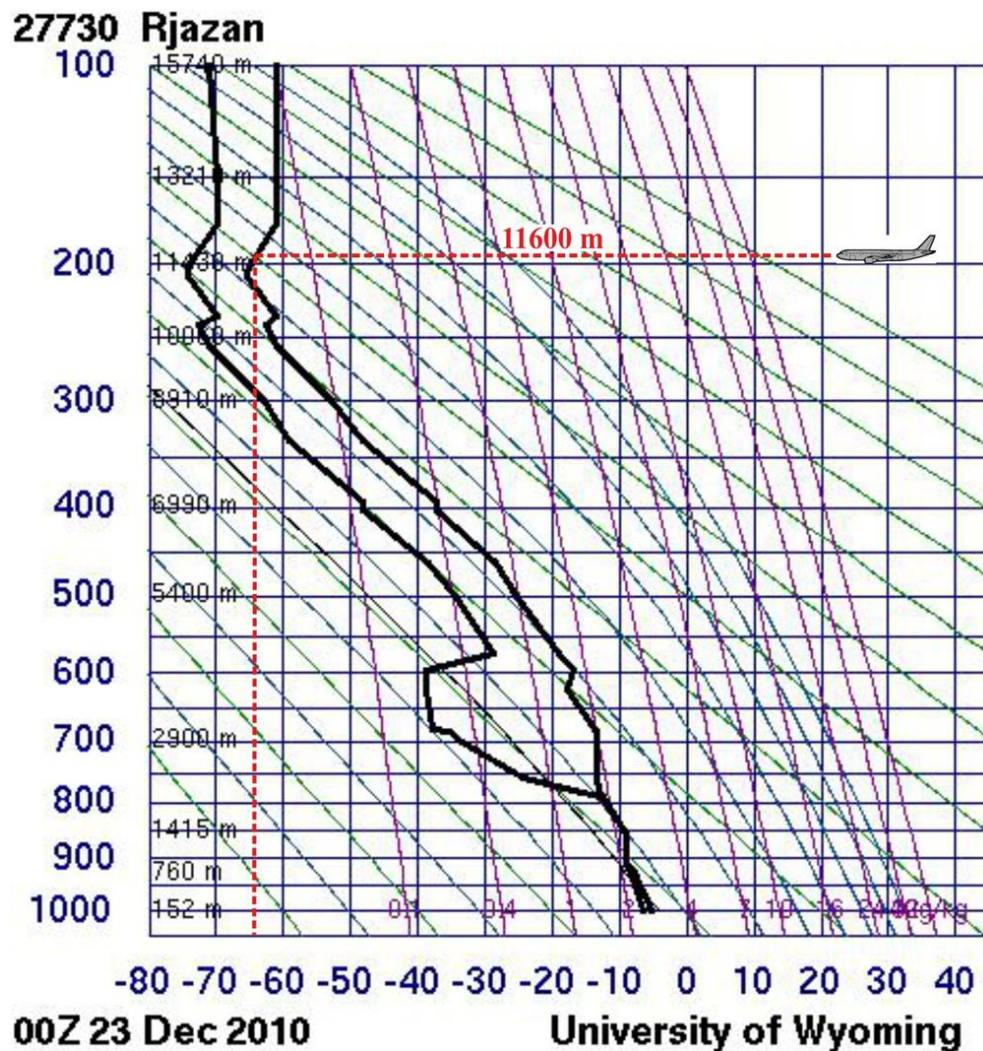
In figure 12 the circumstances with the occurrence flight are shown on a radio-sounding diagram (at 00.00 UTC 23 Dec 2010) from Ryazan, approximately 200 km southeast from Moscow. It shows the cold (ca. -65°C) and mid-latitudes air mass with a high (ca. 11400 m) tropopause. The cruising altitude of the occurrence flight was 11600 m (38100 ft).

Figure 12. Atmospheric temperature as a function of altitude in the Ryazan sounding. The horizontal axis shows temperature [°C] and the vertical axis pressure altitudes [hPa] and metres. The left plot is the dewpoint curve and the right one is the air temperature curve. Source: weather.uwyo.edu.

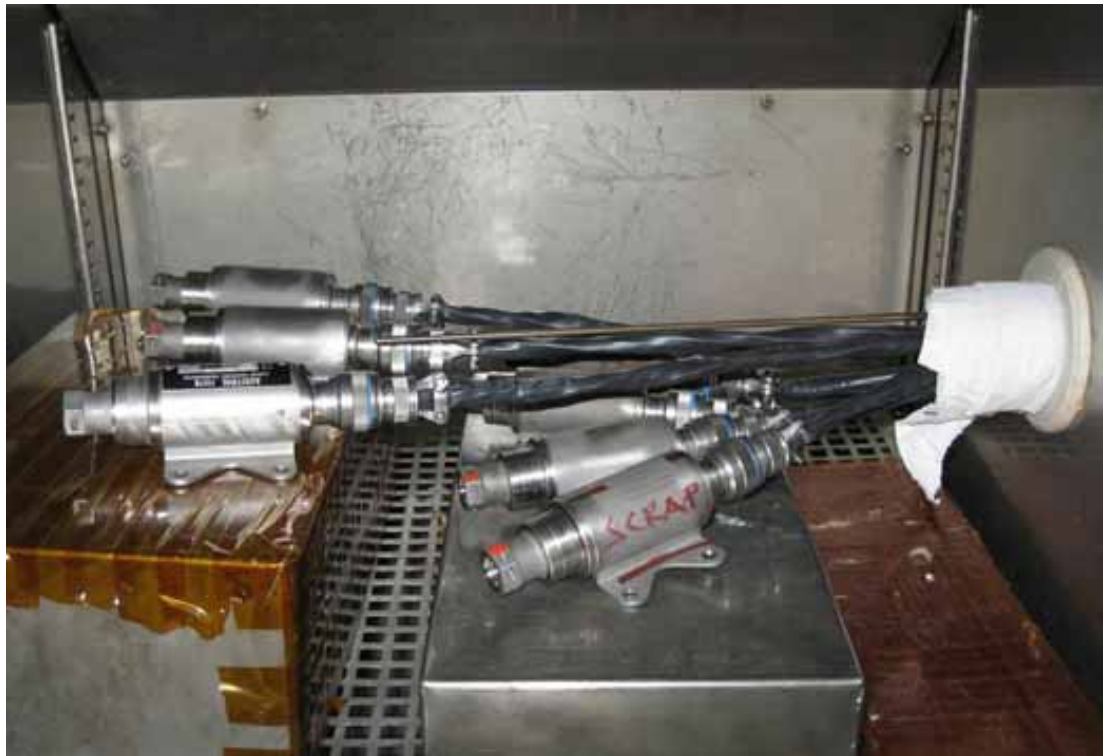
Following the visual inspection all pressure transducers were subjected to the output signal stability test. Test arrangements are explained in figure 18. Tests detected water in three transducers. The clearest indication of this came from OH-LTO's transducer s/n ASA12571. The output signals of OH-LTO's transducers s/n ASA12736 and ASA12735 were inconstant during temperature changes. This is why they, too, were determined to contain water. Nonetheless, the presence of water in them was not as evident as in pressure transducer s/n ASA12571. Some of the water may have disappeared during removal and/or transportation. One of OH-LTO's pressure transducers, s/n 188, was of the first version manufactured. It passed the stability test. The ACMM does not require stability testing for first version pressure transducers.

Figure 18. Pressure transducer output signal stability test arrangements in the test chamber. Source: Esterline-Auxitrol⁵.

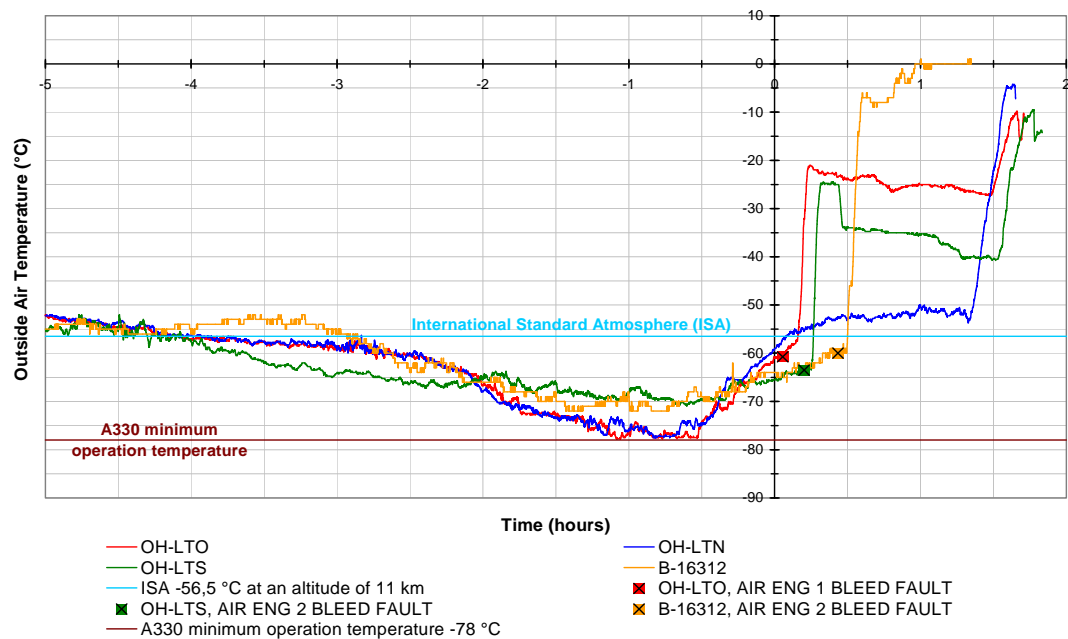
In addition to the occurrence flights, reference material was collected from two other flights. Due to identical flying weather conditions the investigation used measured ambient temperatures as reference material. Figure 19 shows the measured ambient temperatures of all four flights as a function of time for the final five hours before the first bleed air loss. The aircraft used for reference were A330s and the engines were type GE CF6-80E1.

In figures 19 and 20 the graphs of all reference flights meet the zero of the time axis at the point where the first bleed air losses occurred. The second bleed air loss points are marked on the graphs.

Figure 19. Ambient air temperatures on the reference flights as a function of time.

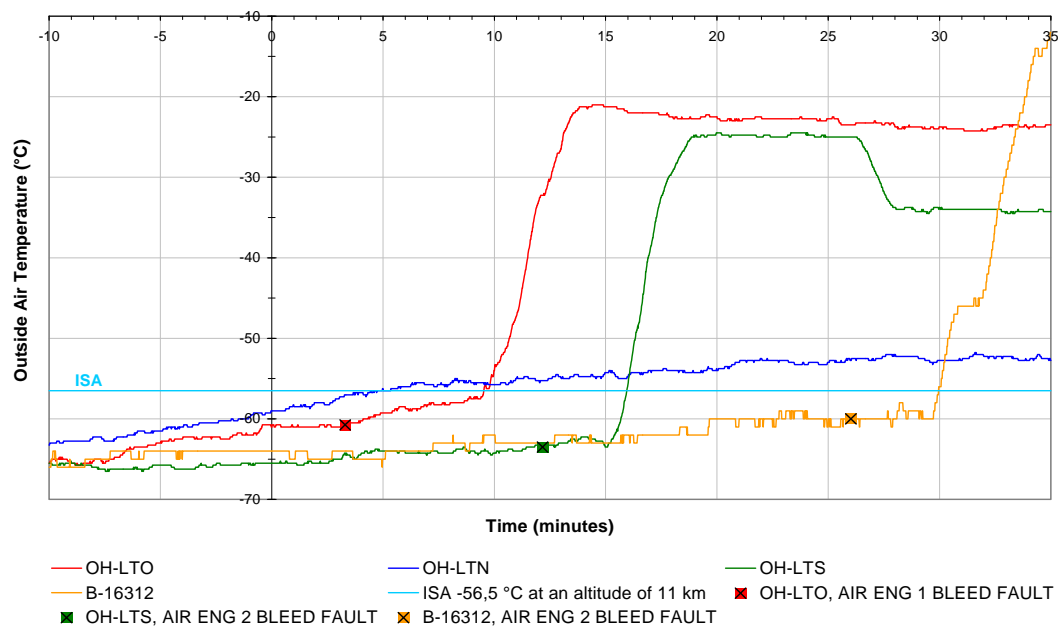
Figure 20. Enlargement of figure 19.

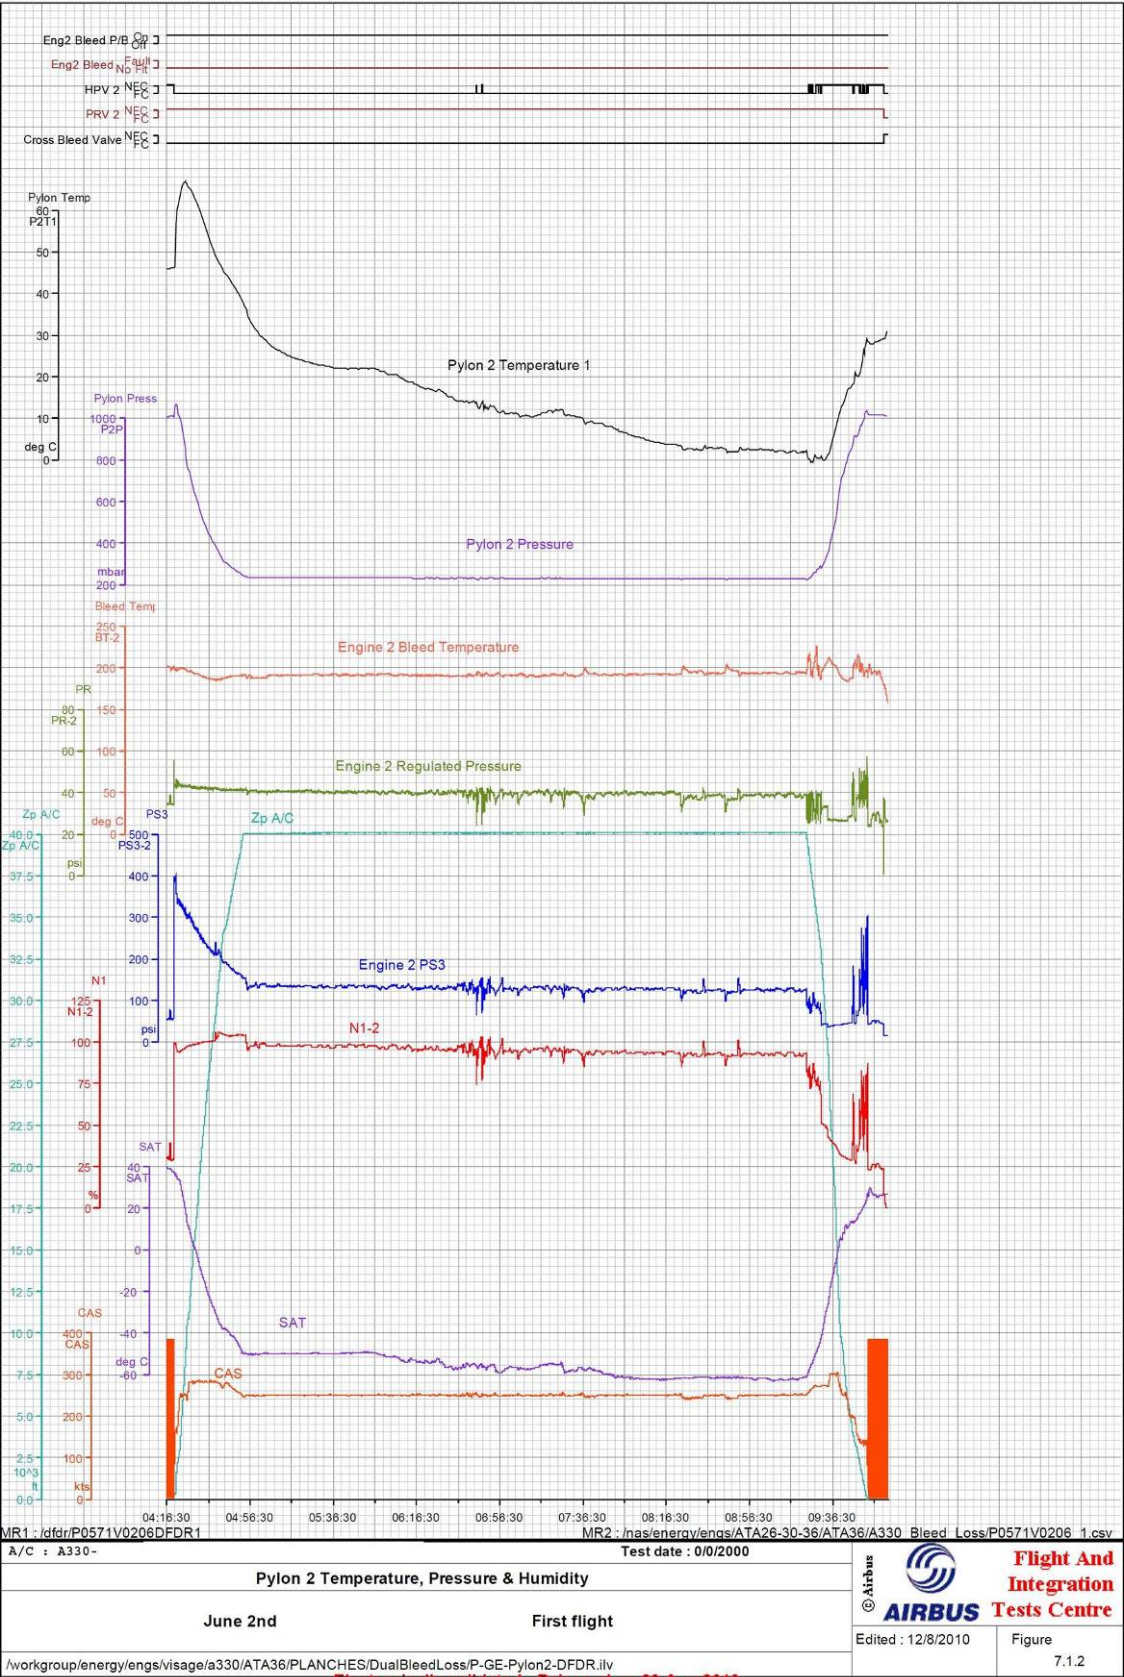
A330 - ATA 36 - Dual Bleed Loss Investigation

Although the number of events had remained stable since 2008, in 2010 a total of 12 events were reported, 7 of which in December. Subject OIT is released to advise operators of the latest developments and provide recommendations to prevent DBL re-occurrence.

Note: all Dec10 DBL events were reported on GE CF6-80E1 powered A330 aircraft. The reason for this specific fleet only being affected is linked to environmental conditions for the pressure transducer PN ZRA380-00 in the aircraft pylon area (IPC REF.4).

- Moisture condensation in the sensing chamber of the pressure transducer 8HA1 (2).
- Negative environmental temperatures at transducer level, leading to freezing of the water contained in the sensing chamber.

Airbus therefore recommends all operators to complete the implementation of the solutions described in TFU 36.11.00.065.

3.1.1 Airbus recommends to periodically (1A check to 3A check, ie 900FH or 150 days to 2700FH or 450 days) drain any water contained in the sense line connected between pressure transducer 8HA1(2) and the Pressure Regulating Valve (PRV). This sense line cleaning procedure is documented in AMM 36-11-16 PB06.

3.1.2 Airbus also recommends to periodically (1A check to 3A check, ie 900FH or 150 days to 2700FH or 450 days) remove pressure transducer 8HA1(2) with PN ZRA380-00 (supplied by AUXITROL) and carry out transducer drying, as per Auxitrol ACMM 36-11-08.

Auxitrol have designed a modified pressure transducer PN ZRA691-00 to replace PN ZRA380-00. Availability of first serial units is planned for September 2011.
