Safety first

The Airbus Safety Magazine

Edition January 2011

- ▶ What is stall?
How a pilot should react
in front of a stall situation
- ▶ Minimum control speed tests
on A380
- ▶ Radio Altimeter erroneous values
- ▶ Automatic NAV engagement
at Go Around

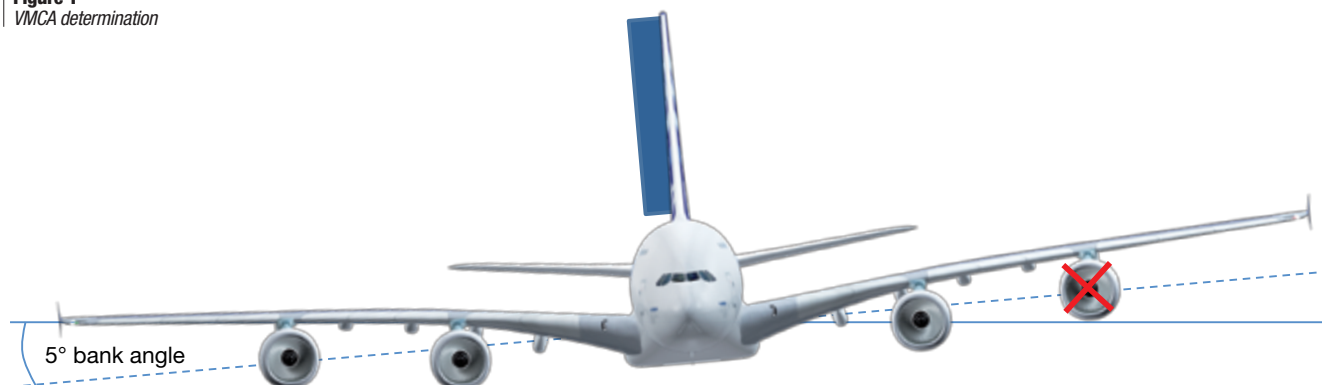
Figure 1
VMCA determination

When engines and systems are configured, we start about 20 kt above the predicted value, then, we decelerate slowly keeping heading constant. Necessary rudder increases as the speed decreases, eventually up to the stop. Further deceleration will need some bank to still keep the heading constant. The “true” VMCA is obtained when the bank angle reaches 5° in the opposite sense to the “failed” engine (fig. 1). This bank angle is very important as it allows a further speed reduction of about 5 to 10 kt, compared to the same test performed with wings levelled. Where is this strange rule coming from? It is a mystery! Maybe that, in the old times, when reliable flight test installations were not existing, somebody had imagined to have some tolerance on the bank angle, because it is true that a perfect stabilization of the bank angle is difficult when the rudder is on the stop. In doing so, he put some knots “in his pocket”! Then the tradition has been kept and officialised. This hypothesis could explain the choice of this odd 5° value.

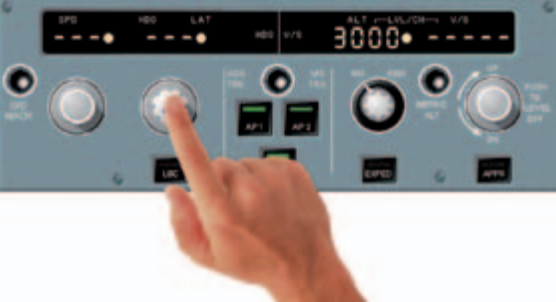
The crew has to arm the NAV mode manually by pushing on the FCU HDG/TRK knob.

Then, the FMA displays the NAV mode.
