**ROYAL
AERONAUTICAL
SOCIETY**

SMOKE, FIRE AND FUMES IN TRANSPORT AIRCRAFT

PAST HISTORY, CURRENT RISKS AND RECOMMENDED MITIGATIONS

Part 2: Training

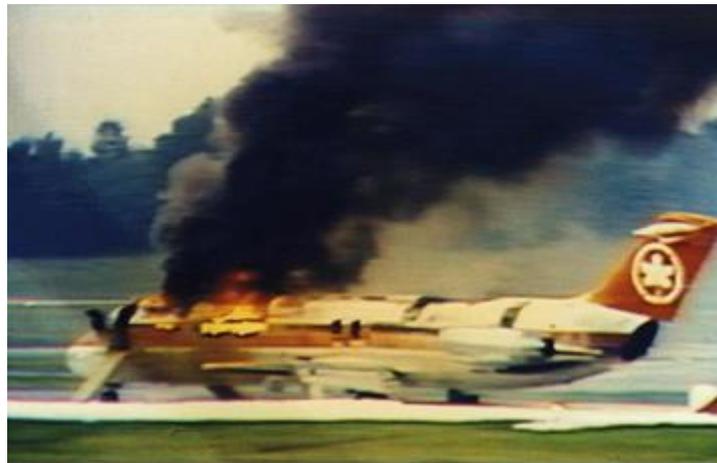
DC-9 accident – Cincinnati June 1983

In Advisory Circular (AC) 120-80 – In-flight Fires (FAA, 2004), the FAA identified that the time for the situation to become non-survivable was as little as seven minutes, and that only in one third of hidden fire events would the aircraft reach an aerodrome before the fire became uncontrollable. An example of this is the accident involving an Air Canada DC-9 which diverted to Cincinnati in June 1983 when a lavatory compartment fire became uncontrollable (NTSB, 1986).

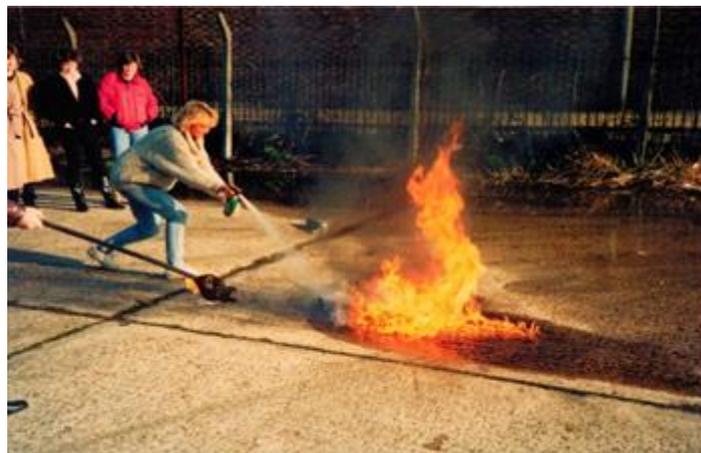
Practical fire training in the 1980's

During training in the 1980's, aircraft crew usually fought fairly large fires in the open air. At that time oil tray fires were favoured and Halon could be used. These fires were usually quite large and challenging. They could be difficult to extinguish unless the correct procedure was used, such as aiming the extinguisher at the base of the flames. Re-ignition was often a major factor. Whilst a fire of such size would be most unlikely to occur on a commercial aircraft, it did provide an awareness of the problem and also the effectiveness of Halon.

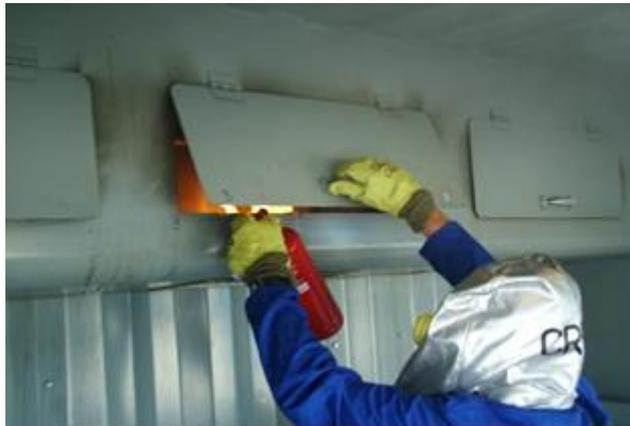
Combining fire extinguisher training with PBE training & fire gloves

Combining fire extinguisher training with PBE training is certainly feasible since some operators and training organisations achieve both elements in one practical fire training scenario. Therefore, regulatory requirements should reflect the likelihood of an in-flight fire in which different items of fire safety equipment need to be used simultaneously. Attempting
