**ROYAL
AERONAUTICAL
SOCIETY**

SMOKE, FIRE AND FUMES IN TRANSPORT AIRCRAFT

PAST HISTORY, CURRENT RISK AND RECOMMENDED MITIGATIONS

**Second Edition 2013
Part 1: Reference**

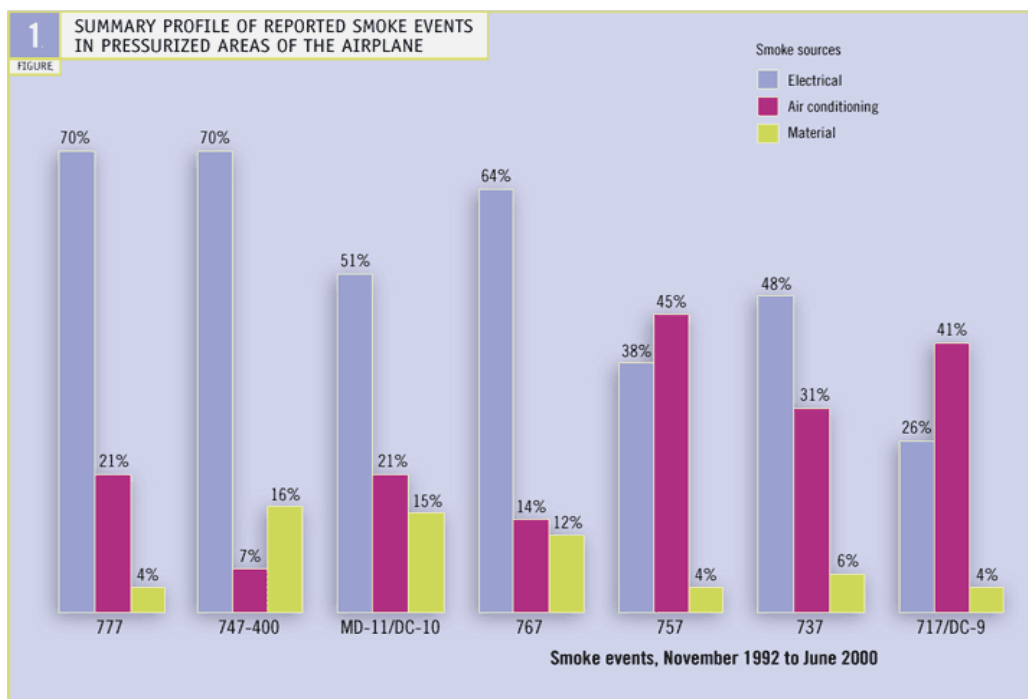
(Fleece, 2003)

The figure below shows some causes of smoke by aircraft type

The most frequent source of fire in transport aeroplanes is electrical. A Boeing study showed that between November 1992 and June 2000 that over two thirds of the in-flight fires on Boeing aeroplanes were electrical (Boeing, 2000). One major ignition source for electrical fires is aeroplane wiring. In a modern large transport aeroplanes there is over 500,000ft (150km) of wire. (Potter, 2003)

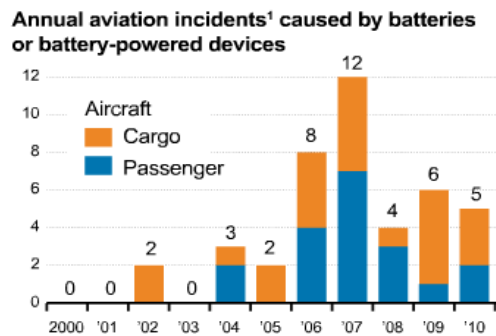
Battery Cargo in Planes

1 – Incidents involving smoke, fire, extreme heat or explosion

Source: Federal Aviation Administration, Transport Canada and England's Civil Aviation Authority

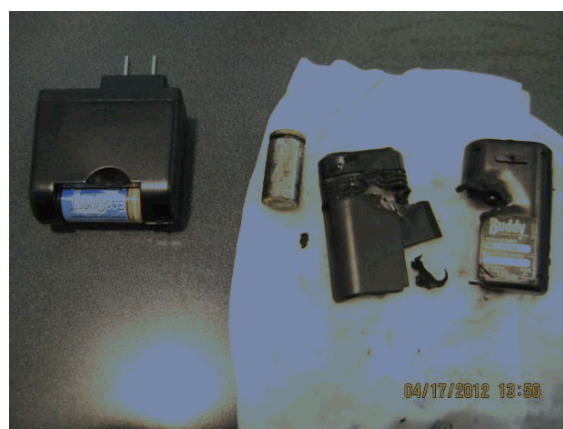
Figure 1. Photo of Mini Air Purifying Device after lithium-ion battery fire on flight from Toronto, Canada, to Minneapolis/Saint Paul, Minnesota, 17 April 2012.

During the in-flight service, the flight attendant noted that the device was on fire on the floor; its battery was burning several feet from the device. Using water from the

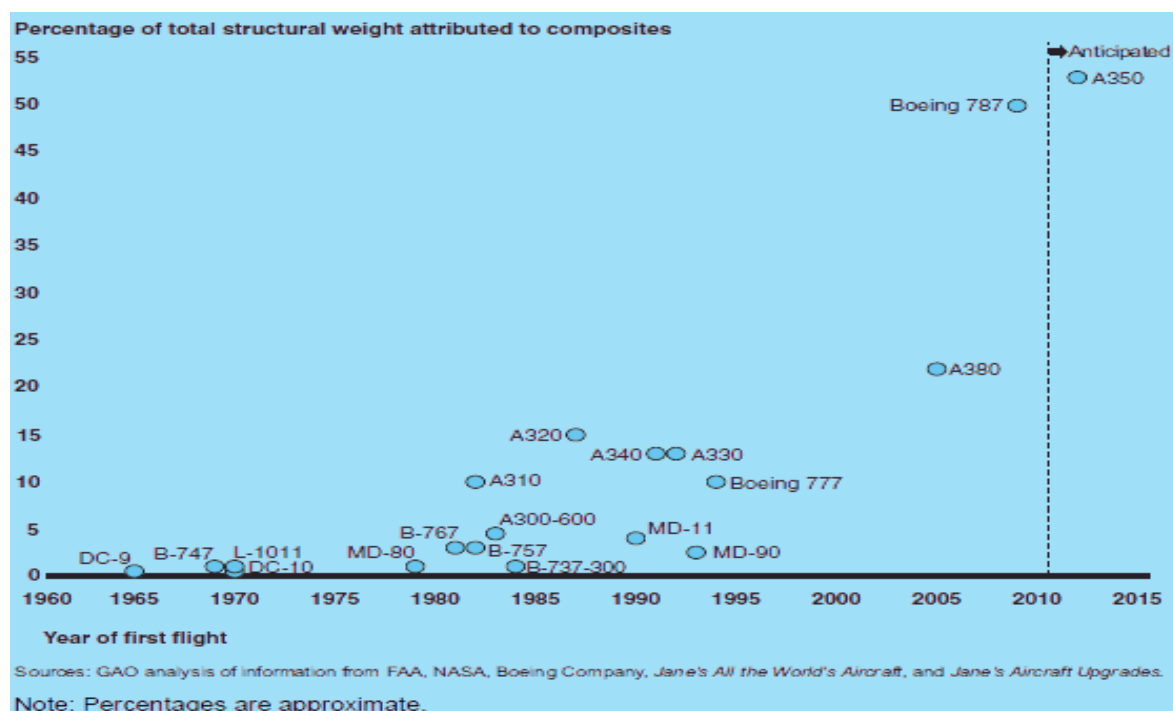
(United States Government General Accountability Office, 2011)

The following Figure shows the percentage of total structural weight attributed to composite materials used in aeroplane construction since the mid-1980s:

For many years aeroplane manufacturers have used composite materials for certain structures (e.g. Boeing 737 rudder). One of the earliest uses of carbon-fibre composites to manufacture commercial aeroplane structure was by Airbus in the A300 in 1972 (Airbus, 2012). Many military aeroplanes have composite materials used in their construction (e.g. the Northrop Grumman B-2 stealth bomber which has a structure largely constructed from composite materials). Both Boeing and Airbus are now using composite materials as the primary method of construction for the fuselage of the Boeing 787 and the Airbus A350, as well as other associated parts.
