**ROYAL  
AERONAUTICAL  
SOCIETY**

# **SMOKE, FIRE AND FUMES IN TRANSPORT AIRCRAFT**

**PAST HISTORY, CURRENT RISKS AND RECOMMENDED MITIGATIONS**

## **Part 2: Training**

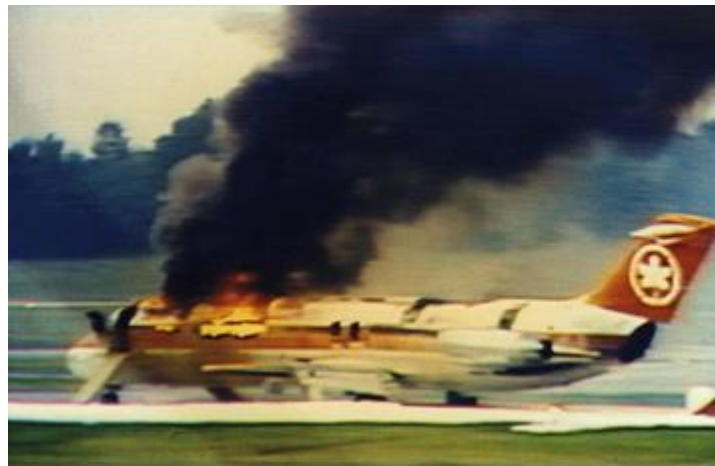
In Advisory Circular (AC) 120-80 – In-flight Fires (FAA, 2004), the FAA identified that the time for the situation to become non-survivable was as little as seven minutes, and that only in one third of hidden fire events would the aircraft reach an aerodrome before the fire became uncontrollable. An example of this is the accident involving an Air Canada DC-9 which diverted to Cincinnati in June 1983 when a lavatory compartment fire became uncontrollable (NTSB, 1986).

DC-9 accident – Cincinnati June 1983

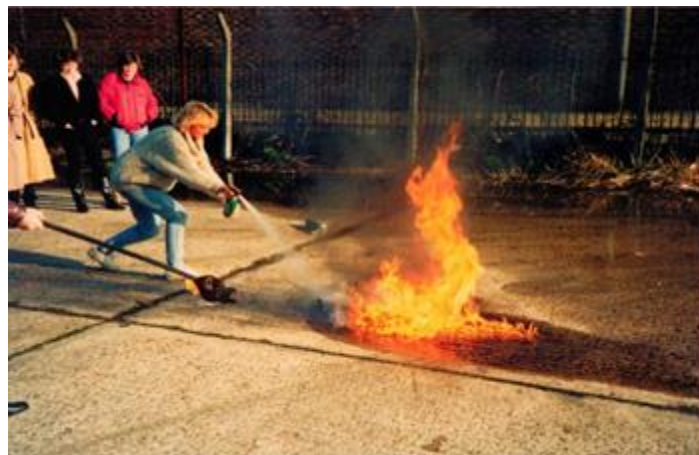
During training in the 1980's, aircraft crew usually fought fairly large fires in the open air. At that time oil tray fires were favoured and Halon could be used. These fires were usually quite large and challenging. They could be difficult to extinguish unless the correct procedure was used, such as aiming the extinguisher at the base of the flames. Re-ignition was often a major factor. Whilst a fire of such size would be most unlikely to occur on a commercial aircraft, it did provide an awareness of the problem and also the effectiveness of Halon.

Practical fire training in the 1980's

Since such fires were not realistic to a cabin fire situation, in the late 1980's the UK CAA decided that the requirement should be changed to cabin crew fighting a fire representative of an interior aircraft fire. This has now become an EASA requirement in AMC1 ORO.CC.125(d) and ORO.CC.140.

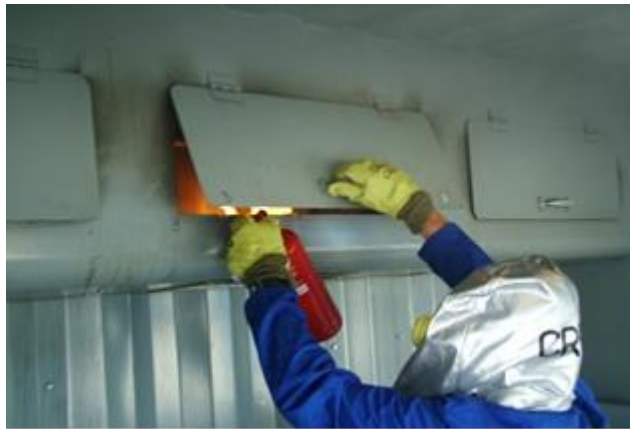
Combining fire extinguisher training with PBE training is certainly feasible since some operators and training organisations achieve both elements in one practical fire training scenario. Therefore, regulatory requirements should reflect the likelihood of an in-flight fire in which different items of fire safety equipment need to be used simultaneously. Attempting

to meet practical fire training requirements in unrealistic, separate fire training scenarios is not satisfactory.

Combining fire extinguisher training with PBE training & fire gloves
