ISSUE 77

ON COMMERCIAL AVIATION SAFETY

The Official Publication of THE UNITED KINGDOM FLIGHT SAFETY COMMITTEE

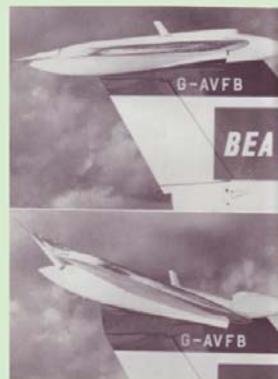
3. Some all moving tailplanes are trimmed conventionally – the Trident's was commanded by both the column and the trim wheel; the 'elevator' was a geared tab (reproduced with

column both operated the tailplane and its geared elevator together (see fig 3).

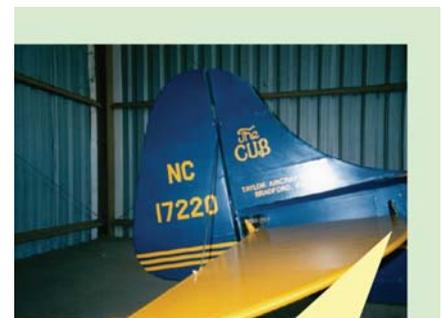
4. Trimming tailplanes aren't confined to the jets – this Piper Cub has one, as shown by the slot near the tailplane i.e. which provides access to the actuating link

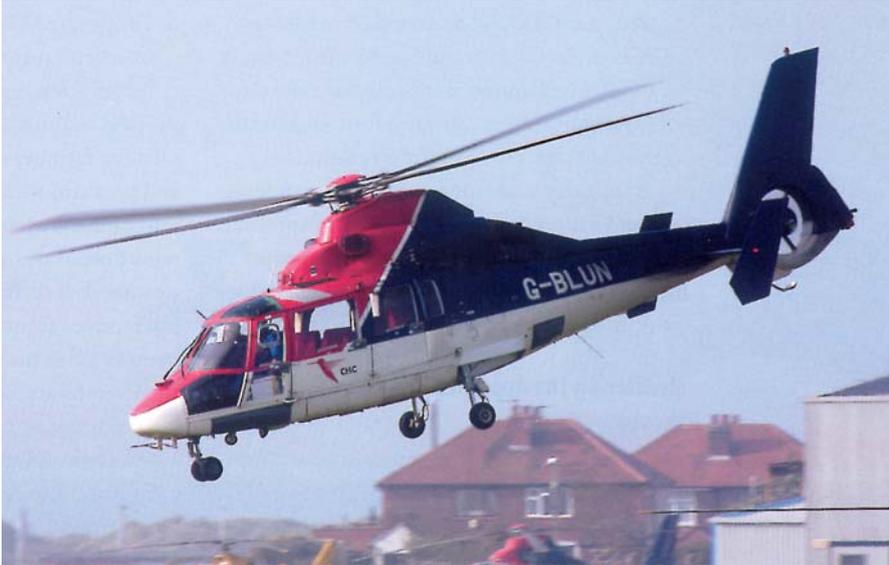
Aérospatiale SA 365N Dauphin 2

The Aérospatiale (now Eurocopter) SA 365N, first flown in 1979, is a twin-engine helicopter designed to carry two pilots and up to eight passengers. It is equipped with Turbomeca Arriel 1C gas turbine engines, each rated at 530 kW (710 shp).

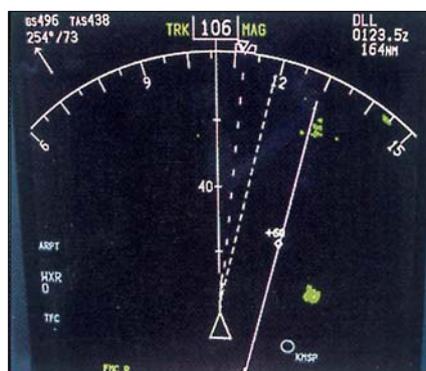
Taken at FL 370, return at 2 o'clock and 20 miles appears weak because the bottom of the beam is approaching the radar top. Note the tilt is set to zero degrees, 80-mile range selected, with no ground returns displayed.

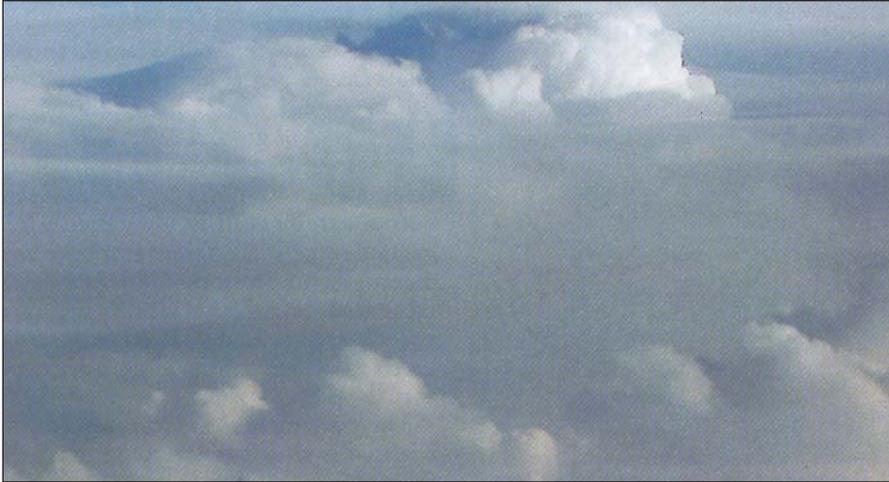
View from the windscreen tells a different story. It was a very hazardous cell extending slightly above our cruising altitude and growing rapidly.
