Focus

On Commercial Aviation Safety

The Official Publication of the United Kingdom Flight Safety Committee

ISSN: 1355-1523 Summer 2025. Issue 129. July 2025.

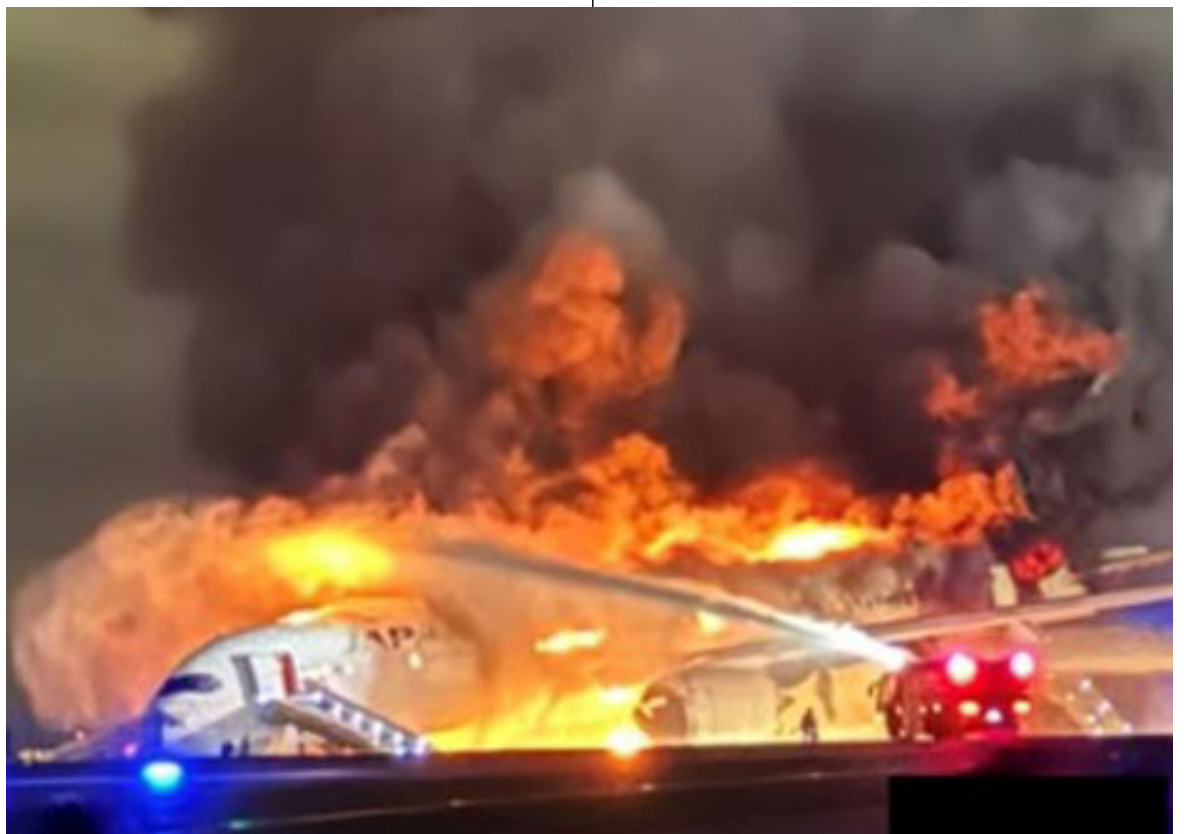
Photo from JTSB Accident Report

The Japan Transport Safety Board (JTSB) has published a major update on the investigation into the cause of the runway collision that occurred on 2 January 2024, at Haneda International Airport in Tokyo, Japan, involving a Bombardier DHC-8 operated by the Japan Coast Guard and a Japan Airlines Airbus A350. There were six people on board the DHC-8 with only the pilot in command surviving after sustaining serious injuries when the aircraft burst into flames and was destroyed by fire. The 379 people on the Airbus A350 all survived despite the aircraft also catching fire and ultimately being destroyed by fire.
