UK Flight Safety Committee

# UKFSC News #36

27 Aug 2025

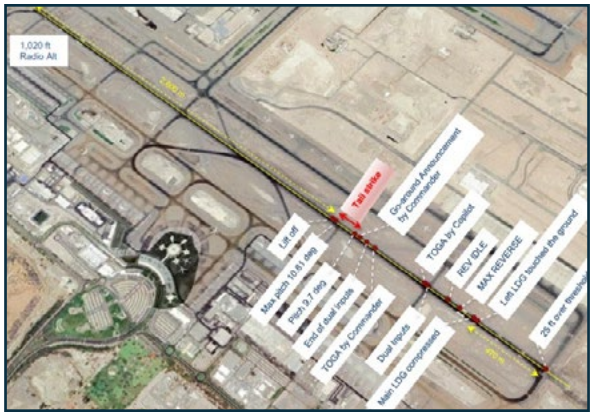
On 29 April 2023, the flight crew of an aircraft did not complete the intended touchdown at Abu Dhabi from the flare to land and initiation of a go-around resulted in a tail strike due to high pitch control input whilst the airspeed was still low and the configuration not correct. Confusion by both pilots as

Photos from the official report

to the aircraft air/ground status after touchdown was a contributory factor and involved significant dual sidestick input with no transfer of control. Once established in the climb, the remainder of the subsequent circuit to land was completed without further event.

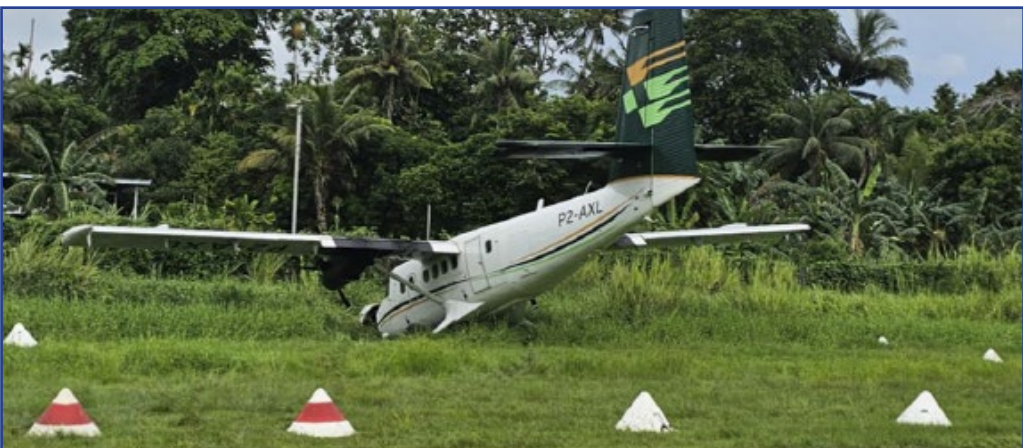
Photo from the official report

DHC 6 Runway Excursion

On 6 February 2025, a De Havilland DHC-6-400 experienced a runway excursion during landing at Kerema Airport, PNG. The aircraft veered off Runway 14 and impacted a drainage ditch. There were no injuries, but the aircraft sustained substantial damage.

A right cross-tailwind and damp grass surface reduced traction and directional control. The PIC’s foot became lodged between the rudder and brake pedals, impairing braking. Uncoordinated control inputs from both pilots (asymmetric thrust and abrupt rudder use) worsened the situation. Poor communication and unclear control authority during the landing roll degraded situational awareness. The crew changed assigned flying roles without notifying the Chief Pilot, and the co-pilot was dual-rostered for both operational flying and a proficiency check on the same day. The report recommends:

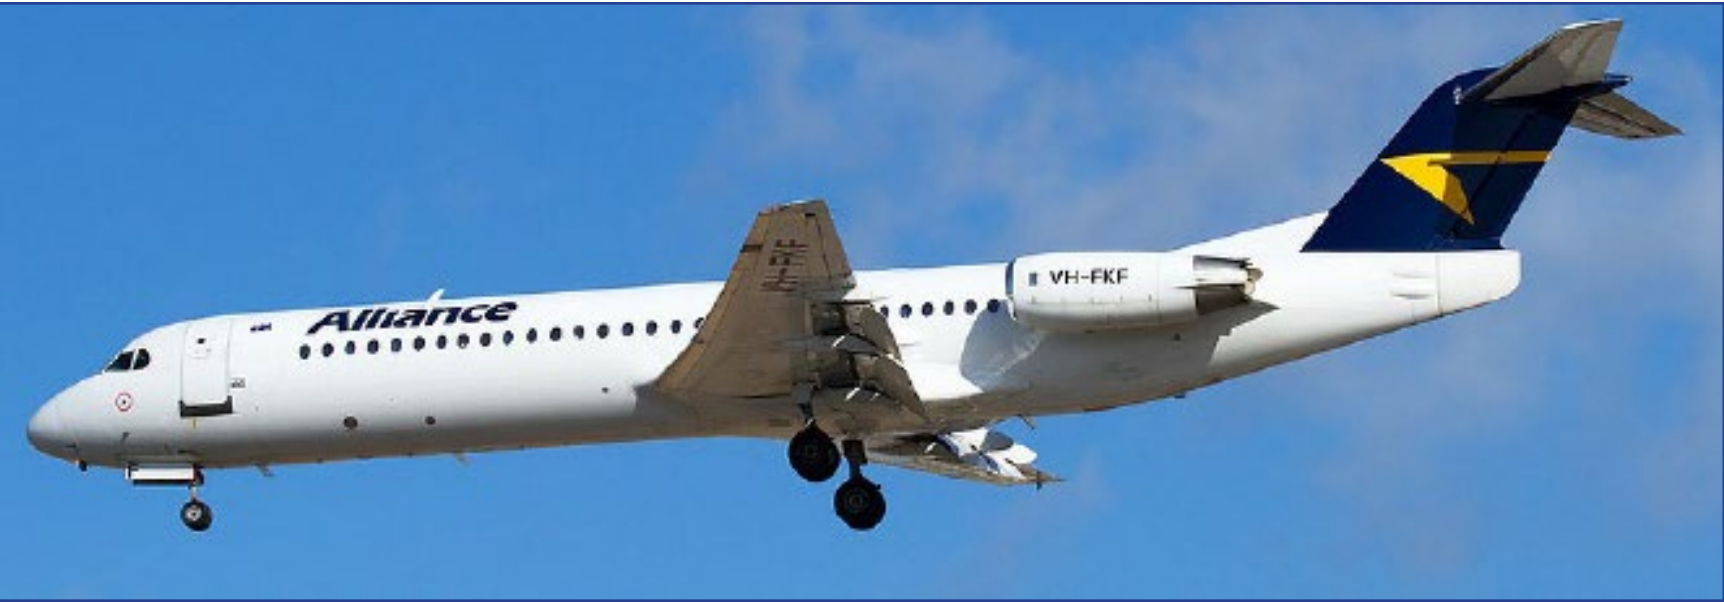
Photos from the official report

The pilot flying incorrectly assessed the stabilisation height as 500 ft instead of the correct 1,000 ft, leading to inadequate energy management during approach.

The captain failed to switch the altimeter from standard pressure to QNH, causing a 300 ft discrepancy between

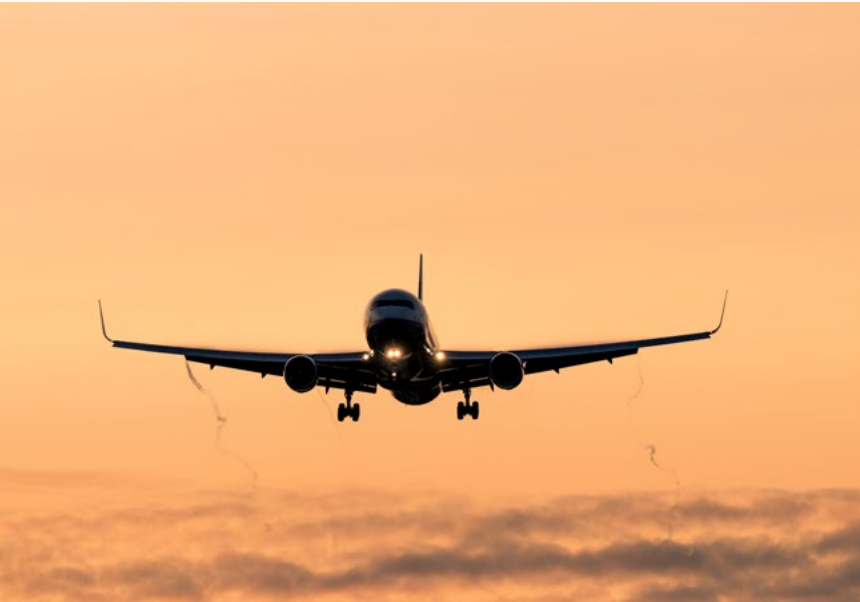
Post-flight inspection revealed that the auxiliary power unit (APU) access doors had separated from the aircraft, causing substantial damage to the lower surfaces of both elevators .

Damage to the recovered door sections suggested that one or more latches were not fully engaged prior to departure.

The probable cause was one or more latches were not fully re-engaged after a service check which resulted in the auxiliary power unit (APU) doors separating from the aircraft during climb out. [NTSB Report](#).
