Safety First The Airbus Safety Magazine

Editorial # 05 | December 2007

The Airbus Safety Magazine	1
News C. Courtenay	2
Near CFIT event during Non Precision Approach P. Charalambides	4
A320 Tail strike at Take-Off? M. Baillion	10
Unreliable Speed J. Barthe	14
Compliance to operational procedures C. Pelegrin	20
The Future Air Navigation System FANS B S. de Cuendas	24
Airbus Flight Safety Contacts/Organisation	32

Near CFIT event during Non Precision Approach

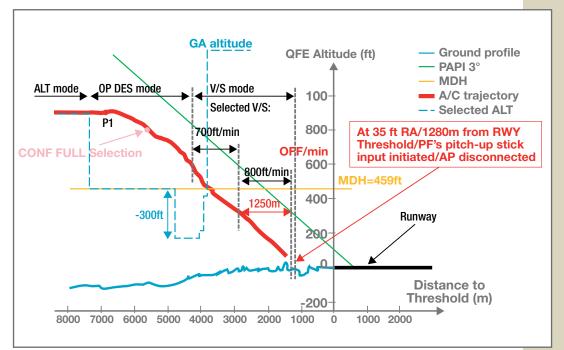
This sequence can be detailed as follows:

- Shortly before overflying "P1", MDA altitude was selected on the FCU, and the OP DES longitudinal autopilot mode was selected so that a thrust reduction was progressively commanded to target idle thrust, while the autopilot pitch mode maintained the speed target.
- At that stage the aircraft was in slats/flaps configuration 3, gear down, both flight directors engaged, autopilot N°2 engaged.

Descent profile

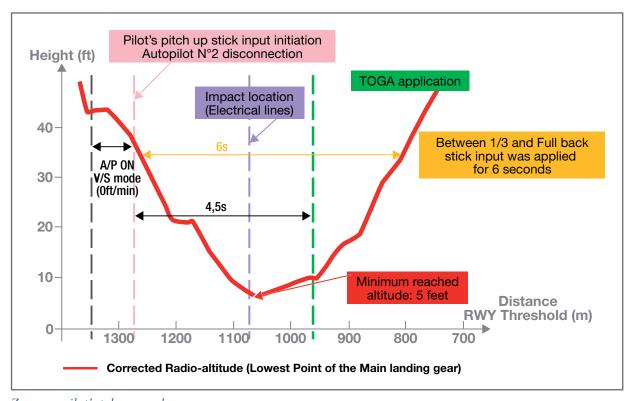
- The radio-altimeter parameters recorded in the DFDR (here plotted in red) indicate the distance between the lowest point of the main landing gear and the ground.
- The initial PF's pitch-up stick input was followed by permanent pitch-up stick input (between 1/3 and full back stick input) applied for 6 seconds, so that the aircraft stopped descending and started to climb.
- Minimum recorded altitude was 5ft RA reached at about 1100m from the runway threshold.

- The estimation of the impact location indicates that, at that moment, the aircraft impacted the electrical lines.
- At 10ft RA, 4.5 seconds after the initial PF's pitchup stick input, thrust levers were moved forward to TOGA detent.
- 43 seconds after TOGA application, landing gears were selected up.
- 2 minutes after TOGA application, Slats/Flaps configuration 3 was selected.
- The aircraft diverted to the scheduled alternate airport.

Zoom on pilot's take-over phase

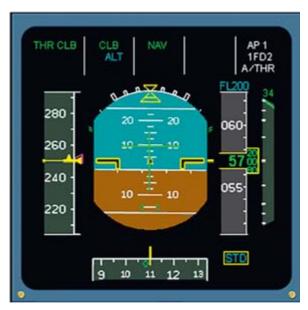
CAPT PFD

Erroneous speed or altitude indications can be suspected, among others, in the following cases:

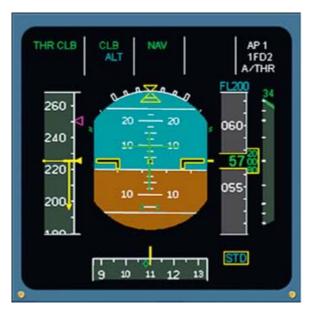
F/O PFD

Depending on the affected probe, i.e. pitot probe or static port, different indications in the cockpit will become unreliable. Therefore the crew should be aware that some of the usual cues to fly could be unreliable as indicated:

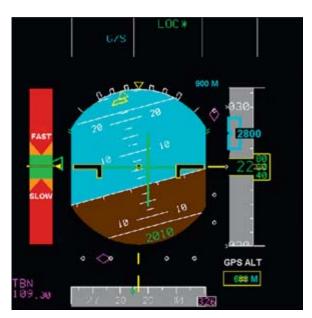
- The Back-Up Speed Scale replaces the PFD speed scale on both PFDs,
- GPS Altitude replaces the Altitude Scale on both PFDs.

The Back-Up Speed Scale then enables to fly at a safe speed, i.e. above stall speed and below maximum structural speeds, by adjusting thrust and pitch.

Buss: "Fly the green"

The BUSS will be displayed once all ADRs are switched OFF. Therefore, on aircraft that have the BUSS, when the flight crew cannot identify the faulty ADR(s) when performing the troubleshooting, or when all ADRs are affected, the flight crew will switch OFF all ADRs, and will fly the green area of the BUSS.

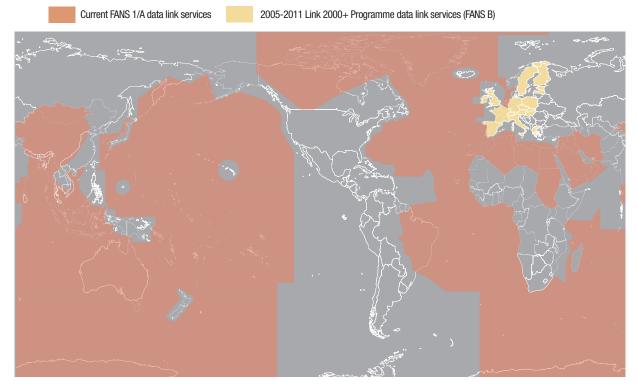
2007 Worldwide air traffic data link services

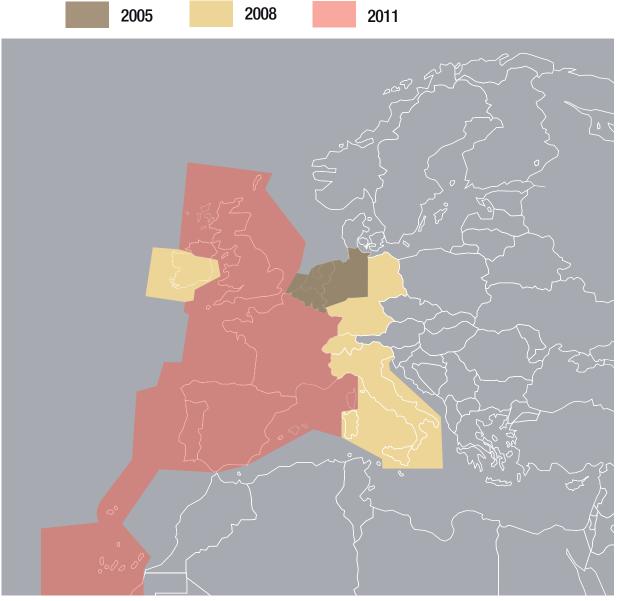
ANSP implementation plan

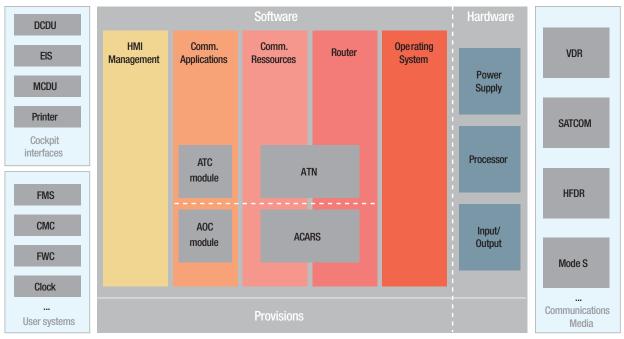
Air Traffic Services Unit - ATSU

The Airbus FANS B product offers, at aircraft level, over ATN air-ground communication network and through VDL Mode 2 sub-network, the data link applications and services (Context Management Application, Controller Pilot Data-Link Commu-

nication application and ATC Communication Management, ATC Clearance, and ATC Microphone Check services) in accordance with Link 2000+ Programme specifications.
