Unmanned Aircraft Systems: Identifying and Mitigating Hazards

U.S. National Transportation Safety Board

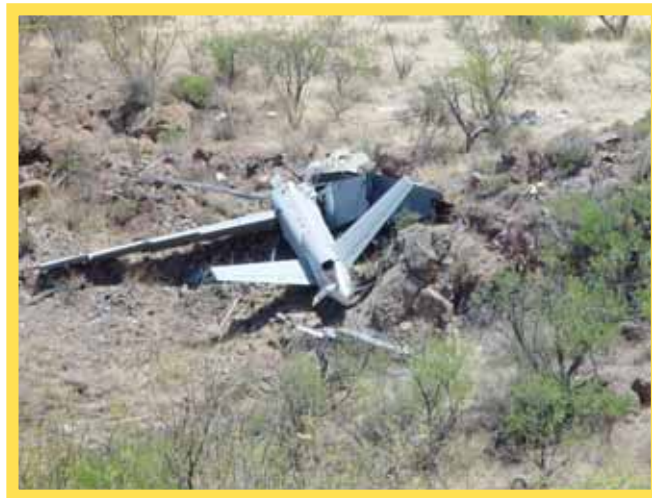
Fortunately, the UA did not collide with another aircraft during its accident descent, and no one on the ground was injured. However, the aircraft crashed less than 100 yards from a large house (see photo below). The NTSB determined that the probable cause of the accident was “the pilot's failure to use checklist procedures when switching operational control from a console that had become inoperable due to a ‘lockup’ condition, which resulted in the fuel valve inadvertently being shut

Photograph 1: Predator B UA Accident Site in Nogales, Arizona
