1 USE OF A PREDICTIVE MODEL TO AVALUATE SLEEP: ANALYSIS OF THE A330 5A-ONG ACCIDENT

RATIER-FIGEAC
Design-office

RAPPORT D'INVESTIGATIONS N°41 - DAI – 12	OT N°5739
Objet : Airbus 330 immatriculé 5A-ONG – accident survenu à Tripoli le 12/05/2010 – Analyse de dépôts ou particules observés sur un bouton de prise de priorité du mini-manche (Disconnect & Priority Switch)

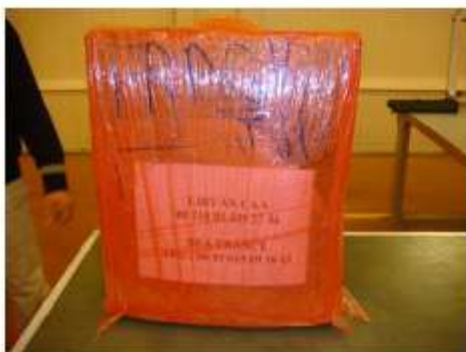
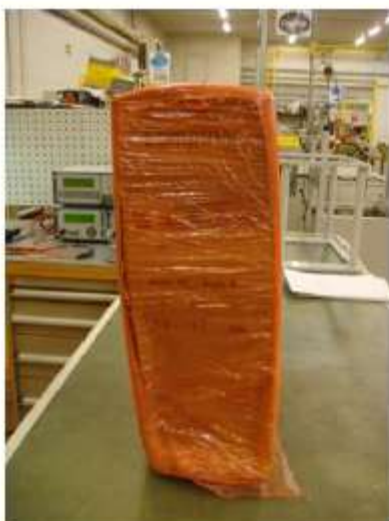
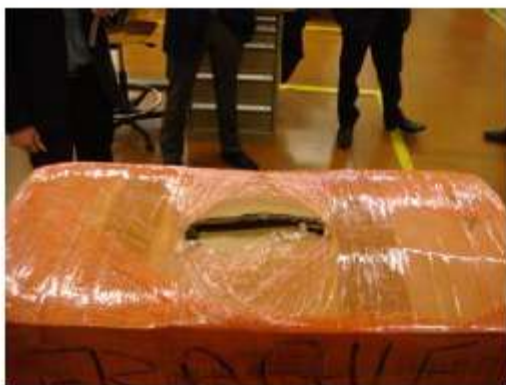
- SSu was brought by AFRIQIYAH Airways representatives, sealed in a plastic film.

Partial conclusion: nothing to report

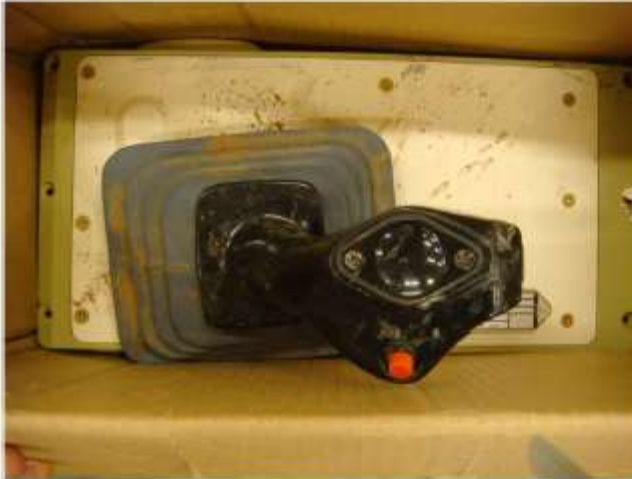
- SSU was removed from its box.

Partial conclusion: nothing to report

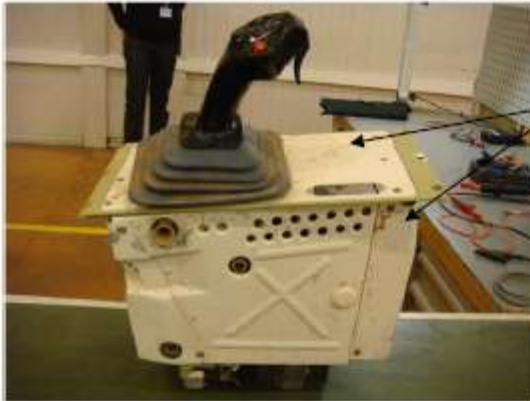
- View looking outboard

Evidences of dried liquid

Brown tracks = track of sand/dust on the covers, below, grip.

Partial conclusion: tracks of brown sand/dust

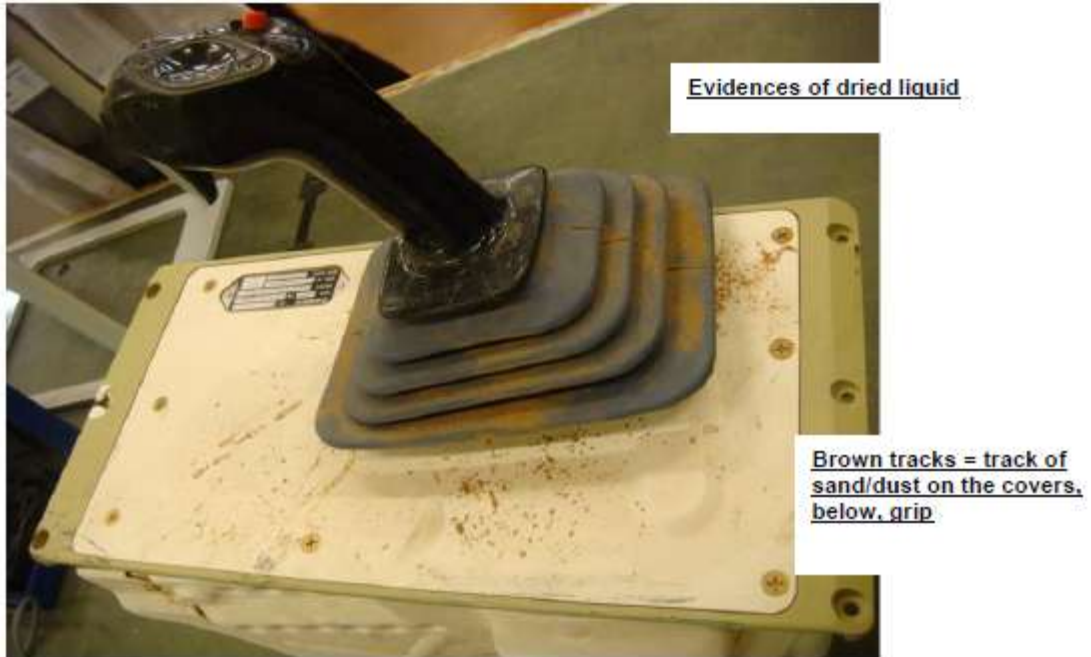
- View looking downward

Partial conclusion: tracks of brown sand/dust

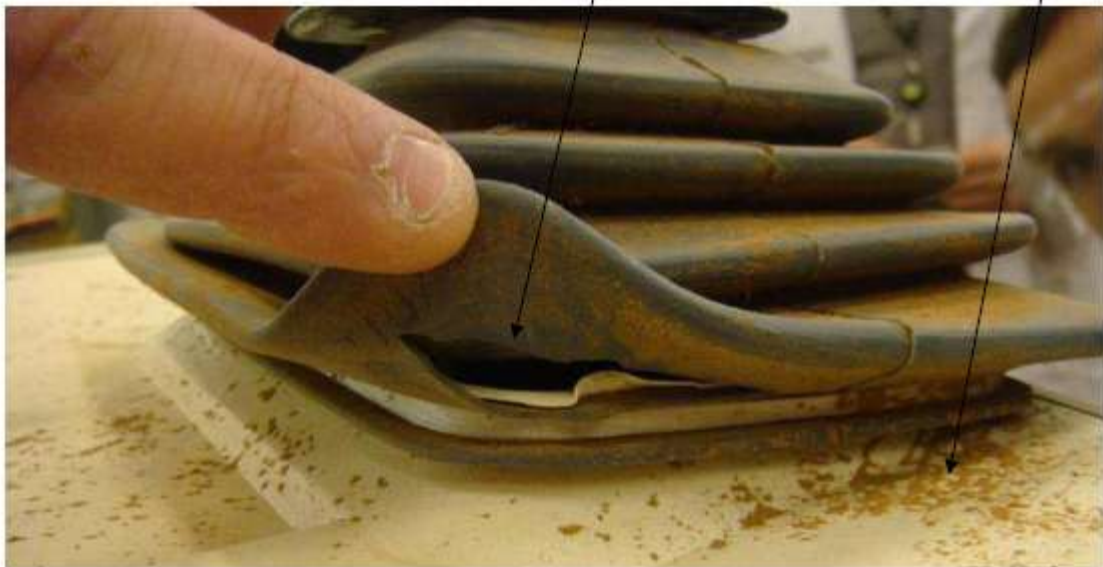
- View looking forward

Torn below in its rear part

Evidences of dried liquid

Partial conclusion: tracks of brown sand/dust. Torn below and of friction

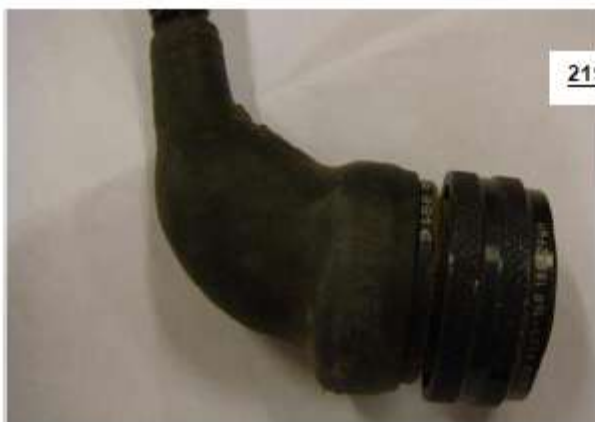
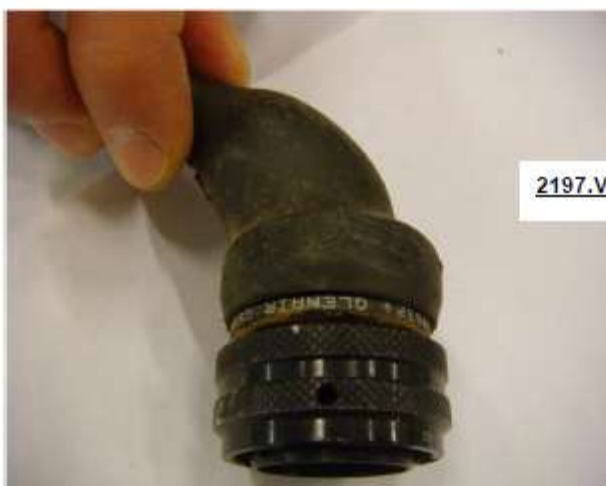
2197.VCA connector

No pin damaged

Partial conclusion: scratch on 2199.VCA connector. No cable damaged. No pin damaged.

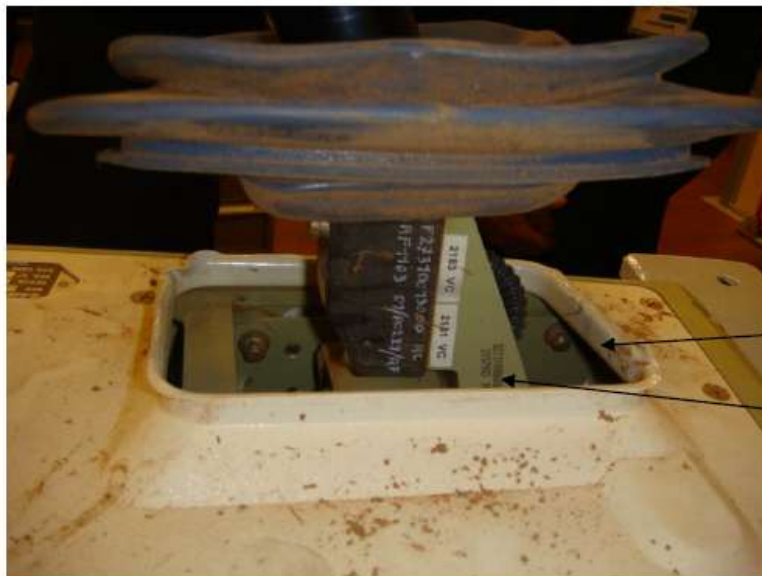
- View looking inboard

Brown tracks = track of sand/dust

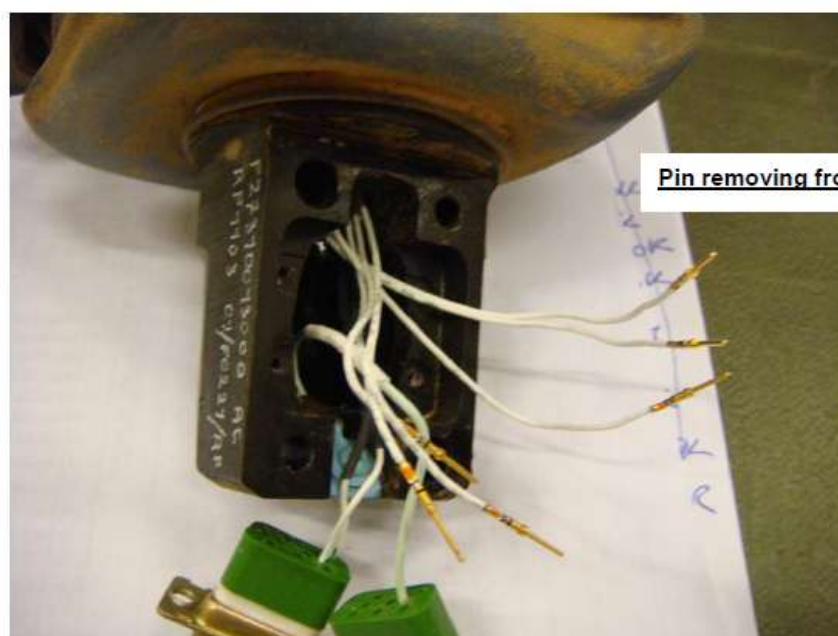
Removal of the 4 screws

Pin removing from the connectors

Partial conclusion: nothing to report

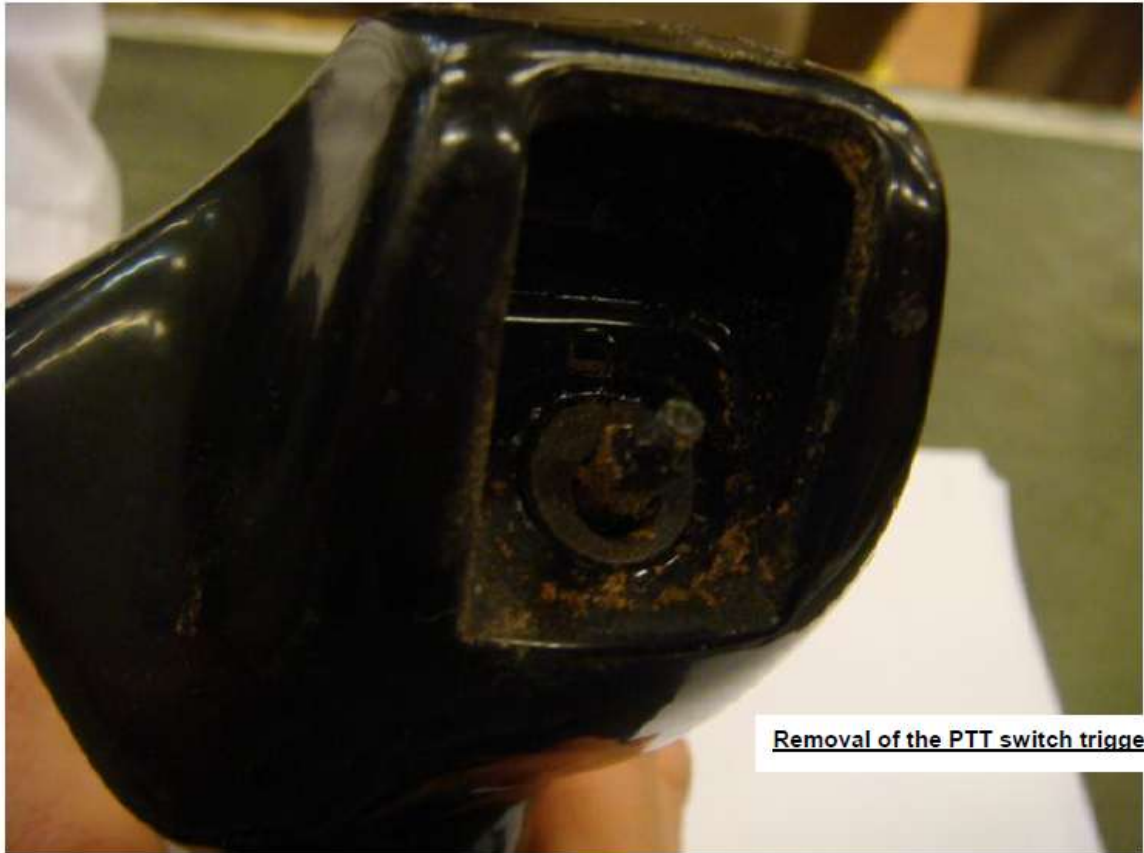
Removal of the PTT switch trigger

Partial conclusion: numerous tracks of brown sand / dust inside.

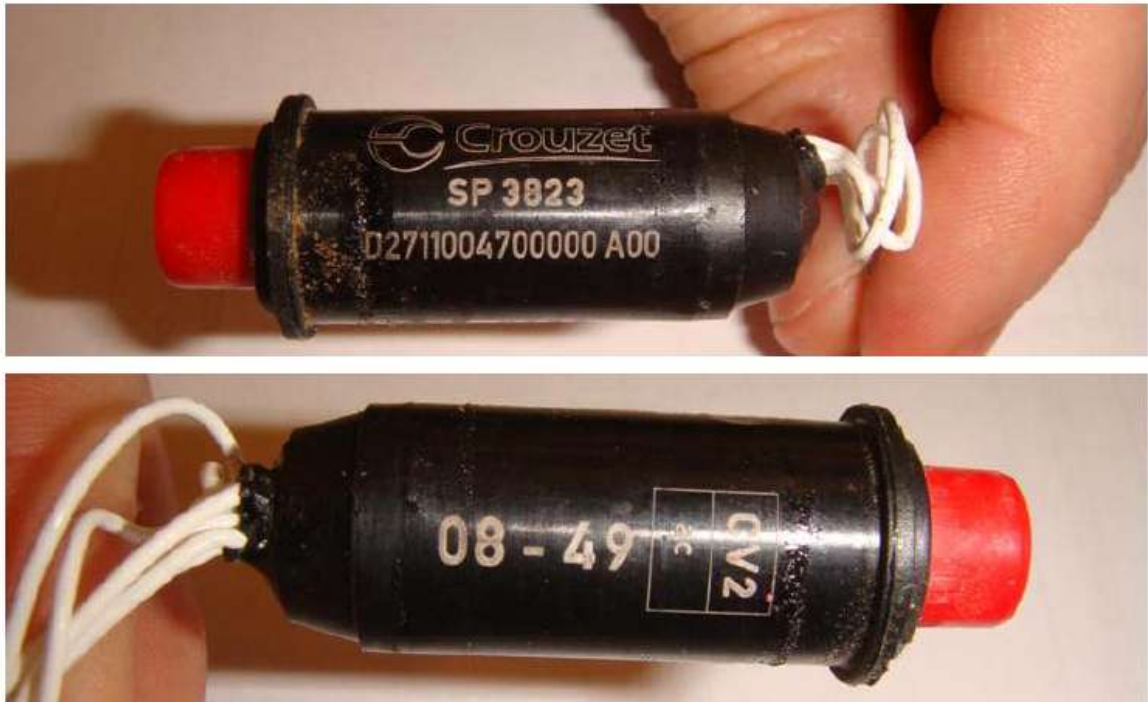
2.14 STEP14: A/P DISCONNECT AND PRIORITY SWITCH IDENTIFICATION

Partial conclusion: identification is correct

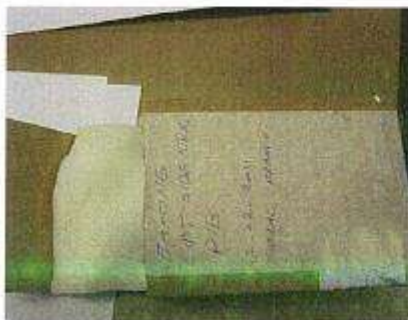
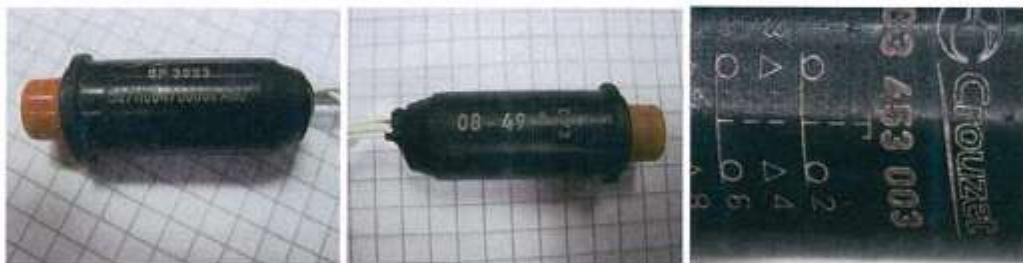
3.1 Step 1 Unpacking and identification

Partial conclusion: Identification is correct

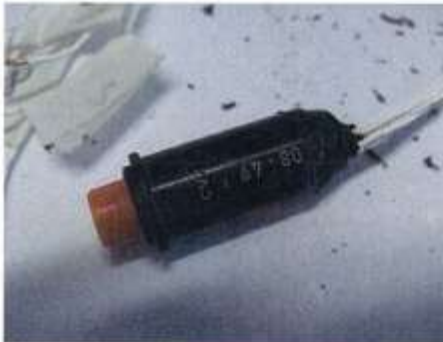
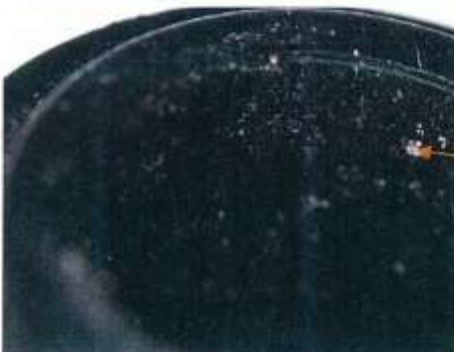
Sand and dust inside the housing

Partial conclusion: sand, dust, contaminant, have been detected inside the button

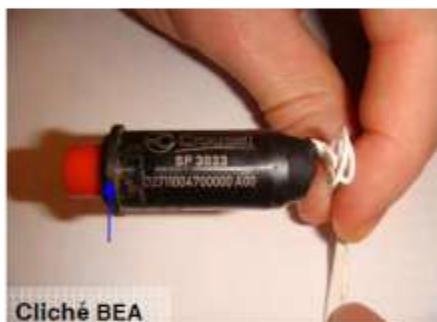
Cliché 1 : Vue d'ensemble
Traces de dépôts sur manchon noir

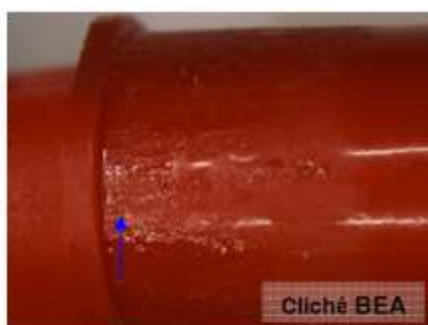
Cliché 3 : Bouton rouge
Traces d'un produit à l'apparence gras

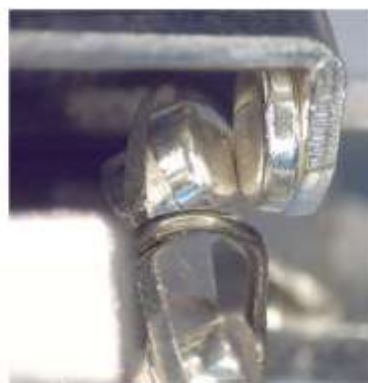
Cliché 6 : plots de contact
Absence de particules

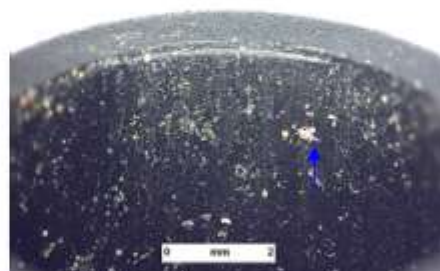
Cliché 8 : Manchon noir
Même constat - Présence de sable
